**MDCRS SITE FORM  
ARCHITECTURAL SITES  
Page 1**

Manuscript/Report Title: KLJ-Consolidated Telephone Cooperative Rhame Exchange:  
 A Class II and III Cultural Resource Inventory in Bowman and Slope Counties, North Dakota  
 Author(s): A. Kulevsky & E. Stine

Field Code: MAC-RE-L2

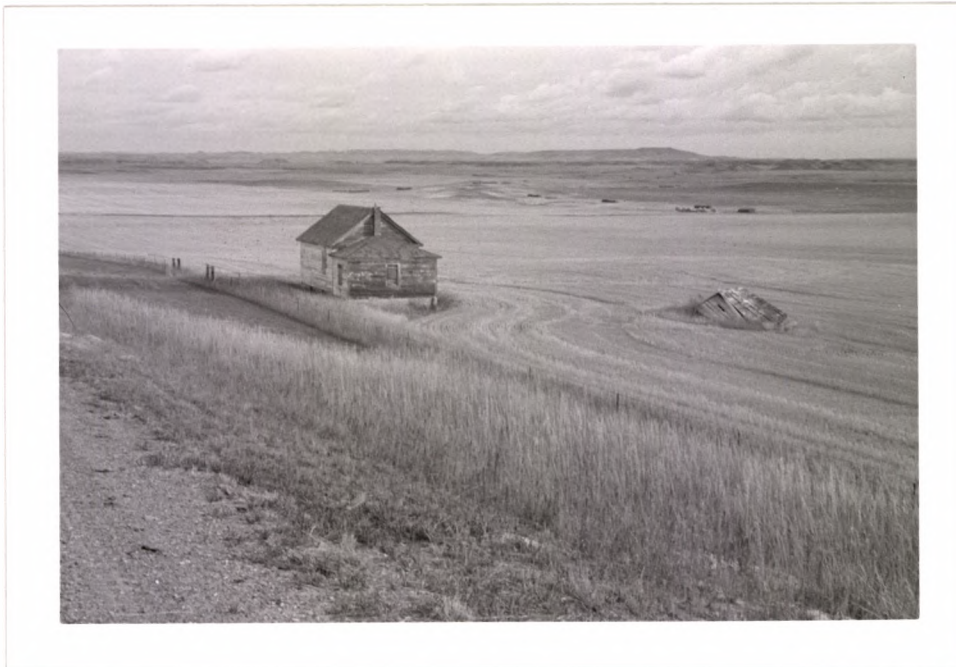
This site consists of one standing structure and one collapsed outbuilding. The standing structure is a schoolhouse measuring 12m x 6m. It has an asphalt shingle roof, horizontal wood siding, a brick chimney and a concrete foundation. The foundation is buckling and the exterior is quite weathered, but was painted white at one time. A porch on the east side of the structure has collapsed. The outbuilding is a collapsed, wood-sheathed structure with no evidence of interior walls. Integrity of this site is poor, and this site is probably not significant. Such school houses are common throughout rural North Dakota and many are in better condition. When the telephone cable for which this was recorded is installed, standing structures will be avoided.

View east-southeast of site (Roll #10/14/96, exposure #14).
