NDCRS ARCHITECTURAL SITE FORM
PAGE 1

Field Code Durham Township School #1 Site Name Durham Township #1
Site Name

Durham Township School #1

Field Code KLJ-DGK3 Site Name John Neva School #2
Site Name _____

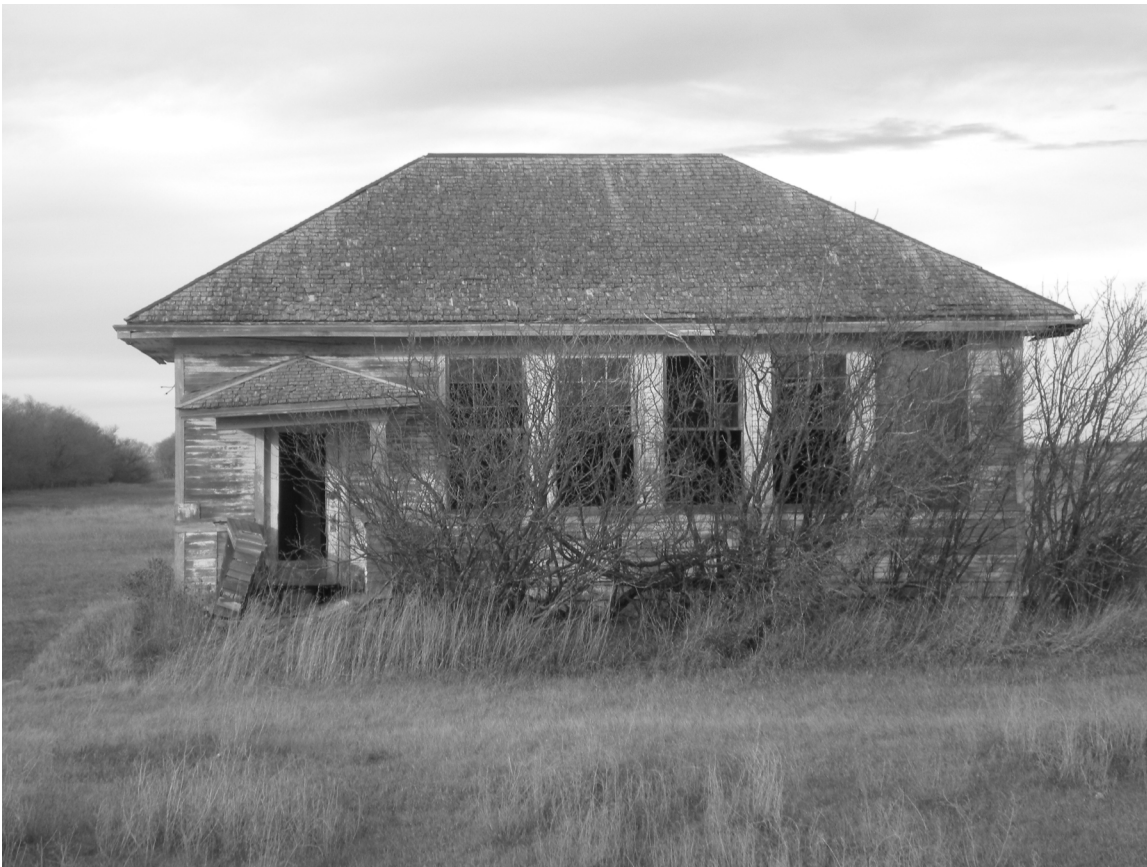
East Side

The exterior walls are sided with 6 inch wood lap with 4 inch wood corner trim with very little paint remaining. There is a watertable at the bottom of the 5 east facing windows and it is present at the same height on the three other sides. There is a portico at the east entrance, one of the columns holding the roof up has fallen away and one of the sidewalls of the entry is leaning toward the step. The portico roof has beadboard on the under side of the roof as well as the soffits. The step itself is concrete. There is part of a wood door at the entry, most of the panels have been kicked in. There is another entry door on the west side, giving access to what might have been the coal or wood storage area. A small door on the wall of the south side looks to be a fuel door. There are two smaller, double hung windows on the south wall giving light into the coat rooms. Also on the south side there are wires and a meter box to indicate electricity. The 5, multipane windows on the east side have some glass intact but much of the lower portion of windows is broken away. One of the windows is totally covered. Much of the framework is still intact.

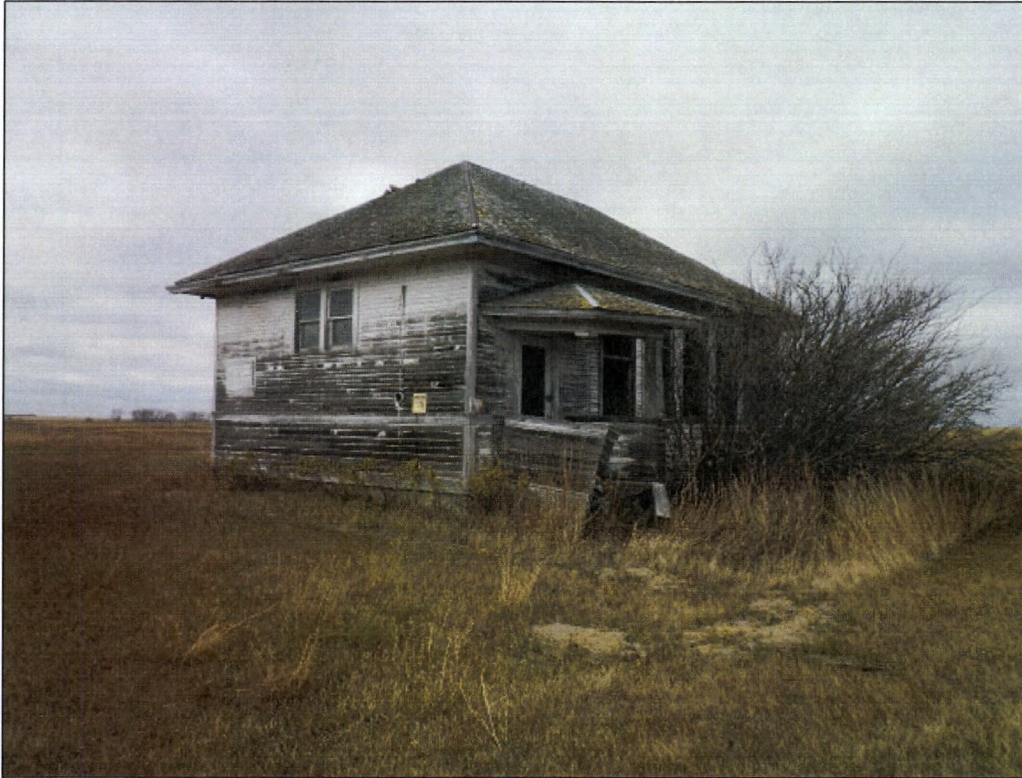
Figure 1: Overview of site, view to the northwest.

The building is wood-framed and is set on a concrete foundation. There are five double-hung windows on the east wall, and two on the south wall. The main entrance has a portico and knee-wall and roof leading to the east door. Siding consists of horizontal wood lap boards. A brick chimney was located on the west slope of the hip roof, but has collapsed.

The building is in moderately poor structural condition. It does, however, retain most aspects of cultural integrity, including setting, design, location, materials, workmanship, and feeling. The original site form recommended more work was required prior to a determination of significance. The updated site form recommended that the building is Potentially Eligible for the NRHP, but that historic associations would require further investigations.

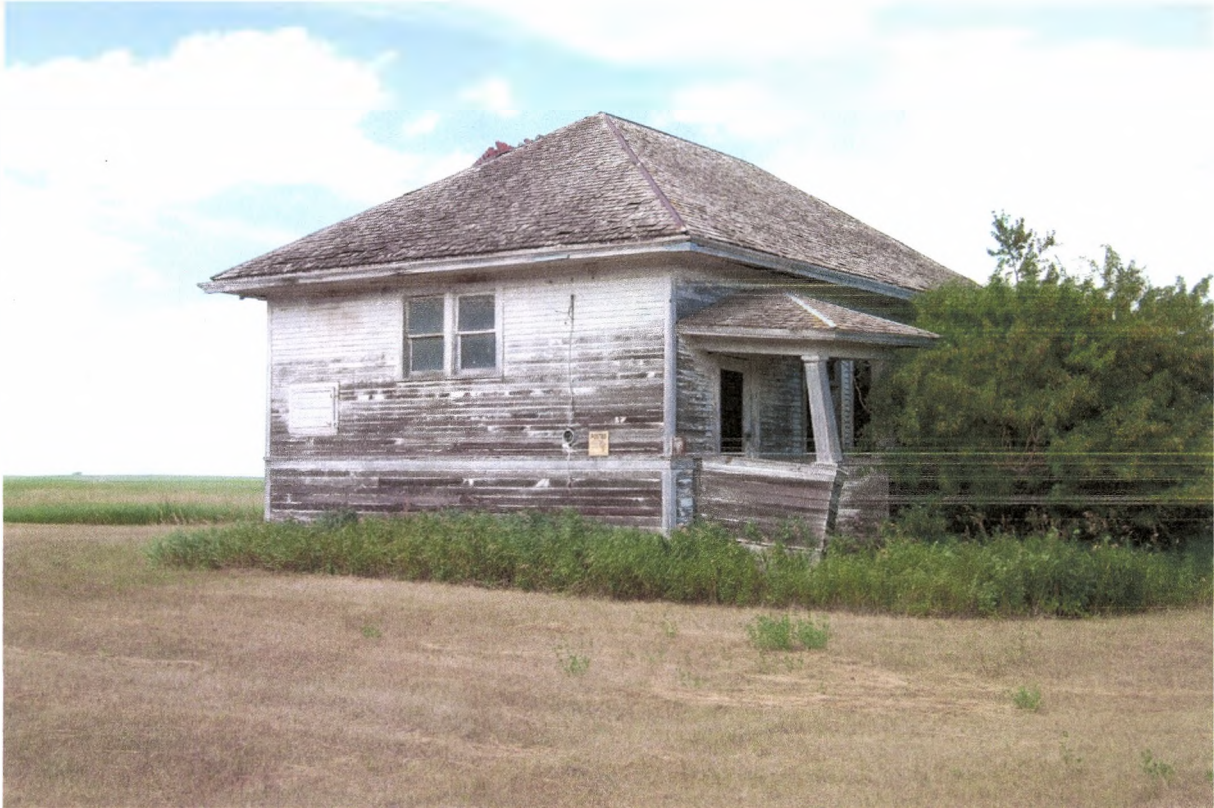
John Neva School #2, Feature 1, Facing northwest

Feature 1 is a simple rectangular plan school building on a concrete foundation. It has wood lap siding and a hipped roof with wood shingles. Five, large, double-hung windows are aligned on the east wall, where the primary entrance is covered by a portico with a knee wall and roof supported by square columns (partially collapsed). A second door is found on the west side. A brick chimney has collapsed on the west slope of the roof.

The building has long been abandoned, and is in poor condition. The windows and doors are broken and partially missing, the portico is beginning to collapse, and the brick chimney has fallen onto the roof. Despite these concerns with its condition, the integrity remains largely intact with original location, materials, design and workmanship giving it a strong sense of association and feeling.

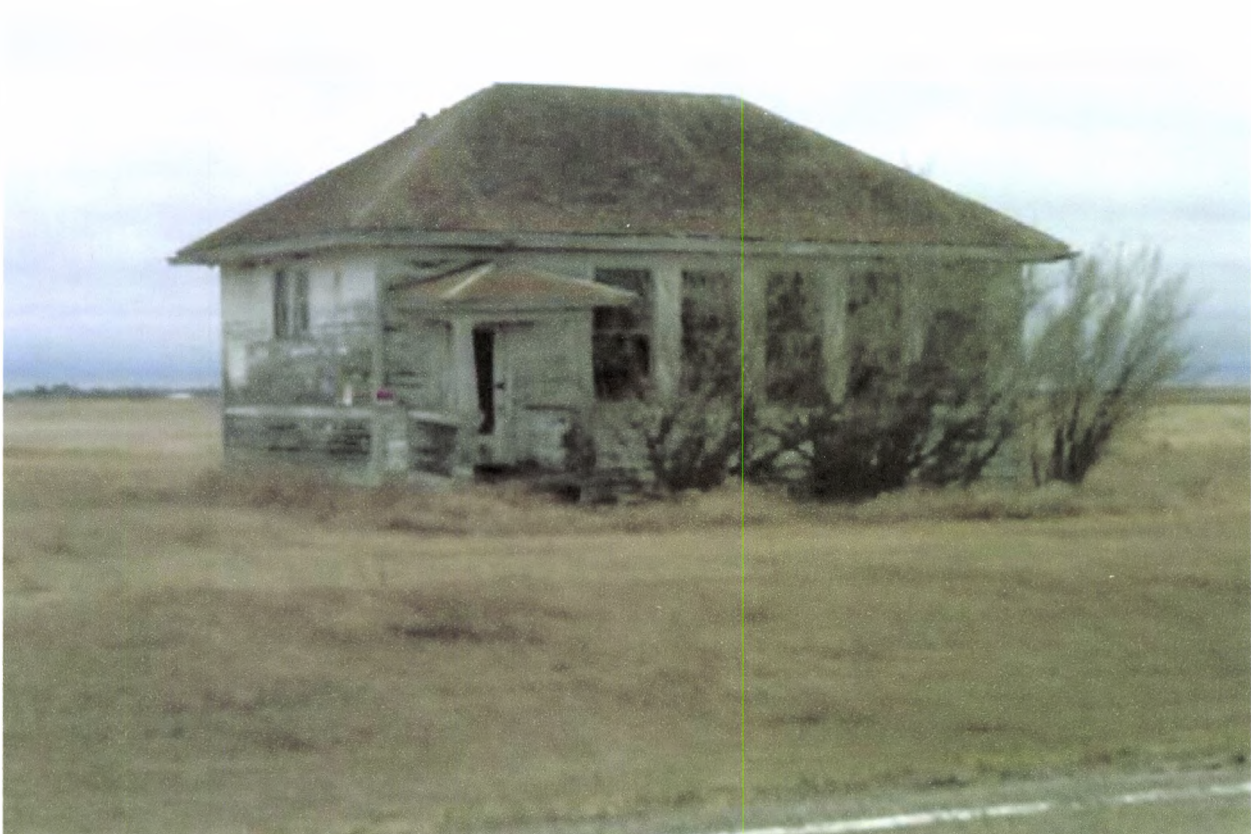
East Southeast

Feature 1 is believed to have been a school based on its architectural form and location. The east side has the main entrance on the south end with five tall double-hung windows. From the photograph, the entrance appears to be a hipped roof supported by the wall and square columns on the two front corners. A knee wall extends directly east from the building and supports the column on each side of the entrance. Two small windows are located on the center wall at the top of the south wall. Views of the north and west sides were not available and the foundation could not be seen from the right-of-way. This is a typical form for a school house in North Dakota with possible exception of the entrance. More research needs to be done before eligibility can be determined.
