NDCRS ARCHITECTURAL SITE FORM

Field Code Schultz School	SITS# 32 SN 825
SITE IDENTIFICATION Map Quad Woodworth	Site Name Schultz School
Map Quad	Site Name
LTLTWP	QQQ QQ Q QQQ QQ Q
NAD 1983, UTM 5223047 N NAD 1983, UTM 477094 E	ZONE 14N Subsection: 1 = N½
City: Woodworth	2 = E½ 3 = S½
Street Number:	$4 = W\frac{1}{2}$ $5 = NE\frac{1}{4}$
Street Name: 56th Ave SE	6 = SE¼ 7 = SW¼
Urban Legal Description:	8 = NW1/4
SITE DATA	
Total # Architectural Features: 1	
Fieldwork Date: 9/2/2018	
Reconnaissance Survey Inter	nsive Survey
Project & Principal Investigator: Country Schoolhouse Project	
Report Title & Author(s):	
Contracting firm or Agency completing the for	m:
Additional Information:	
2100.002	
Area of Significance Area of Significance Ecozone Ecozone Ecozone	9 Verified Site 1 CR Type 2
Kathy Wilner	Date Recorded 1/22/2019
Recorded By (First Name & Last Name)	Date Recorded(mm/dd/year)

Shultz School

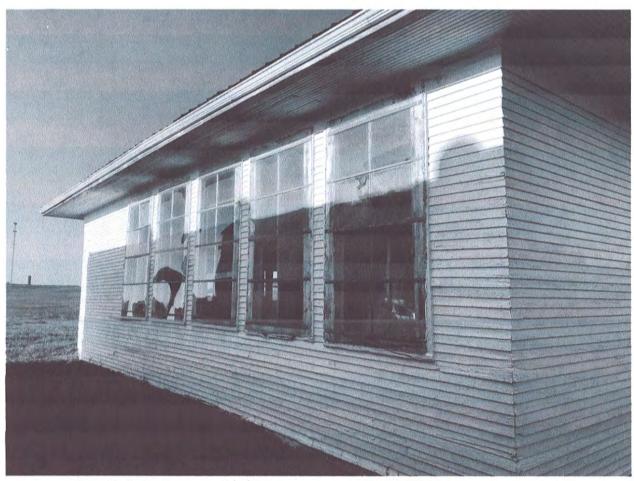
East Side

There is a frieze board just under the eaves on all four sides to start the siding. The remainder of the siding is 6 inch wood lap. There are 5 large, 4 over 4, double hung windows on the east wall of the school. Some of the glass is broken and all 5 are covered with sheets of plexiglass. On the south wall of the school there are two smaller double hung windows. The wall here shows that an entry was persent in the past. The door is a broken wood door with plexiglass on the top half. Another wood door is on the addition on the west, both locked. A small room is in the southwest corner of the building with two door openings, no doors. On the southeast wall there is a row of coat hooks and the remanents of a door frame leading me to think this was a coatroom at one time. The door leading in from the west addition is a 5 panel wood door. There is framing on the west wall from the door to the northwest corner and again on the north wall that outlines where the blackboards were. They have been removed. The walls and ceiling are finished with lathe and plaster with much falling in. There is a picture rail around the entire school room. The floor is tongue and groove hardwood. No wainscot and no evidence of electricity.
