NDCRS ARCHITECTURAL SITE FORM PAGE 1				
	FAGE	SITS# 32	<u>st 192</u>	
SITE IDENTIFICATION				
Field Code Sherbrook#1	Site Name	Sherbrooke #		
Map Quad_ <u>Sherbrooke</u> Map Quad	Site Name			
LTL TWP46 R55 LTL TWP R LTL TWP R LTL TWP R	SEC QQQ _ SEC QQQ _	QQ	Q <u>8</u> Q Q Q	
UTM5252778 UTM595966	_N ZONE _E NAD 1	<u>14N</u> 927 NAD 1983	Subsection: $1 = N\frac{1}{2}$ $2 = E\frac{1}{2}$	
City:			$3 = S^{1/2}$	
Street Number:			$4 = W^{1/2}$ 5 = NE ¹ / ₄	
Street Name: 132nd Ave NE			6 = SE ¹ / ₄ 7 = SW ¹ / ₄	
Urban Legal Description:			8 = NW ¹ / ₄	
SITE DATA				
Total # Architectural Features:	1			
Fieldwork Date:5/16/2016	_			
Reconnaissance Survey 🗹	Intensive Survey			
Project Title & Supervisor: Country Schoolhouse Project				
Report Title & Author(s):				
Additional Information:				
SHSND USE Area of Significance Area of Significance Area of Significance Area of Significance	Verified Site Non-Site	CR Type	2

NDCRS ARCHITECTURAL SITE FORM PAGE 3—Feature Data

Field Code Sherbrook #1

1. Feature Description, Integrity, Eligibility:

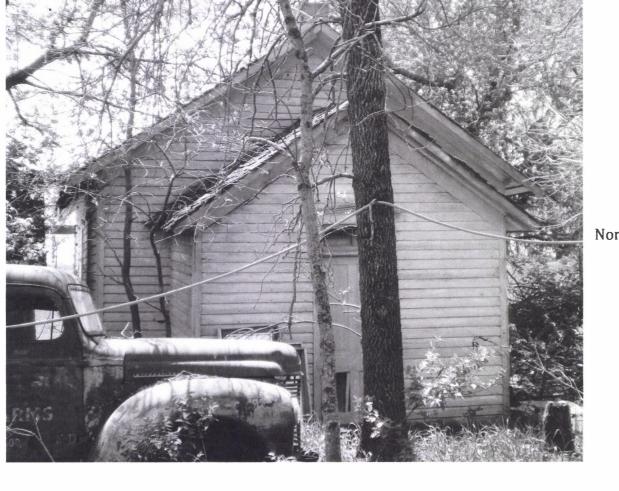
North Side

The feature is a one room prairie school sitting on a concrete foundation. This has been moved to the farm for storage and use of a shop. The gable roof of the school and entry is covered with wood shakes and topped with metal capping and finials at each end. There is a short, concrete chimney at the north end of the school. The soffits are open. This building
