NDCRS SITE FORM  
ARCHITECTURAL SITES  
Page 1

Field Code LH-02-5-2 Site Name MAZA SCHOOL  
Field Code \_\_\_\_\_ Site Name \_\_\_\_\_

Manuscript/Report Title: U.S. 281 RESURVEY

PROJECT TITLE: Project Nos. SER-3-281(072)160 and SER-3-281(071)156, US 281 North of Minnewaukan to North of ND 19 and US 281 South of Minnewaukan

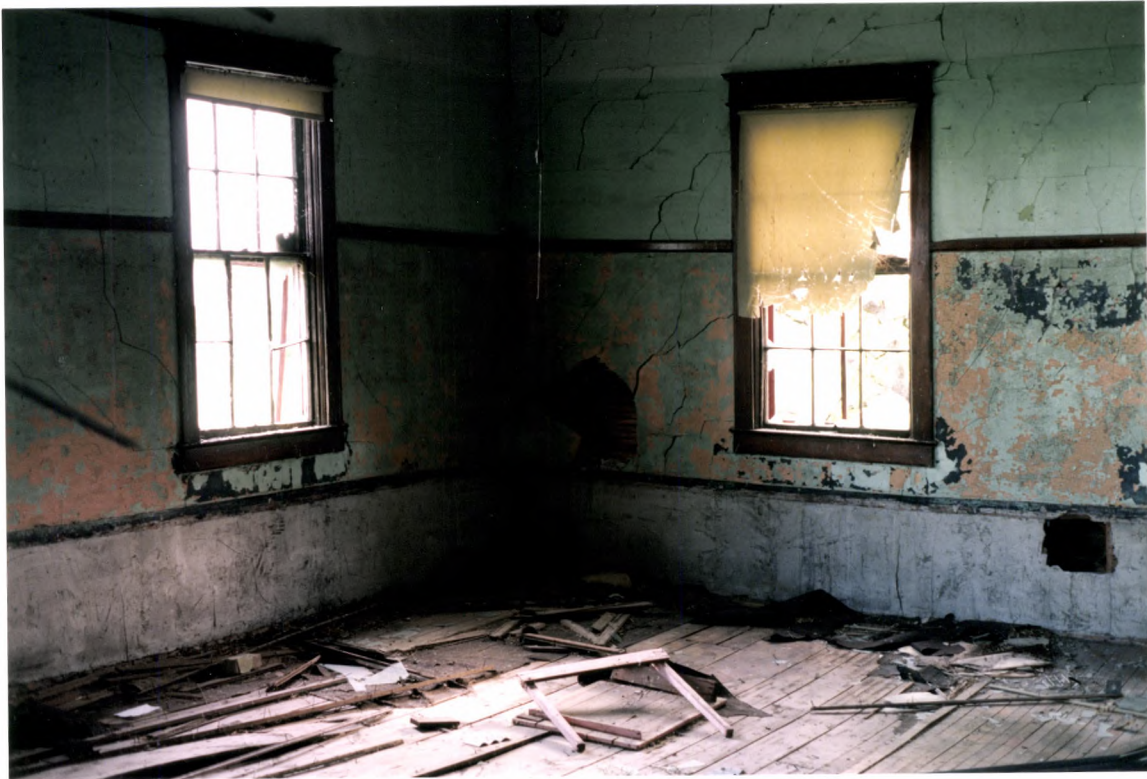
Feature # 1, south room, view from doorway in the northeast corner of the room, roll 1, frame 29.

The building is rigidly symmetrical in floor plan as well as in its exterior appearance. An entry vestibule, 10' x 15', is centered on the east wall. At the south side of the vestibule is a basement stairway, lit by a narrow 4/4 double hung window. On the north wall opposite this window is an opening that originally carried the same sash configuration; today the sash are missing and an eight-light storm sash sits in the opening. On the west wall of the vestibule are doorways, each with a five-panel door with single light transoms, from which the glazing is missing, leading into the two classrooms. These are also five-panel doors. The classrooms measure approximately 27' x 30'. They carry two 6/6 double hung windows on their south walls and three 6/6 double hungs on their north and south walls respectively. On their east walls are cloakrooms measuring approximately 6' x 15'. The south classroom cloakroom contains two doors; the north classroom cloakroom contains only one. Centered on the east walls of the cloakrooms are paired 4/4 double hung sash. Walls are covered with bevel edged tongue and groove wainscot with lath and plaster above. Floors are tongue and groove maple. Originally a picture rail encircled each classroom, but these are now missing. "Blackboards" created by application of numerous coats of black paint (?) applied directly to the lath and plaster encircle each classroom.

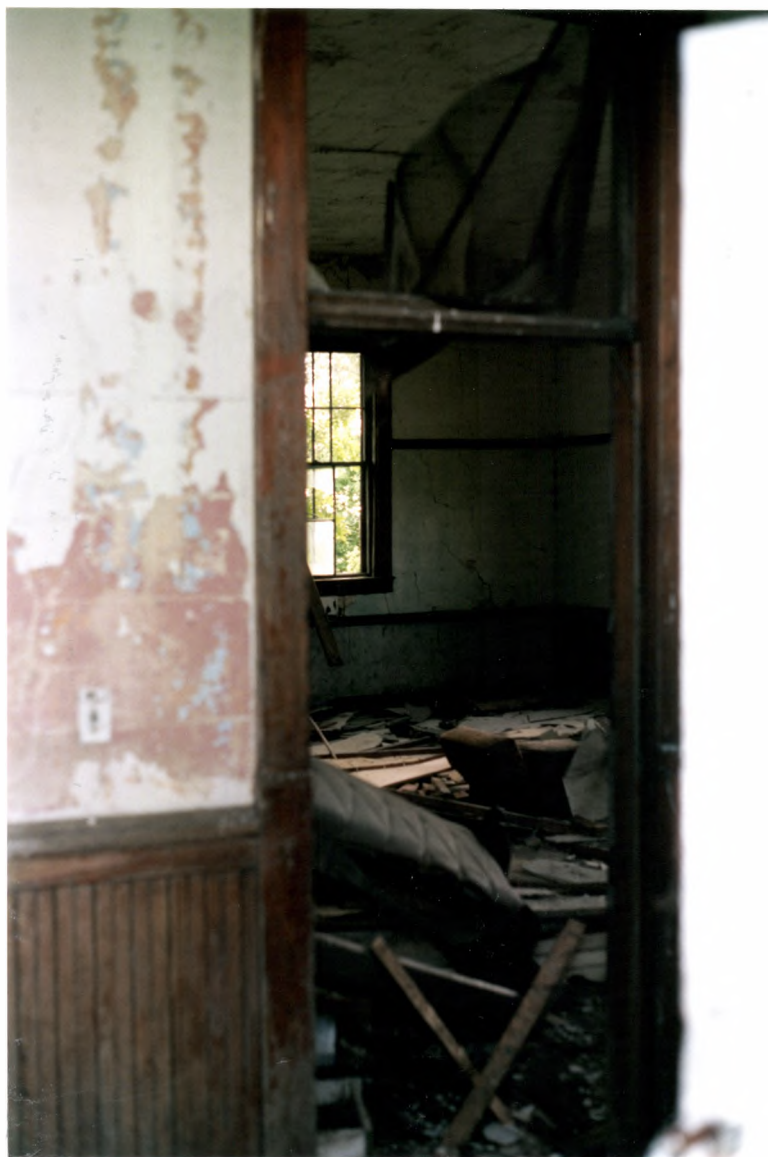
Feature # 1, north room viewed through entry vestibule and doorway in southeast corner of room, roll 1, frame 28.

The building is in very poor physical condition. The wall at the southwest corner of the building has begun to sag, leaving a visible gap between the wall and roof. The floor on the west side of the classrooms has begun to collapse, leaving a sag of some 6" to 7" and causing the wall to separate from the ceiling.

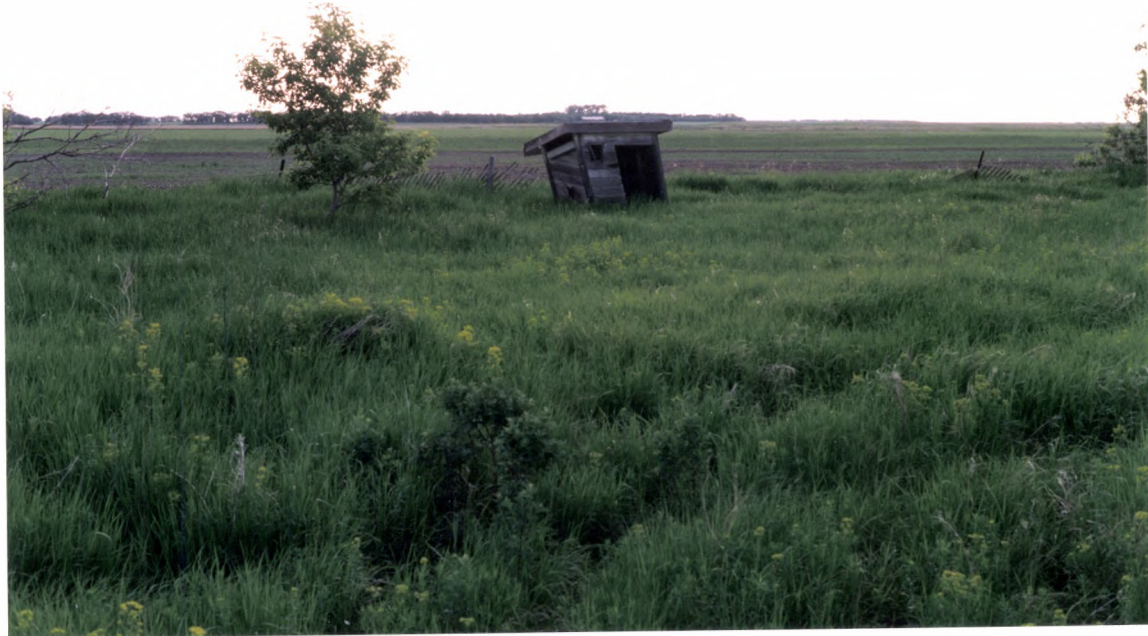
Feature #2, view from southeast, roll 1, frame 31.

This feature is a wood framed, shed roofed, privy measuring approximately 4' x 6'.

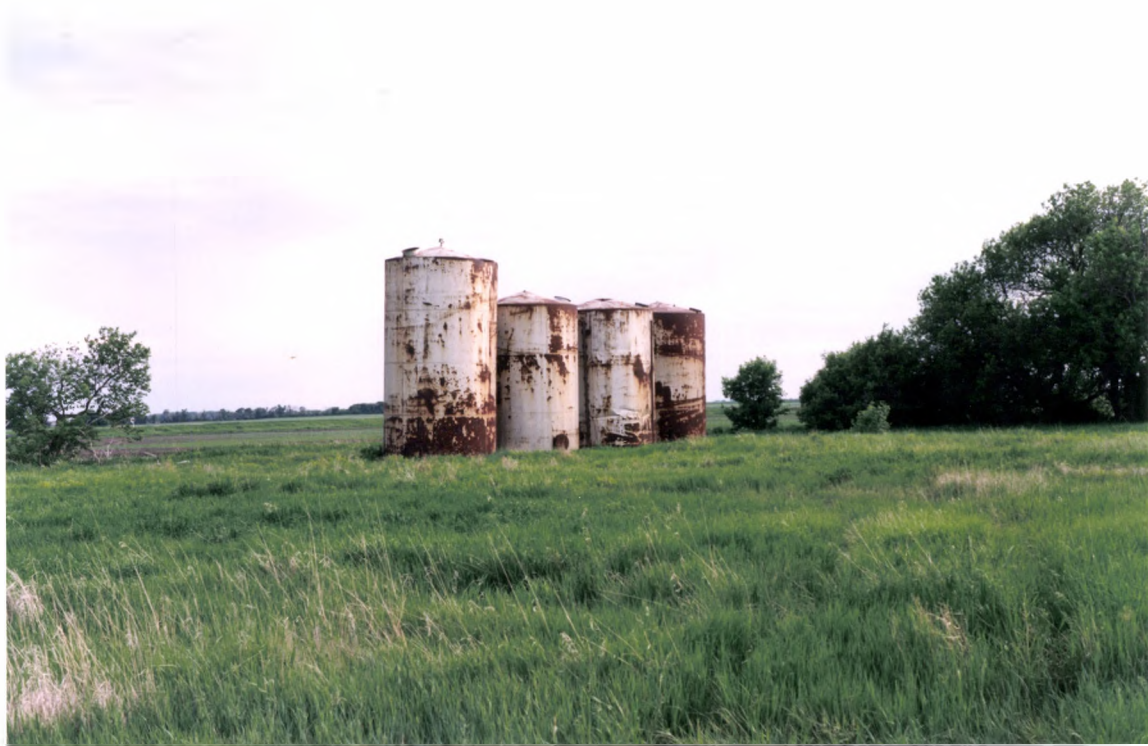
Features # 3 and 4, view from northeast, roll 1, frame 33.

This feature cylindrical oil tank constructed of welded sheet steel plates. It has a conical roof and is approximately 8' in diameter and 20' tall.

This feature consists of three identical bulk oil storage tanks constructed of welded sheet steel plates. They have conical roofs and are approximately 8' in diameter and 16' tall.

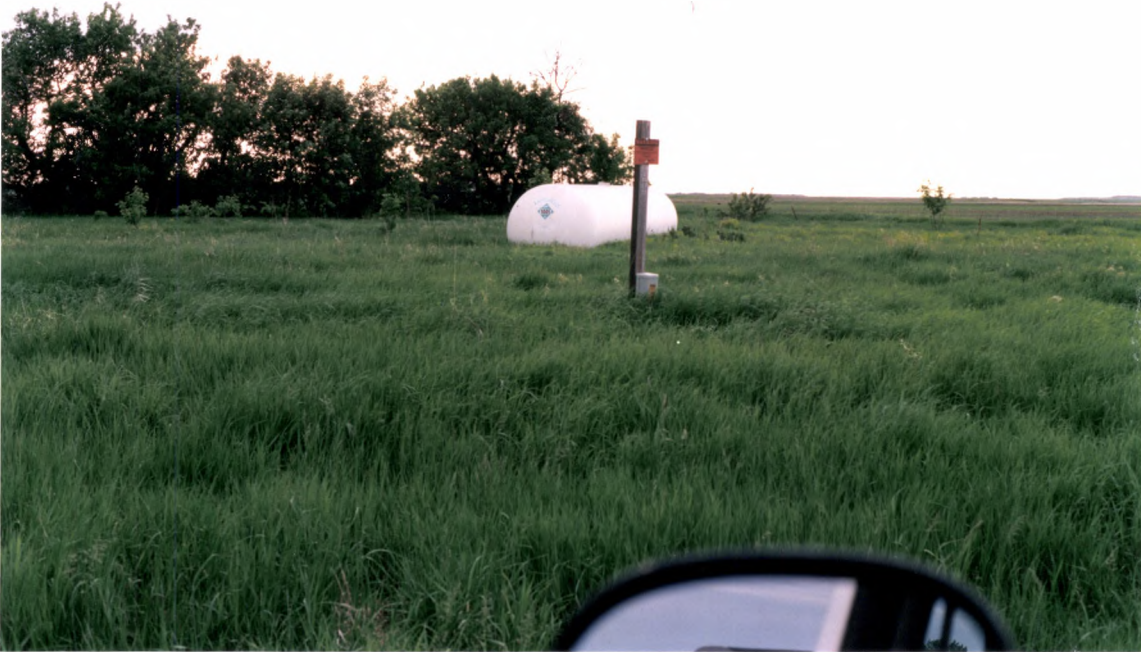
Feature # 5, view from southeast, roll 1, frame 34.

This feature is a welded steel tank, approximately 6' in diameter and 18' long, for anhydrous ammonia storage.

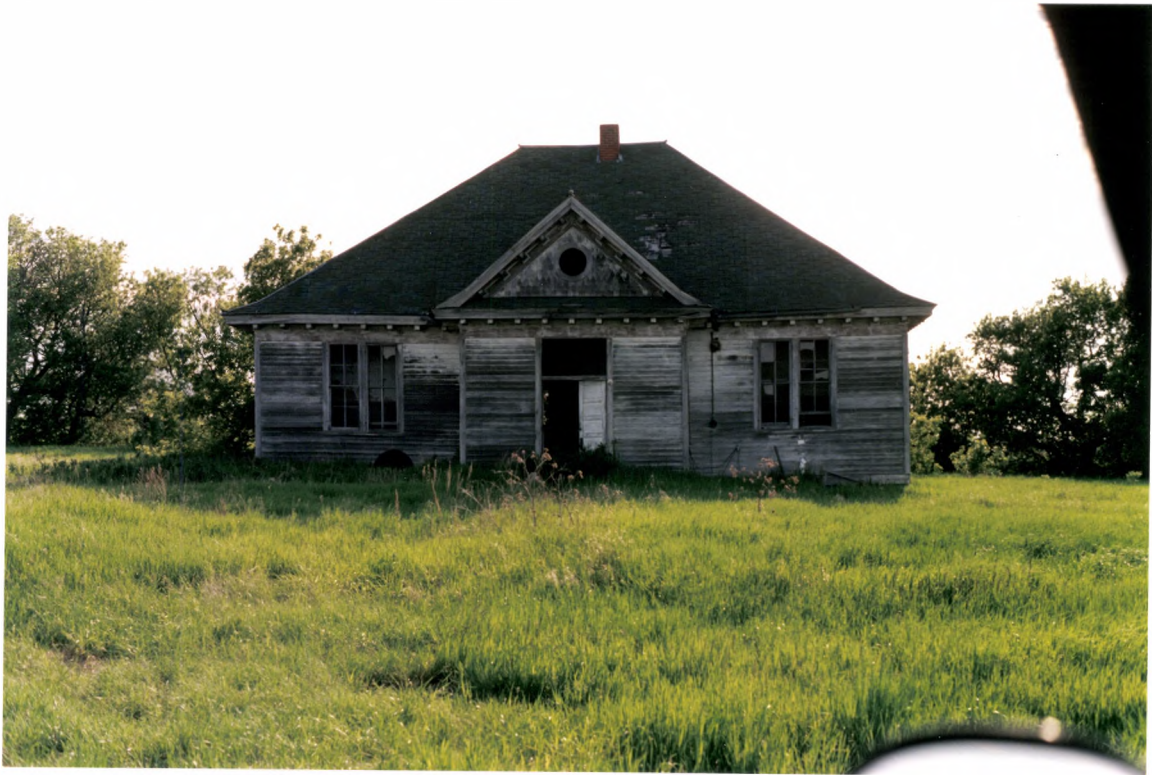
Feature #1, view from east, roll 1, frame 27.

This building was the Maza School. It sits on a block of land, 150' x 300', purchased by the Gopher School District No. 4 in 1907 from R. J. and Laura E. Walker of Towner County, North Dakota, two months before the block was platted. It is a two room school, approximately 36' x 45' rendered in the Colonial Revival Style. The building has a basement, which is inaccessible due to the collapse of its stairs. The foundation wall is poured concrete. It is somewhat unusual in that it appears to have been scored to present the appearance of rusticated concrete block set in mortar, but the mortar joints are applied to the face of the block and serve only a decorative purpose. The building is of wood frame construction, with a hipped roof, weatherboard siding and 4/4 double hung windows, paired 4/4 double hungs, and 6/6 double hungs. The building is basically rectangular, its long axis running north /south. A gable-roofed vestibule is centered on the north wall; the gable peak sports decorative shingles. Centered on the vestibules east wall is a double-leafed door; the doors are five-paneled. The closed soffits are deep and carry a stylized dentil band.
