DESCRIPTION OF SITE This site is an abandoned farmstead located within the Forest River bottoms. It includes a building that was once in use as a school in the Fordville district. A number of grain wagons and parts are located in the woods to the south of this site and were recorded as features.  
 SIG. FEAT. FEATURE 1: HOUSE; FEATURE 5: SCHOOLHOUSE.

11. Project Title/P.I. 1985 Forest River Archaeological Survey, Thomas K. Larson

Continuation Sheet, LT295

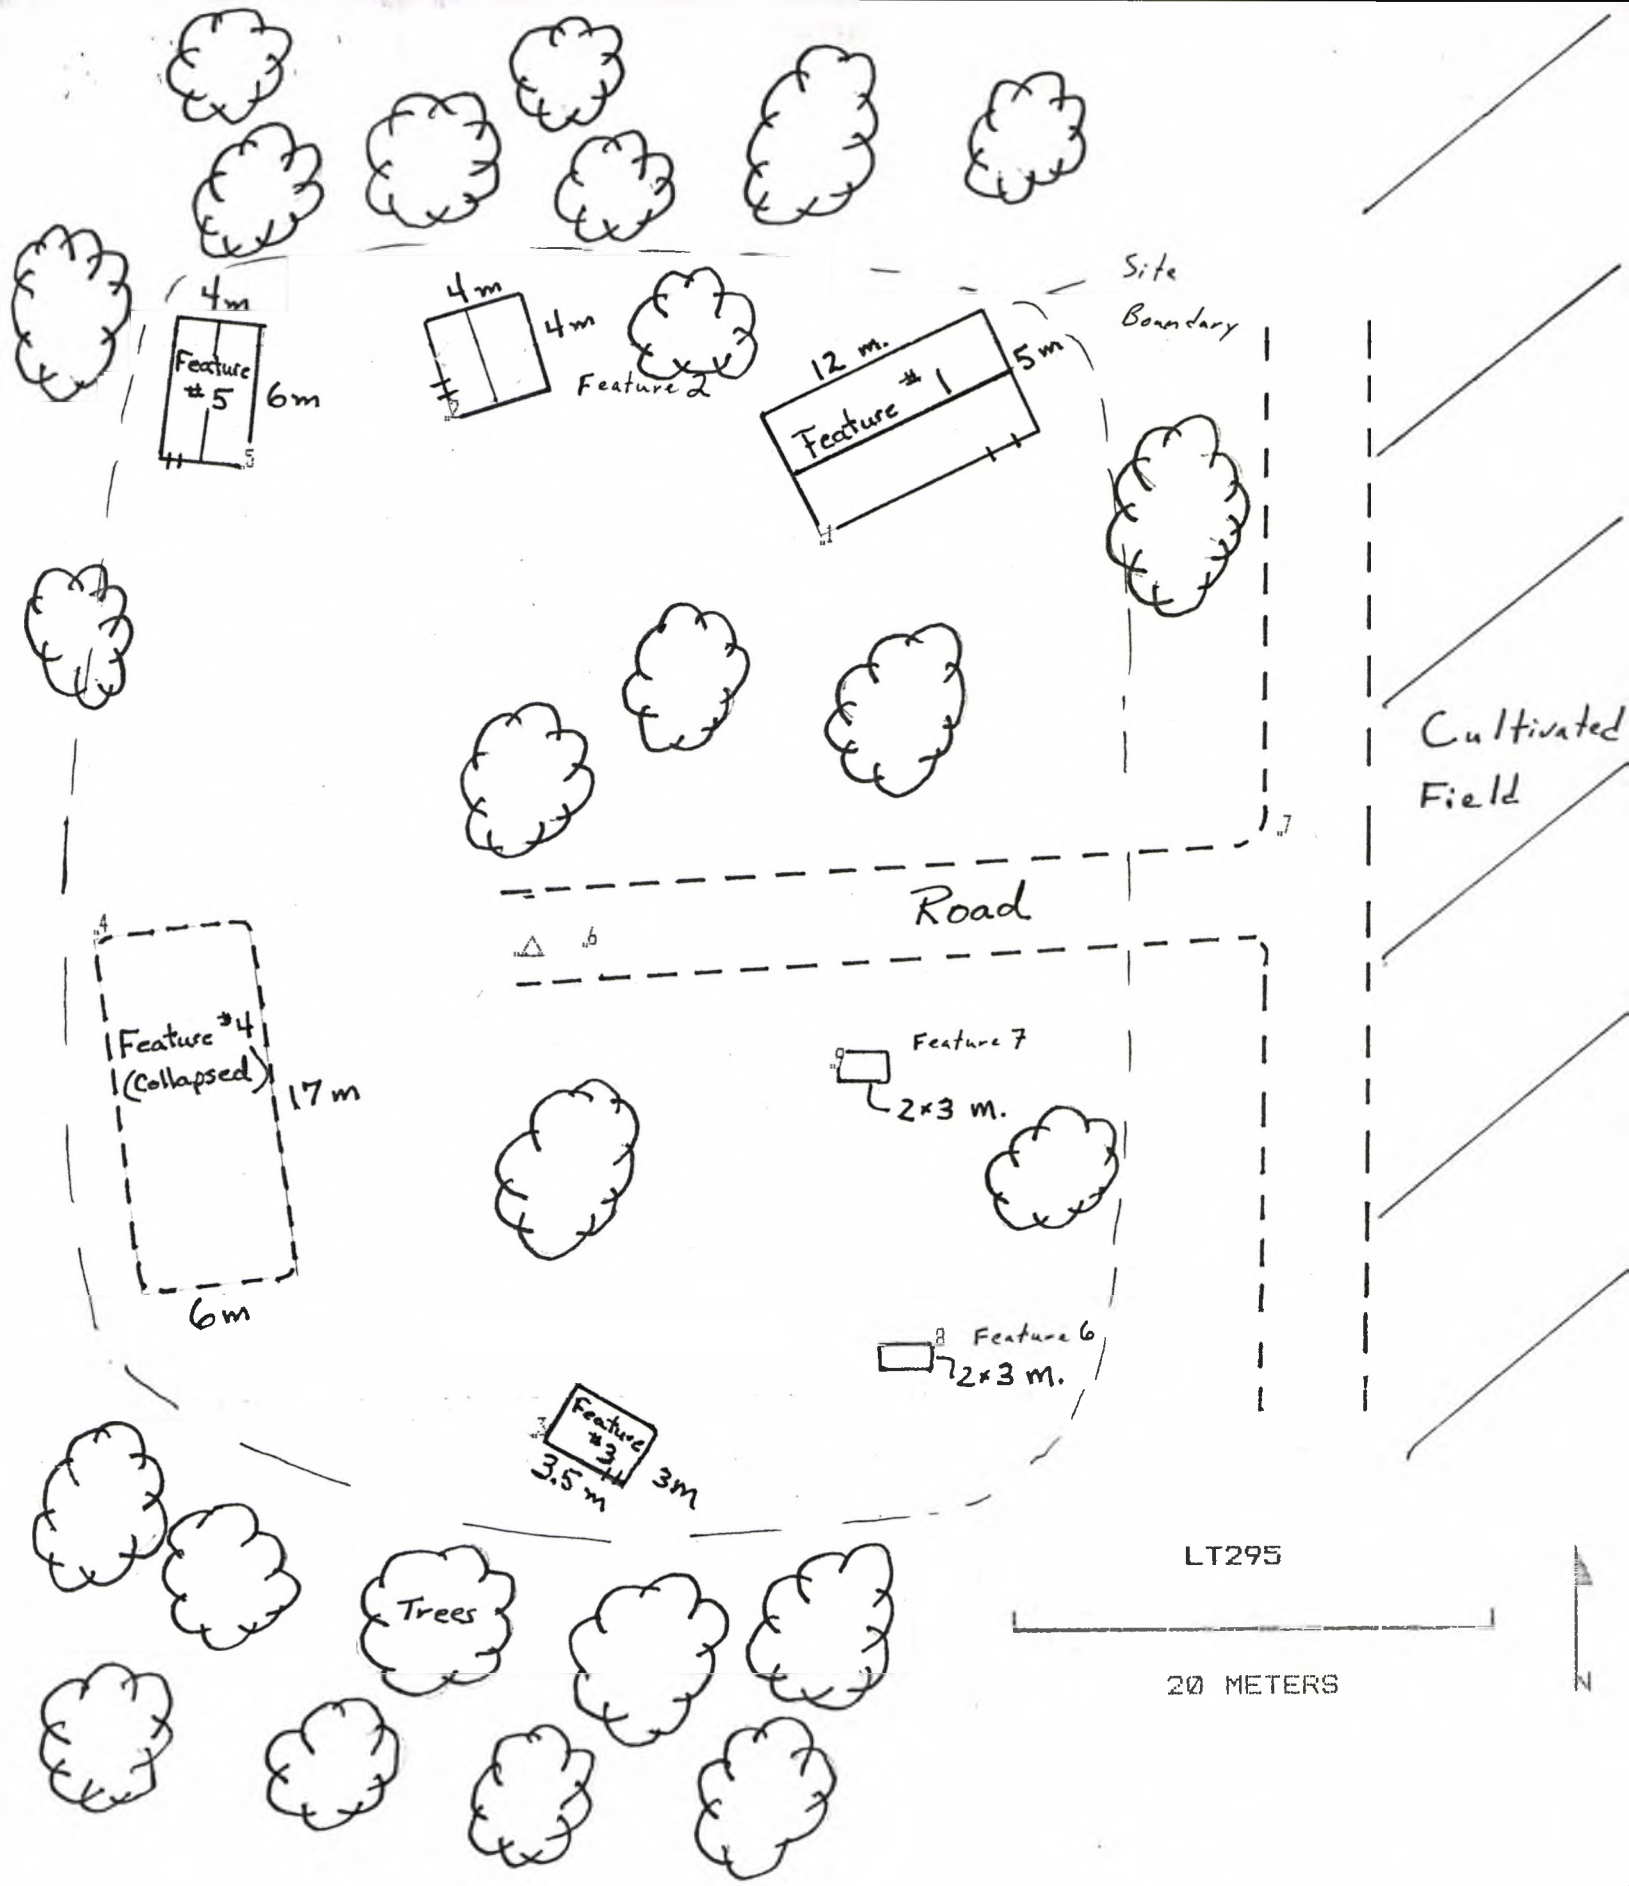
MAP LEGEND  
SITE LT295

- 1 1  
Feature 1
- 2 1  
Feature 2
- 3 1  
Feature 3
- 4 1  
Feature 4
- 5 1  
Feature 5
- 6 1  
Road
- 7 1  
Road
- 8 1  
Feature 6
- 9 1  
Feature 7

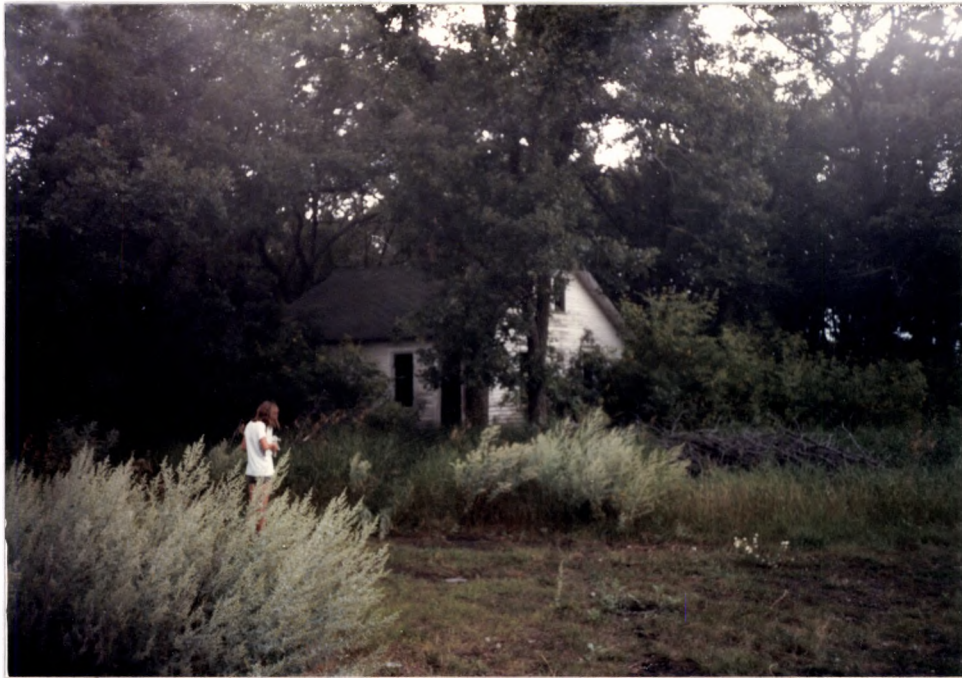
Small add-on on west side of structure that was apparently in use as a pantry or a kitchen before the house was abandoned.  
This house has been vandalized a number of times. While it appears to be in good condition structurally, the interior walls & ceilings have suffered extensive damage.

LT295, FEATURE 1, VIEW TO NORTHWEST (ROLL 16, FRAME 13, COLOR PHOTO, NEGATIVE STORED AT LARSON-TIBESAR ASSOCIATES)

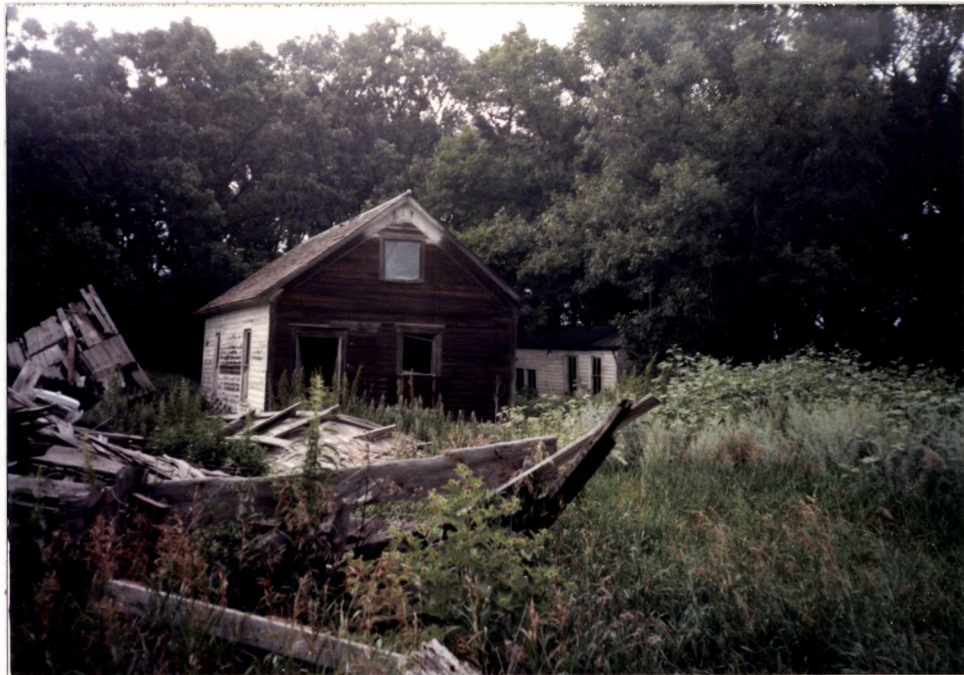
FEATURE DESCRIPTION According to our informant, Mr. Jon McMillan of Fordville, North Dakota he paid \$22 for this building, which was once a schoolhouse in the Fordville district. He didn't get the building moved in time, so the Henry's (this landowner) purchased it and moved it onto this site.

Feature 2, small outbuilding/storage shed, poor condition, rectangular shape, entrance to west, wood frame construction with horizontal wood siding, no porch, no basement, wooden foundation, 1 story, wood cornices, gable roof, undated.

LT295, FEATURES 5 AND 2, VIEW TO NORTH (ROLL 16, FRAME 9, COLOR PHOTO, NEGATIVE STORED AT LARSON-TIBESAR ASSOCIATES)

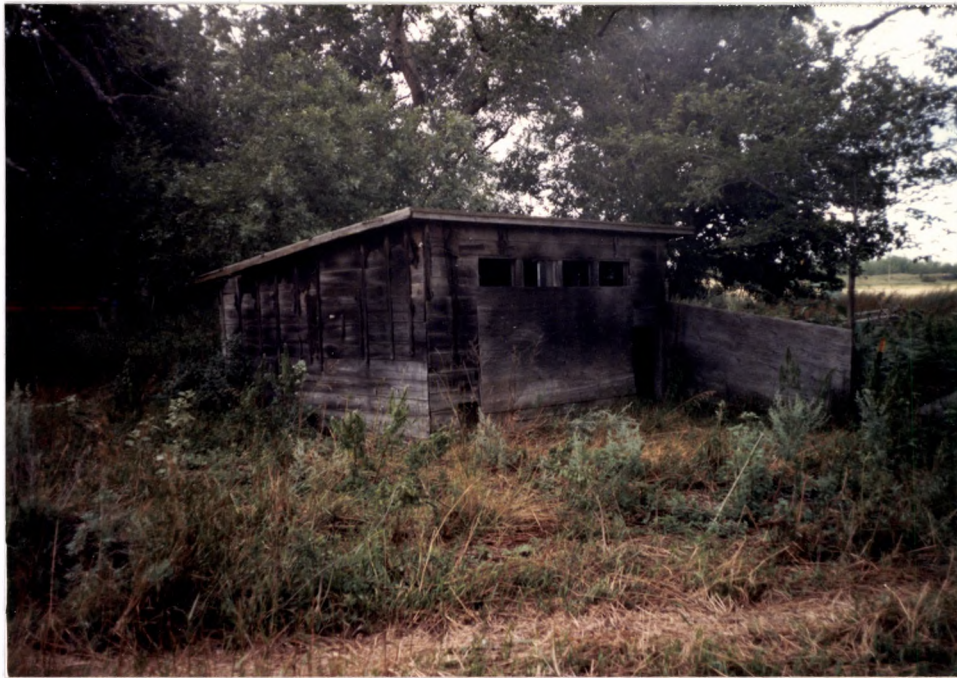
Feature 3, small outbuilding/animal shelter, poor condition, rectangular shape, entrance to southwest, wood frame construction with horizontal wood siding, no porch, no basement, wooden foundation, 1 story, wood cornices, flat roof, undated.

LT295, FEATURE 3, VIEW TO NORTHEAST (ROLL 16, FRAME 10, COLOR PHOTO, NEGATIVE STORED AT LARSON-TIBESAR ASSOCIATES)

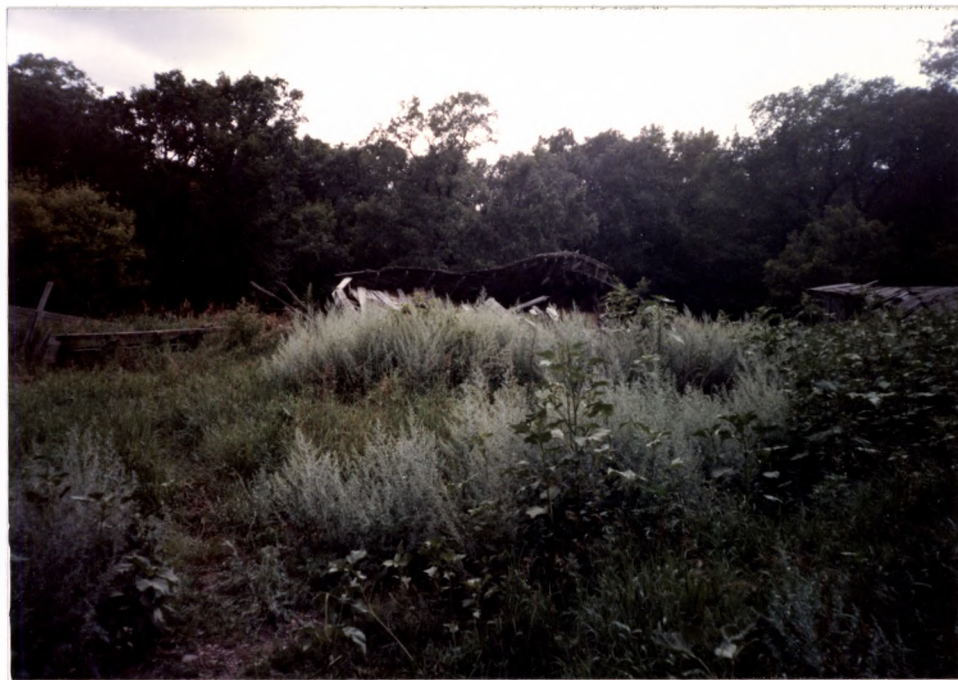
The collapsed boxcar covers an area approximately 17 meters north-south by 6 meters east-west. The exact dimensions of the original boxcar could not be determined, but the feature appears to have been the modern, wide-gauge type boxcar.

17. Statement of Significance: The nonstanding portions of this site have poor physical integrity. One (the boxcar) feature has obviously been moved from its original place of use. These features are therefore not believed to be significant or eligible for nomination to the National Register of Historic Places.

LT295, FEATURE 4, VIEW TO WEST (ROLL 16, FRAME 8, COLOR PHOTO, NEGATIVE STORED AT LARSON-TIBESAR ASSOCIATES)

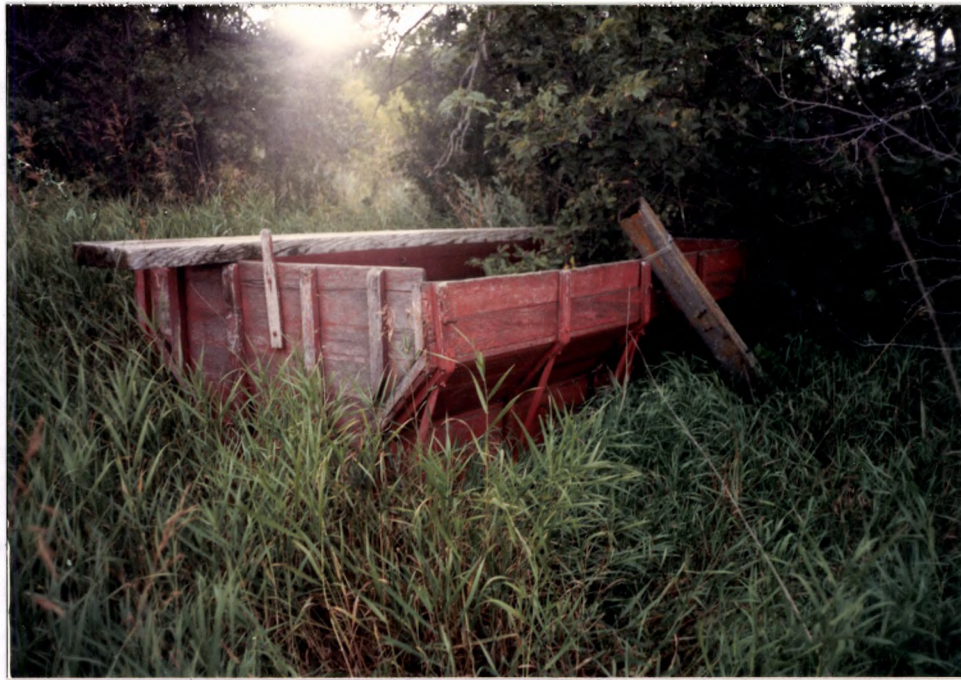
The wooden grain wagons are similar to others recorded during the present survey. The wheels have been removed from both and they are quickly deteriorating.

LT295, FEATURE 6, VIEW TO WEST (ROLL 16, FRAME 12, COLOR PHOTO,  
NEGATIVE STORED AT LARSON-TIBESAR ASSOCIATES)

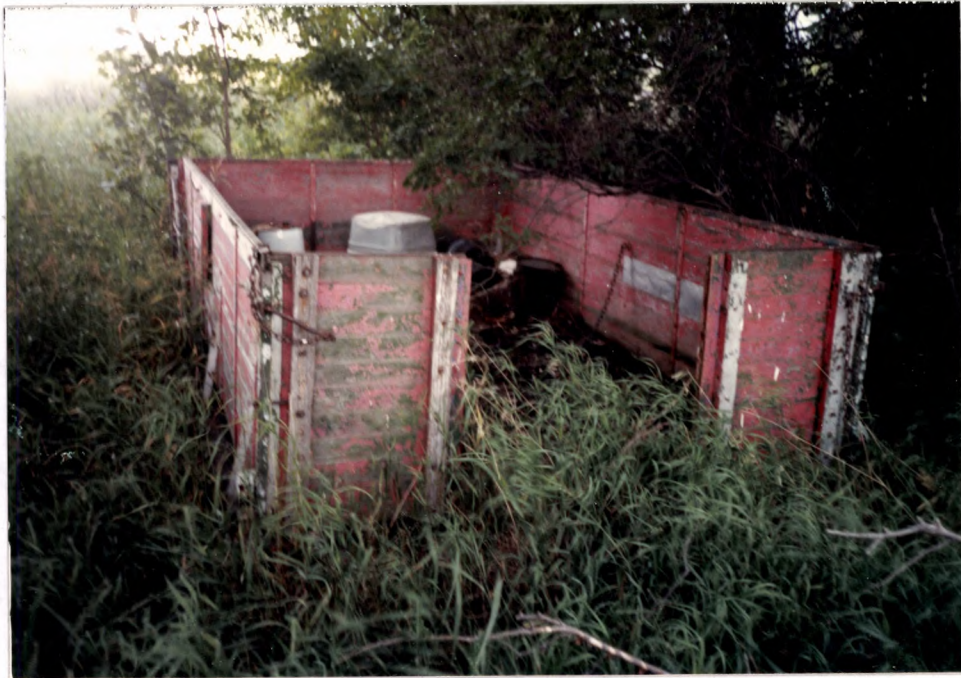
LT295, FEATURE 7, VIEW TO EAST (ROLL 16, FRAME 11, COLOR PHOTO,  
NEGATIVE STORED AT LARSON-TIBESAR ASSOCIATES)
