NDCRS ARCHITECTURAL SITE FORM PAGE 1

Field Code Valhalla Township School #6

Country Schoolhouse Project

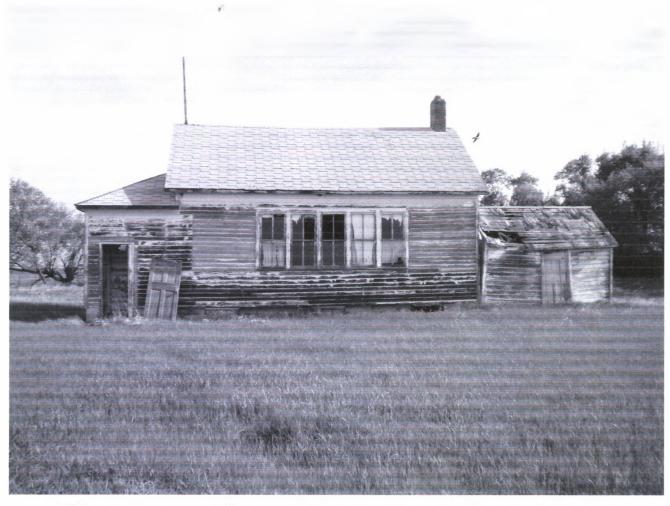
Valhalla Township School #6 5/31/2010 South Side Kackywilner WE

This is a one room prairie school built with a longer body for the main part of the building. The school, with the entry, measures 35 ft, east to west and 18 feel north to south with a 14foot by 10 foot shed on the east side. The main body and the entry of the school have asphalt shingles. A chimney of brick can be seen at the east end of the main body of the school. The shed at the rear of the school was shingled with shakes and there were very few left. The school has a poured concrete basement under the main body and the entry of the school. The shed is mostly sitting on the ground. The shed was used for coal before it was later used to house the fuel oil barrel. There is a flagpole on the roof of the main body of the school at the west end of the building. There are 5 one-over-one double hung windows on the south wall. The windows are all uncovered and some panes of glass have been broken. The siding is narrow lap siding on all of the building and it badly in need of painting. It looks like a window on the west side of the entry was removed and a smaller one replaced it with lap siding used to close the lower part. I wonder if there was also another window on the south side of the entry as the wall looks to have been repaired. There was a wood door leading into the school, it now rests against the outside walls. There is an opening on the east end of the shed that was probably used for coal. A door on the south side of the shed is falling out of the opening. The north wall of the basement has fallen and the entire school is bowing on that side.
