NDCRS ARCHITECTURAL SITE FORM PAGE 1

Field Code Crystal Lake Township School Site Name Crystal Lake Township School
(School name is Hillside #2)

Country Schoolhouse Project

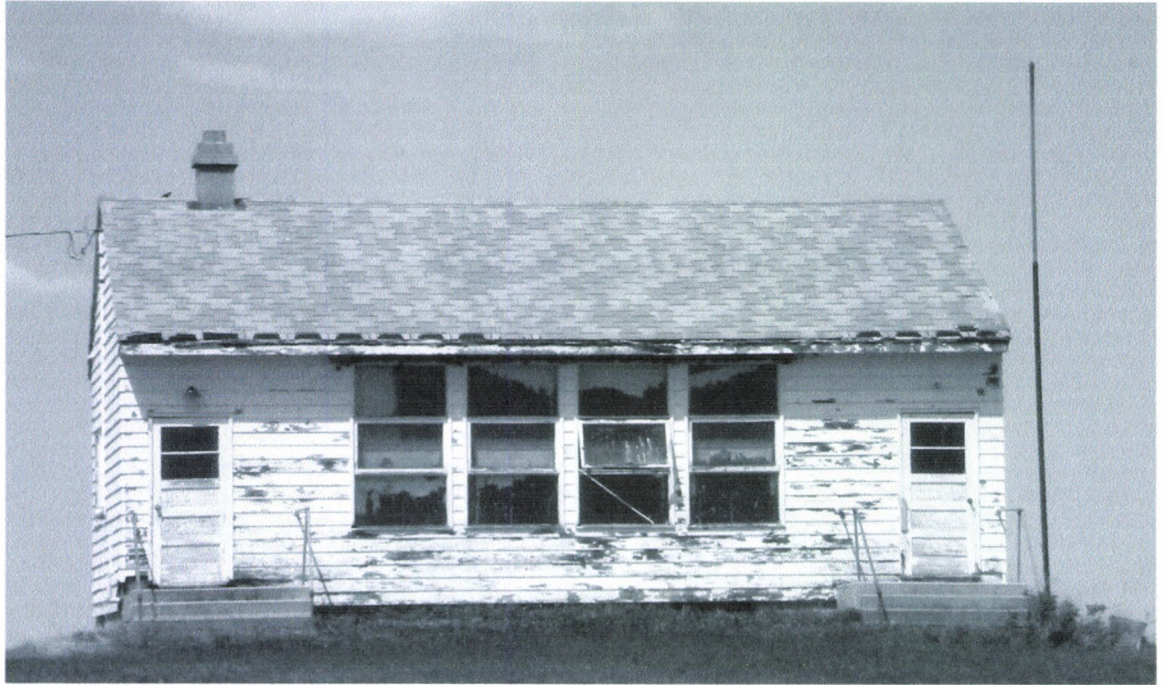
1 – Crystal Lake Township School South side 5/19/2010 Kathy Wilner WE

This school building is larger than most, built on a poured concrete basement. The walls are wood lap siding with composite siding over the wood. It is deteriorating. The roof has asphalt shingles with a concrete chimney at the west end of the building. There are windows on three sides, glass gone from one of the windows on the west side. The south side has 5 fairly large windows that are three part windows with a roll out window in the middle of the three. On the west and east sides of the building there are double hung windows. On the south side of the school there are two doors, one at either side of the building. You get to the doors up concrete steps. The west door opens into an entry area and then goes right downstairs. The east door opens up to the entry area for the students and they use that as their coatroom. I could not go into the school so this is what I could see through windows and doors. At the west end of the building the two side by side windows look into a storage area with cupboards on the south and north sides of the alcove. I could not see into the east windows however looking through the west windows across the main classroom area it looks like there were two small rooms. No idea what they were used for. I saw blackboards on the north and west walls of the main classroom area.
