NDCRS ARCHITECTURAL SITE FORM

Field Code Eigenham Township School #5 Site Name Eigenham Township School #5
Site Name

Country Schoolhouse Project

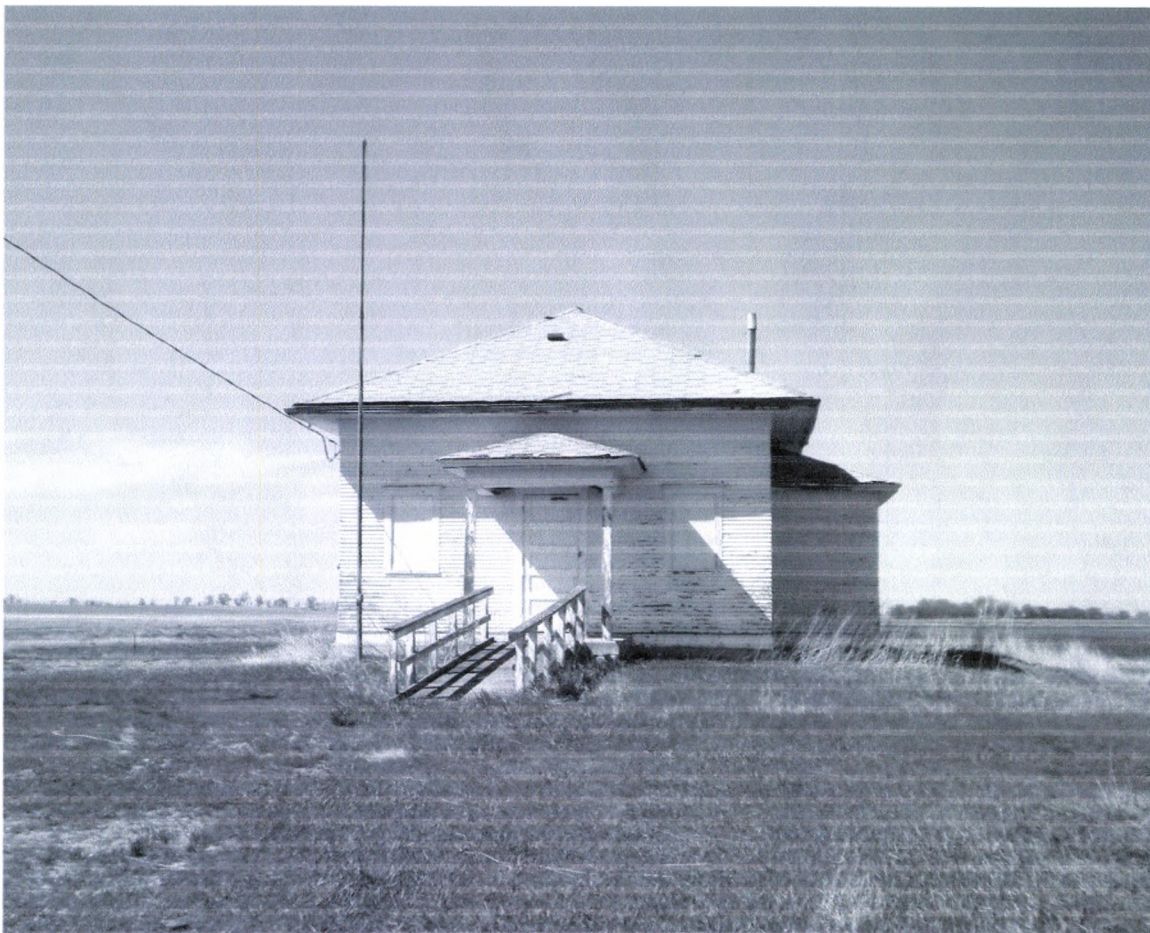
Eigenham School #5 West side 9/23/2010 Kathy Wilner WE

On the west side is a meter for electricity and the hookup to a power pole. This building is still used as a township meeting hall. Also on the westside are shutters over 5 large windows. Two south facing windows are also covered. The small porch has corner pillars to hold the roof. These pillars sit on a large concrete step. The wood door could be original. There is a ramp to allow access for handicapped individuals.

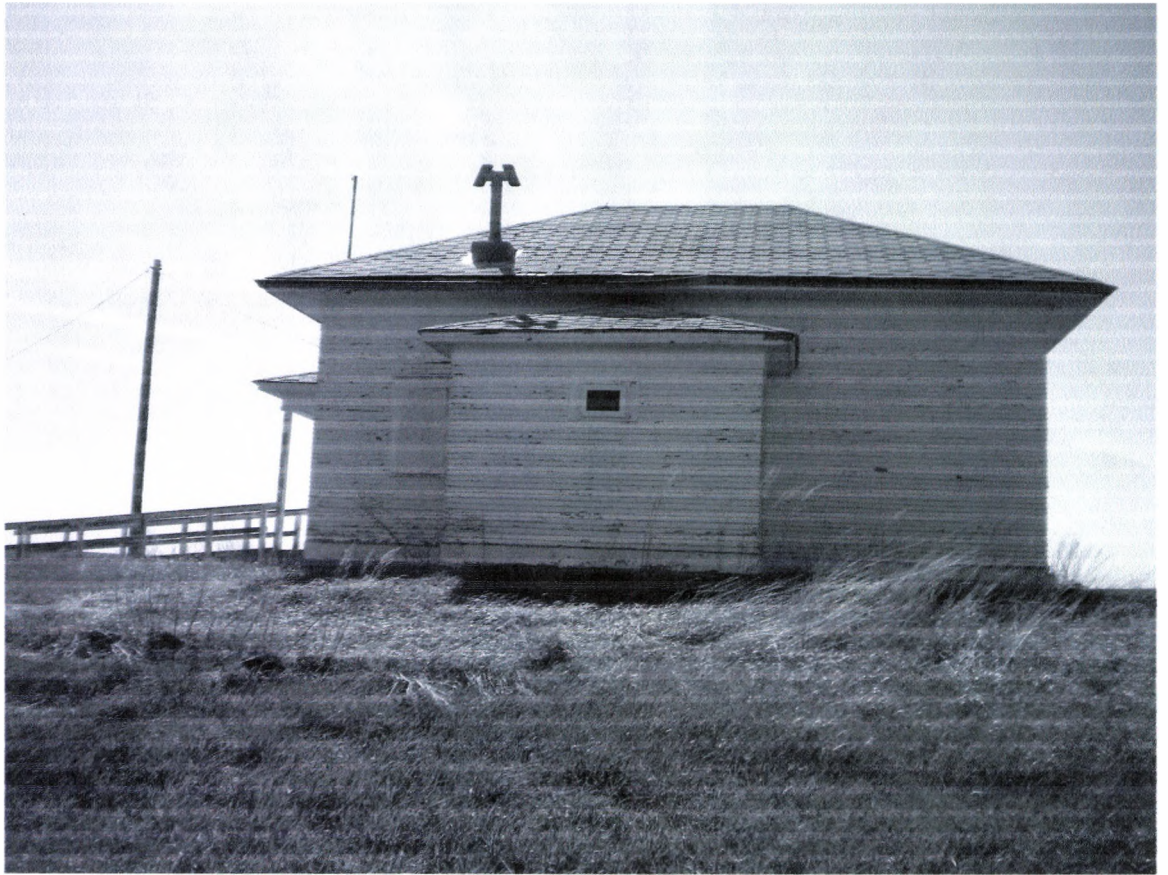
Eigenham School #5 South side 9/23/2010 Kathy Wilner WE

This is a large, 32' by 22', building with an extra room to the east. The school is wood lap siding with a lot of paint still visible. It appears cared for. The roof is of asphalt shingles with a fairly modern looking chimney. They have installed eaves troughs along the south side and around corners on the east and west. It looks like there is venting on the south and north slopes of the roof. To the north of the school there is an outhouse.

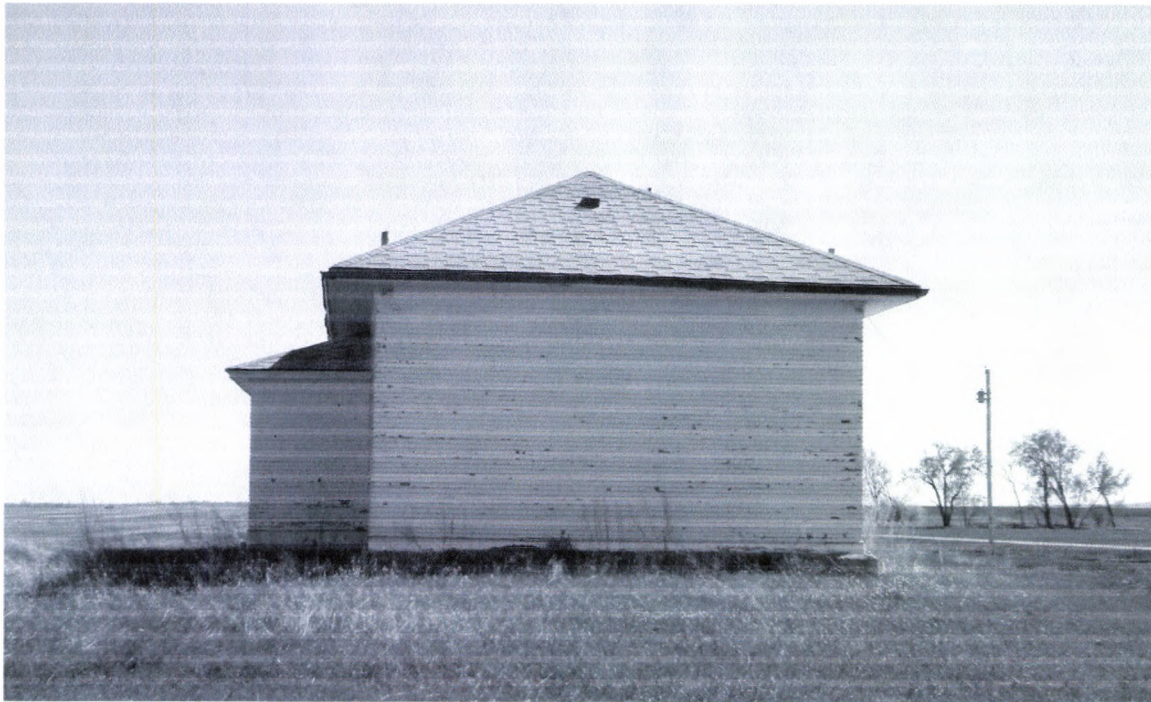
Eigenham School #5 East side 9/23/2010 Kathy Wilner WE

On the east side of the school is one more window, also covered. According to a student of the school this window was in the entry. The bump out part of the school on this side was used for fuel storage. There is a small window in this addition and perhaps it was used to unload coal for the school.
