NDCRS ARCHITECTURAL SITE FORM PAGE 1

PAGE 1		SITS# 32 WE 402	
SITE IDENTIFICATION			3113# 32	702
Field Code D Heintz School			chool	
Map Quad Chaseley Map Quad		ame		realization deputing with the control of the contro
LTL TWP R LTL TWP R LTL TWP R LTL TWP R	SEC SEC SEC	QQQ 5 QQQ QQQ QQQ	QQ 5 QQ QQ QQ	Q 6 Q Q Q
UTM 5255513 UTM 438132	N E	ZONE 14N NAD 1927	NAD 1983	Subsection: 1 = N½
City: Chaseley				2 = E½ 3 = S½
Street Number: 34th				4 = W½ 5 = NE¼
Street Name: Ave NE 6 = SE¼ 7 = SW¼				
Urban Legal Description:				8 = NW1/4
SITE DATA				
Total # Architectural Features:	1			
Fieldwork Date: 11/02/2018				
Reconnaissance Survey Intensive Survey				
Project Title & Supervisor:				
Country Schoolhouse Project				
Report Title & Author(s):				
Additional Information:				
SHSND USE Area of Significance Ecozone	19	erified Site	_ CR Type	2

1. Feature Description, Integrity, Eligibility:

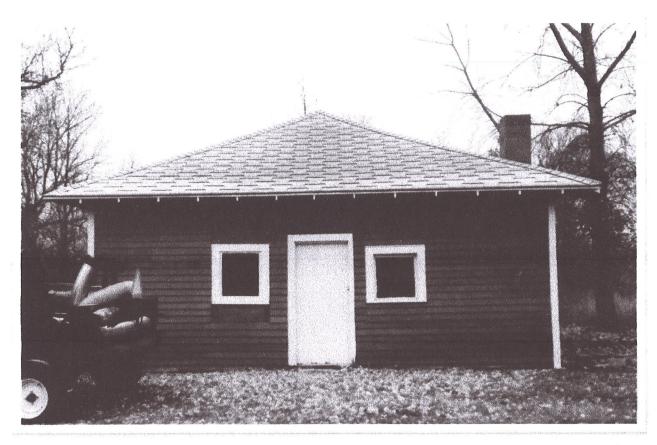
East Side

The siding is 6 inch wood lap with 4 inch wood corner trim. The building is painted red with white trim on the corners and around the windows. On the east side there is a wood entry door with two fixed pane windows either side. They are not original to the school. On the south side there is one double hung window window and a sliding door. The west and north walls both have two windows openings, two are covered (one on each side) and two are replacement, fixed pane windows. All glass intact. The floor in a small room in the southeast corner of the building has tongue and groove hardwood, the remainder of the flooring in the building is concrete. The walls and ceiling are mostly lathe, nearly all of the plaster has either fallen off or been removed. The ceiling is metal sheeting. there are no blackboards, wainscot or electricity. Story has it that the school was at one time used as a teacherage.
