NDCRS ARCHITECTURAL FORM PAGE 1

NDCRS ARCHITECTURAL FORM PAGE 2 – Feature Data

Wheelock Township School

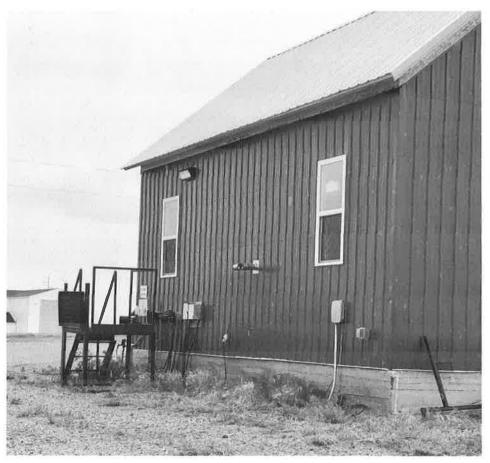
North Side

The feature is a one room school on a poured concrete foundation. It has been refurbished for use as an office for Ray Farmers Union Elevator. The gable roof is covered with vertical metal sheeting. The chimeny is gone. The soffits are open.

The siding is vertical metal sheeting. A locked metal door gives entry from a wood porch on the east side. The windows have all been replaced with two double hung combination windows on the north wall and two more to the left of the entry door on the east side. There's a small one on the west wall and another on the south wall of the old entry. A second metal door is located on the east side of the old entry. Electricity is present

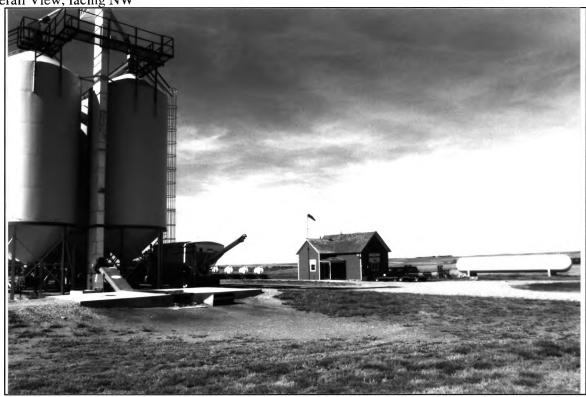
Overall View, facing NW

Field Code <u>BRW US2 S097</u>	Feature N	lumber	_1	SITS # <u>32WI</u>	
<u>DESCRIPTIVE SECTION</u>					
FOUNDATION	STORIES	ROOF	TYPE/CORNICE		
Poured concrete	1	Gable;	wood shingles		
WINDOW CONDITION		DATIN	DATING METHOD		
Original windows replaced/openings a	ltered	Profess	Professional estimate, historic plat maps		
PRESERVATION RECOMMENDATION	ON (check all t	that app	ly):
