### NDCRS ARCHITECTURAL SITE FORM

Project & Principal Investigator:  
Country Schoolhouse Project

**Corinth School**

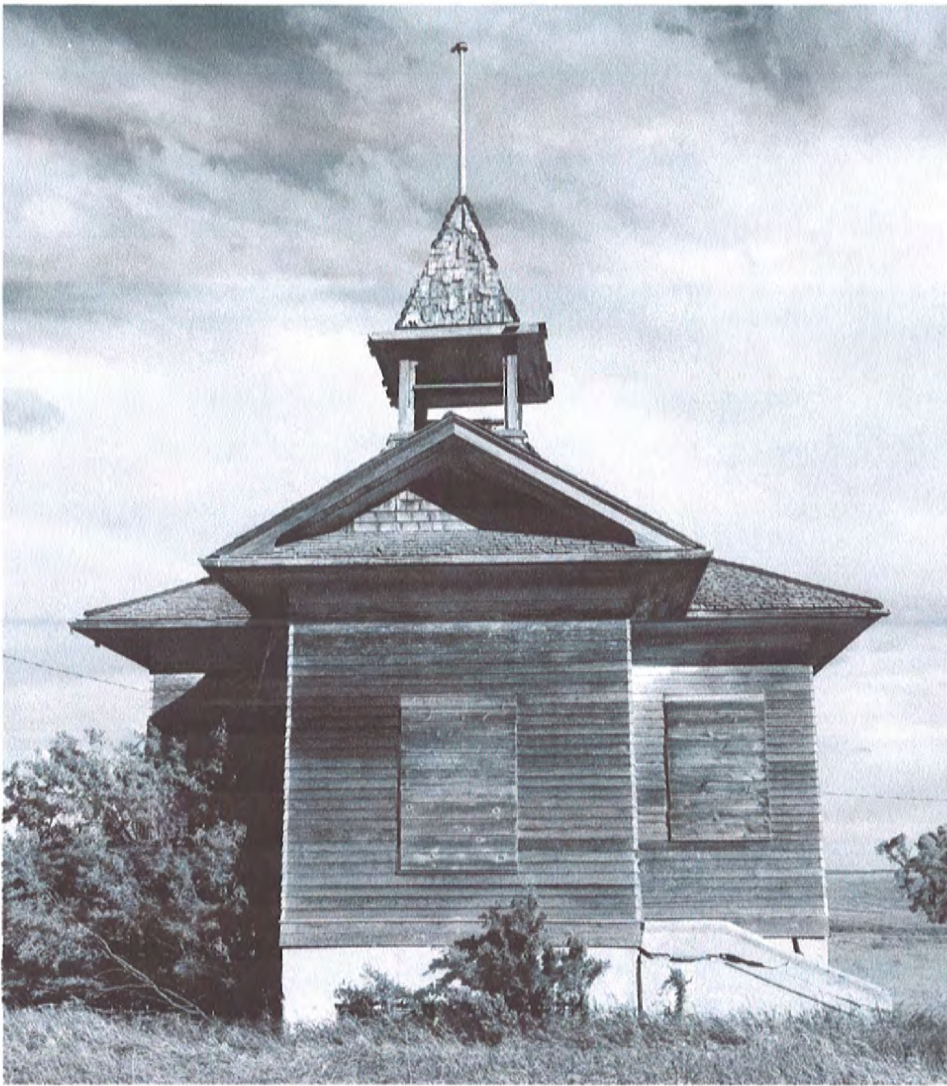
**Northwest Side**

The feature is a large, one room prairie school sitting on a poured concrete basement. The main body of the school has a hip roof, the northwest entry has a gable roof as does the addition on the southeast side. All the roofs have wood shakes. The bell tower has a base on the peak of the entry, both the base and the roof have wood shakes. There is a flag pole at the peak of the leaning bell tower. There is metal capping on all the hips as well as the gable peaks with one finial. Under the peak of the entry roof there is a decorative short wall to a bit of shed roof with wood shakes. A crumbling red brick chimney is at the confluence of the gable roofed entry and the northwest slope of the hip roof. The main building measures 28 feet northwest to southeast and 30 feet southwest to northeast. The entry measures 10 feet by 10 feet with the southeast addition measuring 10 feet by 12 feet. The soffits are closed with beadboard.

A frieze board runs under the eaves of the hip roof. The siding on the school is 6 inch wood lap with metal corner trim. At the lower edge of the siding there is a skirting board with water table. The school sits high on a basement that is about 4 feet above ground. There are three 4 pane windows on either side of the school basement, some glass. Looking into the basement windows, broken lumber and a broken door lay on the floor along with other debris. Four, multipane, large double hung windows, are on the northeast wall of the school. All have some glass and all are shuttered. There is a shuttered, double hung window in the northwest end of the entry as well two more shuttered windows on either side of the entry. A wide concrete set of steps leads up to a broken 5 panel wood door. The entry leads either up to the school room or down in the basement. Wide wood steps lead up to a wood door with 6 panes of glass at the top. The walls in the entry are lathe and plaster with wainscot on the lower 1/3 as well as along the steps up to the coatroom. Above the door at the top of the steps is a 3 glass pane transom. The coatroom has coat hooks along the wall. Another 5 panel wood door, with another 3 glass pane transom, leads into the school room at the southwest most side. The walls in the school room are fiberboard on the upper 2/3 with a railing to separate the lower 1/3 which appears to be flat wallboard painted a different color. The ceiling is finished with ceiling tile and some of that is falling in. Also on the ceiling are light fixtures indicating electricity. The flooring throughout the building is tongue and groove hardwood. Blackboards run the entire southeast wall as well as part of the northwest wall. There is no wainscot in the main school room. Did not see anything in the southeast entry, door locked.
