NDCRS ARCHITECTURAL SITE FORM PAGE 3—Feature Data

Field Code Judson School

SITS# 32 WI

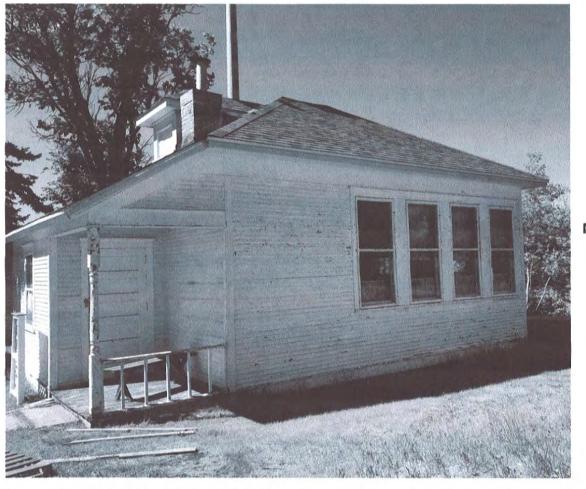
North Side

A frieze board runs under the eaves on all side of the school. The siding is 4 inch wood lap with 4 inch corner trim. There is a wood porch at the northeast corner of the school, tucked under the buildig roof. the north side of the porch has a railing with a cornerpost supporting the roof. Entry is through a 5 pane wood door which is kept locked when no one is around. There is one small double hung window on the east wall, this lights up the entry/coatroom. There are four larger double hung windows on the north side as well as two more on the west side. All the windows have glass. The interior door is another 5 panel wood door. The interior of the school room is undergoing some renovation as they has water damage. The ceiing and walls were lathe and plaster and they are replacing some of the damage with sheetrock. There is a plate rail in line with the tops of the windows. The window trim is dark and well kept. A wide mop board finishes the walls. There are blackboard along the entire south wall and it corners to the east wall over to the entry door. The chimney inside is to the right of the door as you walk into the room and just beyond that is a large cupboard. All other furnishings are in storage. The floor is tongue and groove fir. Light fixtures indicate electricity.

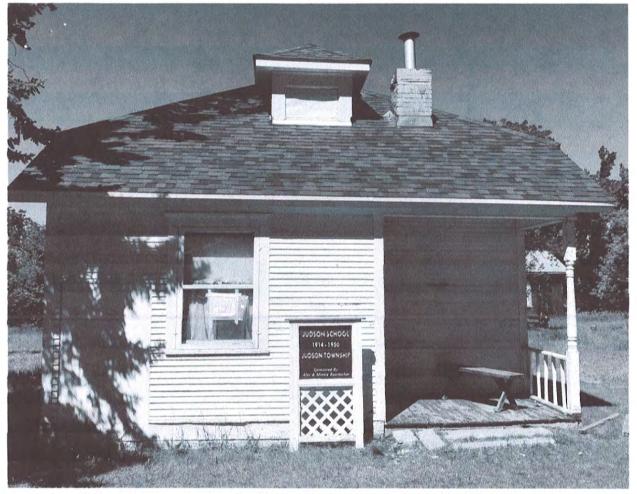
East Side

The feature is a one room prairie school on a foundation of poured concrete foundation. This school was moved from Judson Township west of Williston. The hip roof is covered with asphalt shingles as it the dormer roof. The dormer is on the east facing slope of the roof and a window opening is boarded up. There is a concrete block chimney, with a stove pipe sticking out the top, to the north of the dormer. The soffits are closed with beadboard finish. The building measures 24 feet north to south and 30 feet east to west.
