NDCRS ARCHITECTURAL FORM
PAGE 1

Field Code Brookside School

Project & Principal Investigator:

Country School House Project
Kathy Wilner
366 43rd Ave SE
Bowdon ND 58418

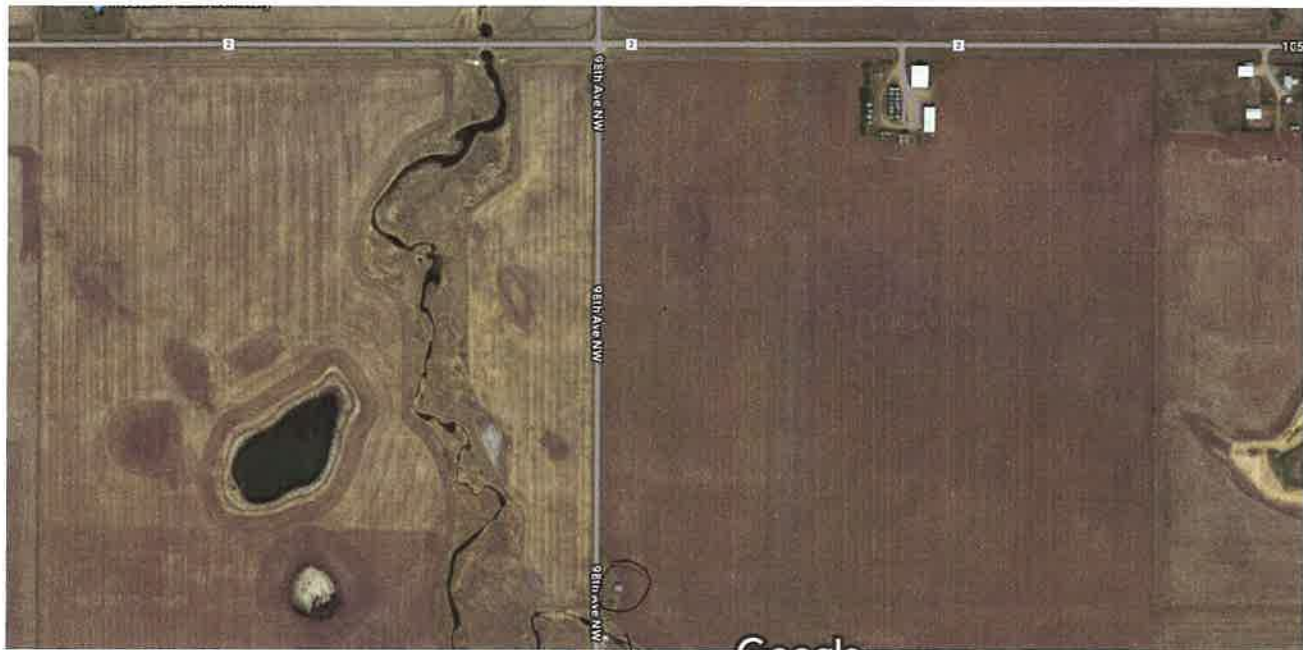
Condition Poor

The feature is a one room school sitting on the prairie. I have one picture to tell the story. The hip roof of the school and the entry roof are partially covered with failing blue asphalt shingles. There are several holes in the roof. There is a flag pole at the peak of the entry roof. A large, red brick chimney is located outside the south wall of the of the building. The chimney extends from the ground all the way up to the height of the roof peak. There are two long anchor wires connected to the south slope of the school roof to keep the chimney in place. The soffits are closed.

The foundation is a combination of cement and partial basement. The front side addition, called a porch by the owner, leads up a few steps into the school on the right side and to the left the stairway goes to the partial basement. The furnace was never in the basement. He told me the furnace was located in the middle of the classroom. The furnace was stolen several years ago. Someone chainsawed under the window to the left of the chimney to get the furnace out of the school. He thinks the floor is wood. The walls and ceiling were plaster and it says much of that has fallen in. There was a fiberboard black or green board on the north wall and part of the west wall. The old entry has been boarded up because the steps inside the school have fallen in. He told me that those few steps went up to a hallway between two smaller rooms. He thought to the left was a small office for the teacher and to the right was a coat room. The office had a door near the north wall that led into the school and the coatroom had a door near the south wall that led into the school as well. He told me a few desks are still in the school. As you can see it is wide open to the weather.

The only picture available of this school.
