NDCRS SITE FORM  
ARCHITECTURAL SITES

Field Code SU 137 Site Name Schoolhouse  
Field Code \_\_\_\_\_ Site Name \_\_\_\_\_

Manuscript/Report Title: Survey of Bowman County

Photographic Coverage, Historic Architectural Survey of Bowman County, 1997

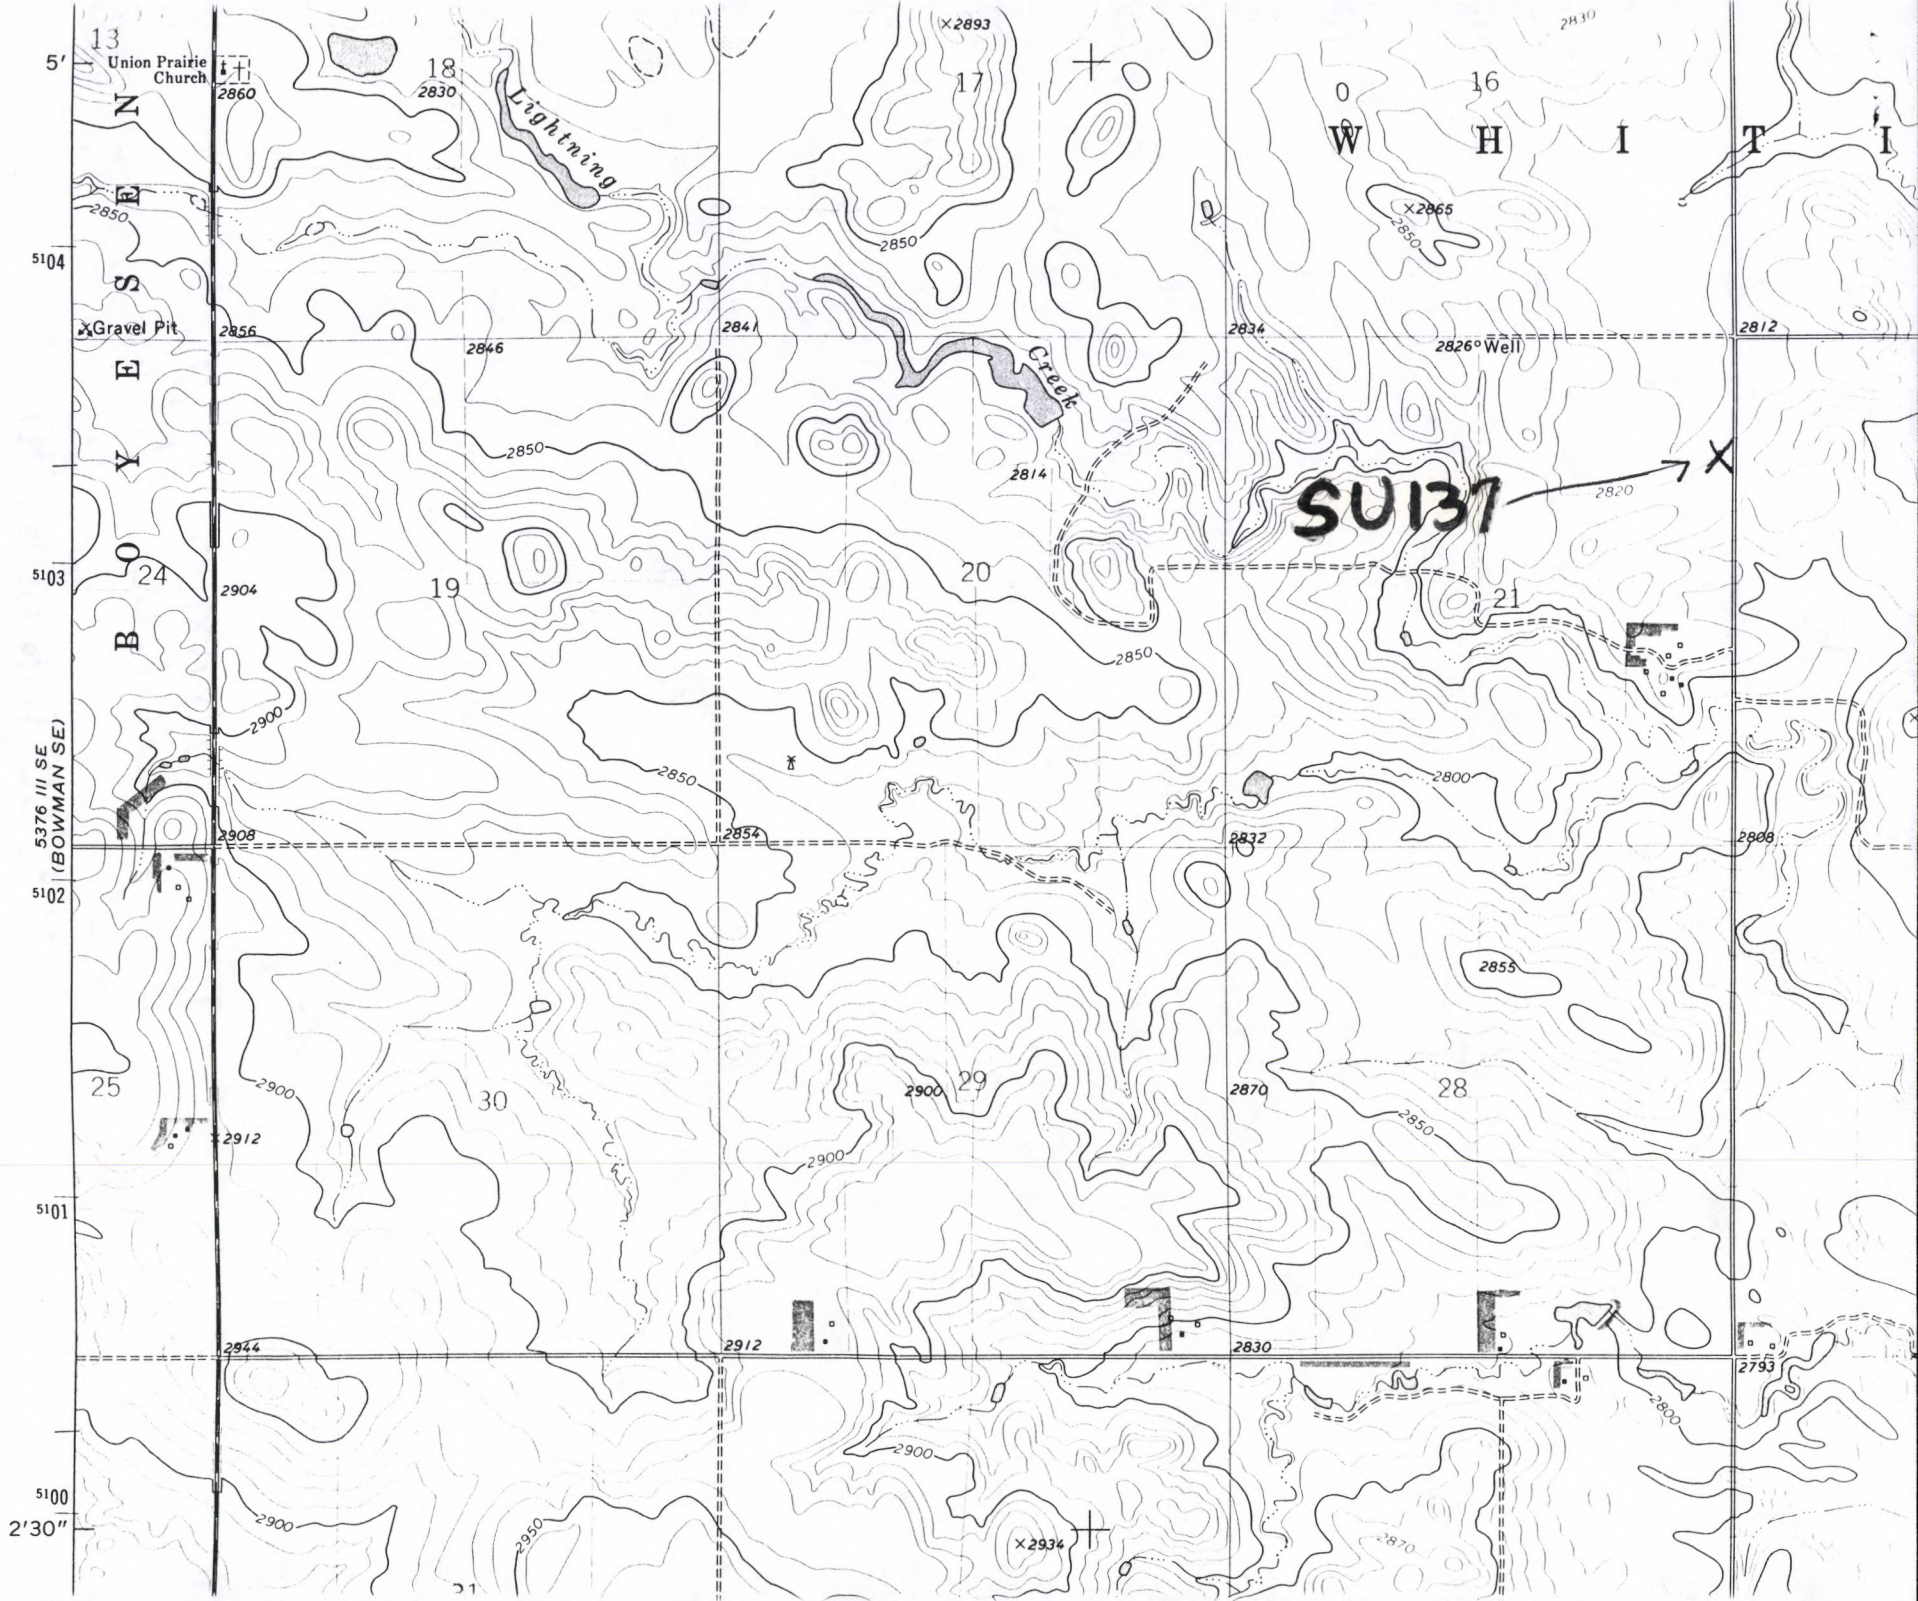
Subject: Schoolhouse

This one-room schoolhouse, constructed in about 1910, is a wood frame building on a foundation of poured concrete. Its exterior is horizontal wood siding, and its gable roof is covered with wood shingles. There is a brick chimney at the north end of the gable. The front door to the building is on the south, but the front steps leading to it have deteriorated. There is a double-hung window on either side of this front door, there are two double-hung windows on the opposite (north) side of the schoolhouse, and there is a line of five double-hung windows on the east side of the schoolhouse. These all remain in good condition, although several have been covered with plywood, and the glass is out of the front windows. As you enter the schoolhouse from the south entrance, stretching to the left is a class room, to the right is a closet accessible via a door from the classroom, and immediately ahead is the classroom. In the classroom the ceiling plaster is partially fallen. The interior has wooden wainscoting on all walls.
