NDCRS SITE FORM
ARCHITECTURAL SITES

Field Code SU 187 Site Name Schoolhouse
Field Code _____ Site Name _____

Reconnaissance Survey Historic Architectural Intensive Survey _____
Survey of Bowman County

Author(s): Isern & Velure

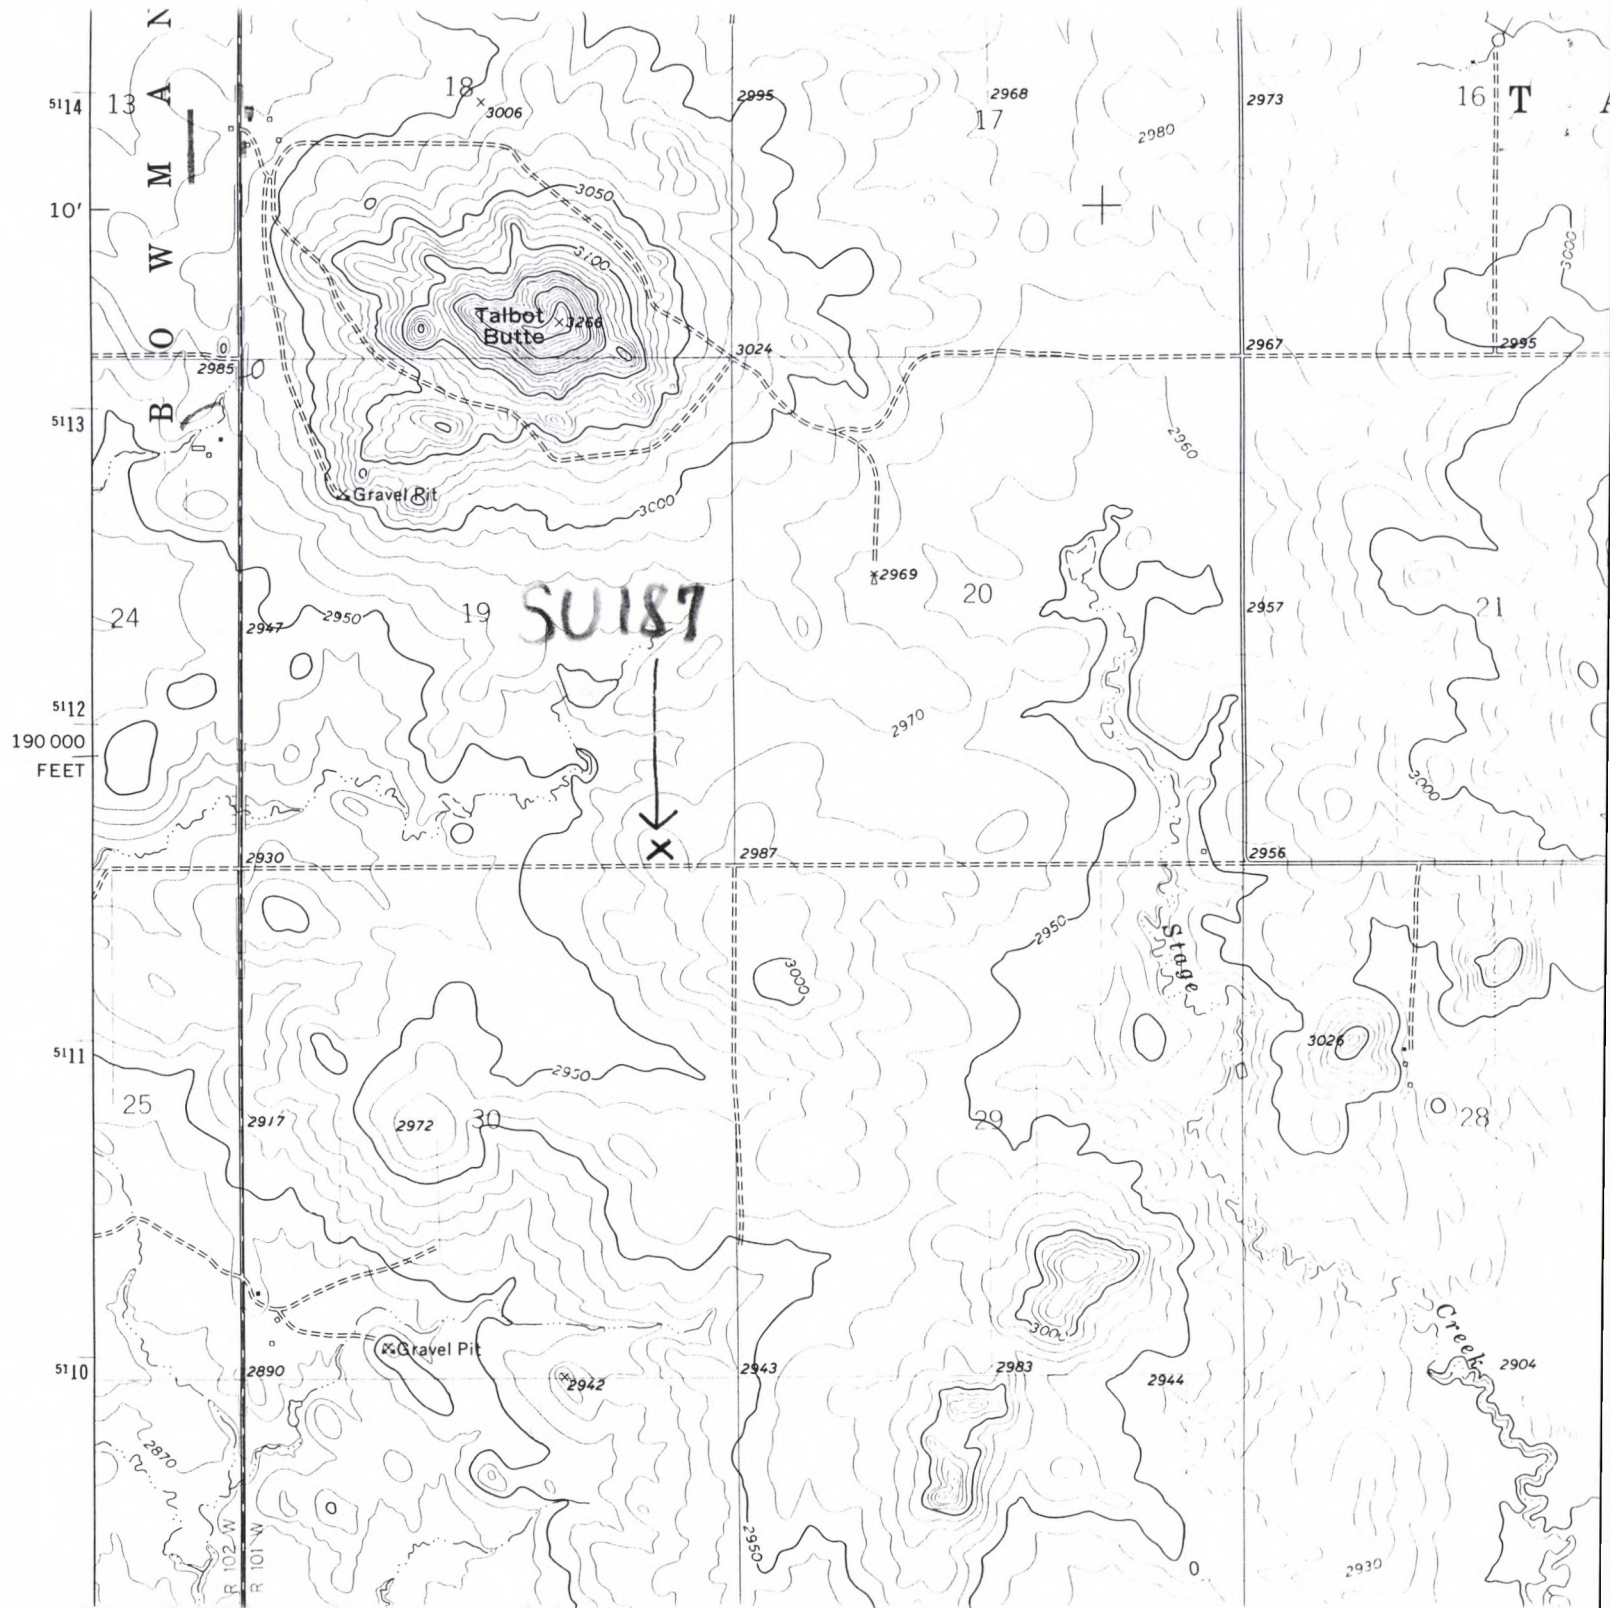
Roll KKK Frame 7 Site SU 187 Feature Date 8/12 View from SF

This one-room schoolhouse was constructed in about 1910. This is a wood frame building on a foundation of poured concrete. Its exterior walls are stucco, its gable roof is covered with wood shingles. The brick chimney at the north end has collapsed. The front entry of the school was on the south end of the building and was reached by wooden steps. It appears there may have been some sort of entryway constructed over this south door, but it has been removed. Also, on the west wall of the building, extending west from the northwest corner, there was an addition to the school, wood frame, that has been demolished. The windows on the east and north walls of the school are in poor condition and have been boarded up.
