## NDCRS SITE FORM ARCHITECTURAL SITES

Field Code US.W.R.O.6 Site Name PUBLIC SCHOOL #69  
Field Code \_\_\_\_\_ Site Name \_\_\_\_\_

# NORTH DAKOTA CULTURAL RESOURCES SURVEY

#### Feature 1: Historic Schoolhouse

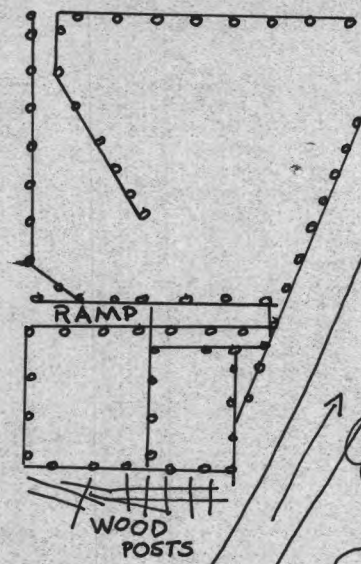
FEATURE 3  
CORRAL

To the southeast of these buildings is Feature 3, a large wooden corral complete with cattle gates and ramps. It is in good condition. Extra wooden posts for the corral lie next to it with some also behind the school house/house.
