NDCRS SITE FORM
 ARCHITECTURAL SITES
 page 1

Field Code B.R.W.U.S.2.S.O.2.4 Site Name F.L.I.C.K.E.R.T.A.I.L.V.I.L.L.A.G.E.
 Field Code _____ Site Name _____

Manuscript/Report Title: US Hwy 2 Cultural Resource Inventory in Ward, Mountrail, & Williams Counties

PROJECT TITLE US Hwy 2 Cultural Resources Inventory for FHWA and North Dakota Dept. of Transportation
(subcontracted through Houston Engineering); B. E. Perkl and B. A. Mitchell, Co-Principal Investigators

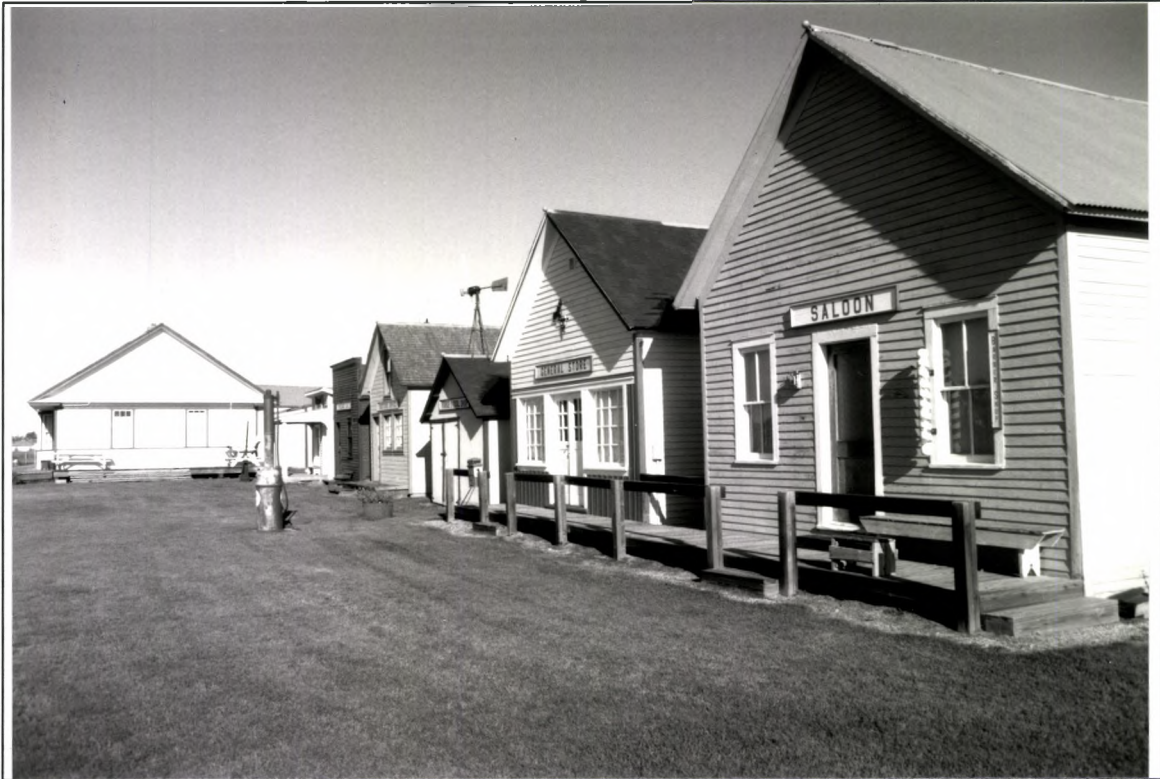
DESCRIPTION/INTEGRITY/ELIGIBILITY Feature #6 is a rural schoolhouse that has been moved into Flickertail Village and currently serves as the "general store." The one-story building is rectangular in plan and is located along the "Main Street" of Flickertail Village. The wood-frame structure has a concrete block foundation and is primarily clad with horizontal wood siding with corner boards. The cladding is not original. A portion of what now serves as a "storefront" has vertical board-and-batten cladding. The front-gable roof is clad with composition shingles. There are two large, divided-light windows on the "storefront." The rest of the windows have been filled in. There is a wood platform on the front of the building that connects it to Feature #7. On the rear of the building there is a slightly shorter gable-roofed addition. The building has been severely altered to be interpreted as a general store, including the in-filling of windows, the introduction of a "storefront," the replacement of the wall cladding, and the addition to the rear.

The building retains little integrity. Furthermore, its removal from its original location has damaged its eligibility. The building does not meet any of the considerations under Criteria Consideration B.

DESCRIPTION/INTEGRITY/ELIGIBILITY Feature #7 is a rural schoolhouse that has been moved into Flickertail Village and currently serves as the "saloon." The one-story building is rectangular in plan and is located along the "Main Street" of Flickertail Village. The wood-frame structure has a concrete block foundation and is clad with horizontal wood siding with corner boards. The cladding is not original. The front-gable roof is clad with corrugated metal. The windows are primarily wood-framed two-over-two-vertical double-hung. Several of the windows have been filled in. There is a wood platform on the front of the building that connects it to Feature #6. The building has been severely altered to be interpreted as a saloon, including the in-filling of windows and the replacement of the wall cladding.

General View of Features #1, 2, 3, 4, 5, 6, & 7, facing West

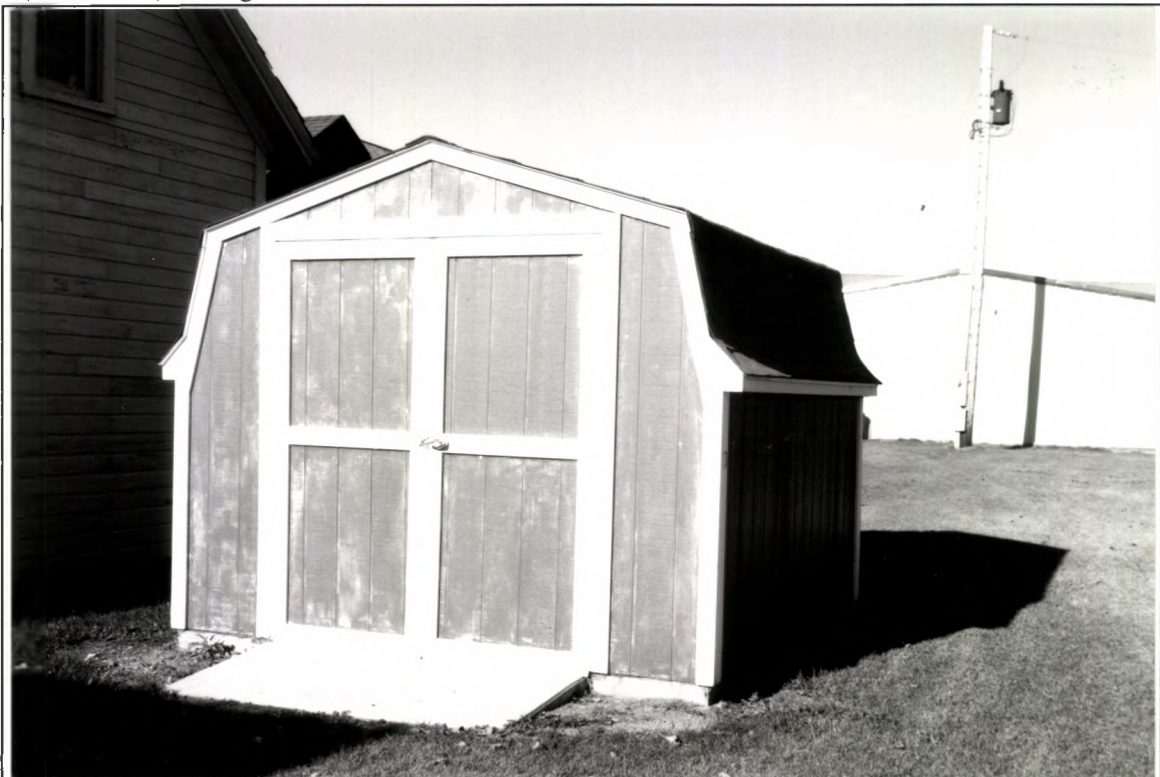
Shed (Feature #8), facing SW
