SITS# 32 MZ x1470

NDCRS ARCHITECTURAL FORM PAGE 2 – Feature Data

SITE IDENTIFICATION	PAGE 1	SITS# 32_	MZ X 1470
Field Code <u>MAC-NKL-56x</u> Map Quad <u>Schafer SE</u>	Site Name		
Map Quad 150 R97 SEC LTL TWP R SEC SEC LTL TWP R SEC SEC LTL TWP R SEC SEC	 C11 QQQ _ C QQQ _ C QQQ _ C QQQ _	8QQ 7 QQ QQ QQ	Q <u>7</u> Q Q
UTM5298228N UTM644625E	ZONE NAD 1	<u>13N</u> 927 NAD 1983 _	
City: Street Number:			$2 = E\frac{1}{2}$ 3 = S\frac{1}{2} 4 = W ¹ / ₂ 5 = NE ¹ / ₄
Street Name:			6 = SE¼ 7 = SW¼ 8 = NW¼
SITE DATA Total # <i>Architectural</i> Features:6 Fieldwork Date:10/15/2014			
Reconnaissance Survey <u> </u>	ensive Survey		
Project Title: Basin Electric- North Killdeer I Supervisor: Emily Sakariassen	Loop		
Report Title & Author(s): Report Title: Visual and Historic Sensitivity Transmission Project Author: Emily Sakaria	-	ed North Killdeer Loop) (NKL)
Additional Information: Site lead: Two school	olhouses, six grain b	oins, and one two-stall	garage.
SHSND USE Area of Significance Area of Significance Area of Significance Area of Significance	Verified Site Non-Site	С я ту	pe

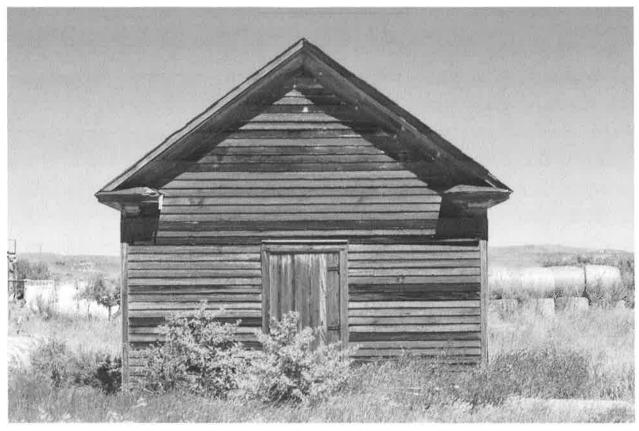
South Side

The feature is a one room prairie school with no visible foundation. The gable roof is covered with asphalt shingles and there are cornice returns on both the north and south sides at the eaves. There is no chimney. The soffits are closed. This building was moved from its original location.

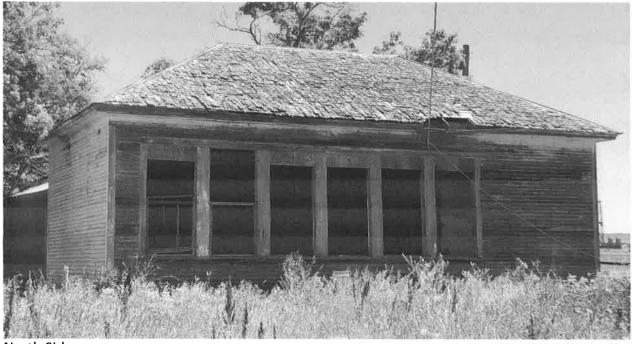
North Side

This feature is a large one room prairie school on a wood foundation. It was likely moved from its original location. The hip roof is covered with wood shakes with metal capping at the peak as well as all four ribs. Some of the wood shakes have blown away. The soffits are closed. There is no chimney.
