## NDCRS ARCHITECTURAL SITE FORM PAGE 1

<u>ad 227</u>
SITE IDENTIFICATION		
Field Code Orange Township School Site Name		
Map Quad <u>Lemmon NE</u> Site Name Map Quad		
LTLTWPRRR       SECQQQ         LTLTWPRRSECQQQ         LTLTWPRRSECQQQ         LTLTWPRRRSECQQQ	QQ	Q <u>8</u> Q Q
UTMN ZONE UTME NAD 1927	NAD 1983	
City:		$2 = E\frac{1}{2}$ $3 = S\frac{1}{2}$
Street Number:		$4 = W\frac{1}{2}$ 5 = NE <sup>1</sup> / <sub>4</sub>
Street Name: 28th St E		6 = SE¼ 7 = SW¼
Urban Legal Description:		8 = NW1⁄4
SITE DATA		
Total # Architectural Features:1		
Fieldwork Date: 6/21/2016		
Reconnaissance Survey Intensive Survey		
Project Title & Supervisor:		
Country Schoolhouse Project		
Report Title & Author(s):		
Additional Information:		
SHSND USE	CR Typ	
Recorded By Kathy Wilner Date	Recorded	1/24/2017 (mm/dd/year)

Field Code Orange Township School

The feature is a one room prairie school on a foundation of mixed rocks and concrete. The gable roof of the school and the shed roof of the entry are covered with older asphalt shingles. There is a short, red brick chimney at the north end of the peak of the roof. The soffits are closed. The building measures 32 feet north to south, inclusive of

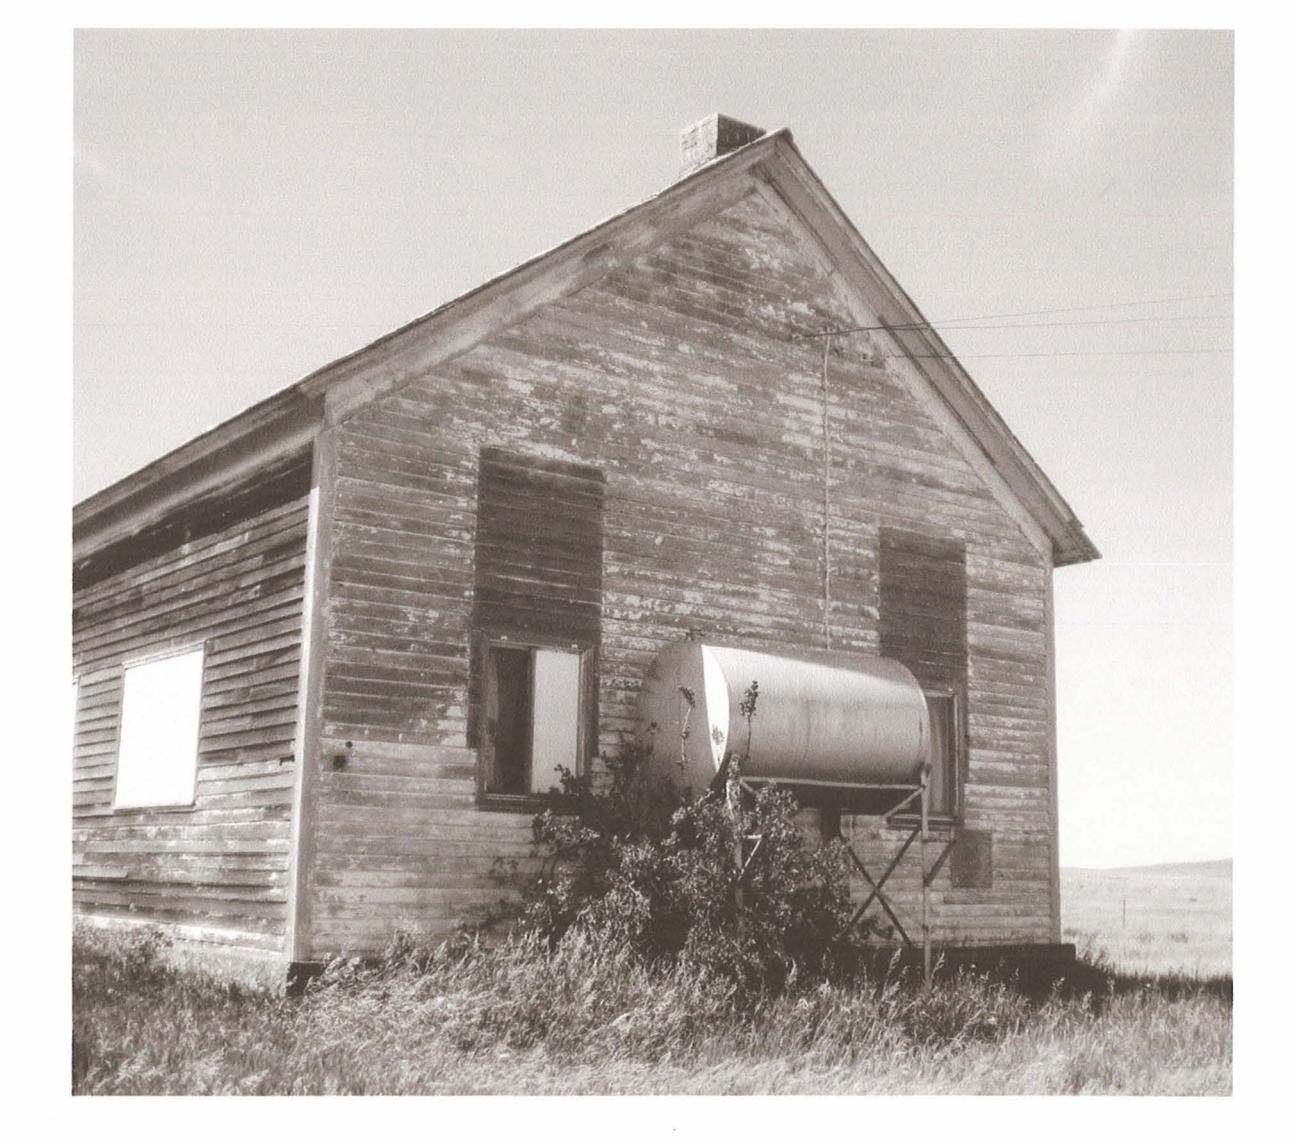
North Side

A large fuel tank sits along the north wall. There are newer deskes in the classroom. Playground equipment remains in the south yard. Light fixtures and outside conduit suggest electricity.
