# NDCRS ARCHITECTURAL SITE FORM PAGE 1 SITS# 32\_\_\_\_\_BL 781

Field Code Lyman Township School

SITS# 32 BL

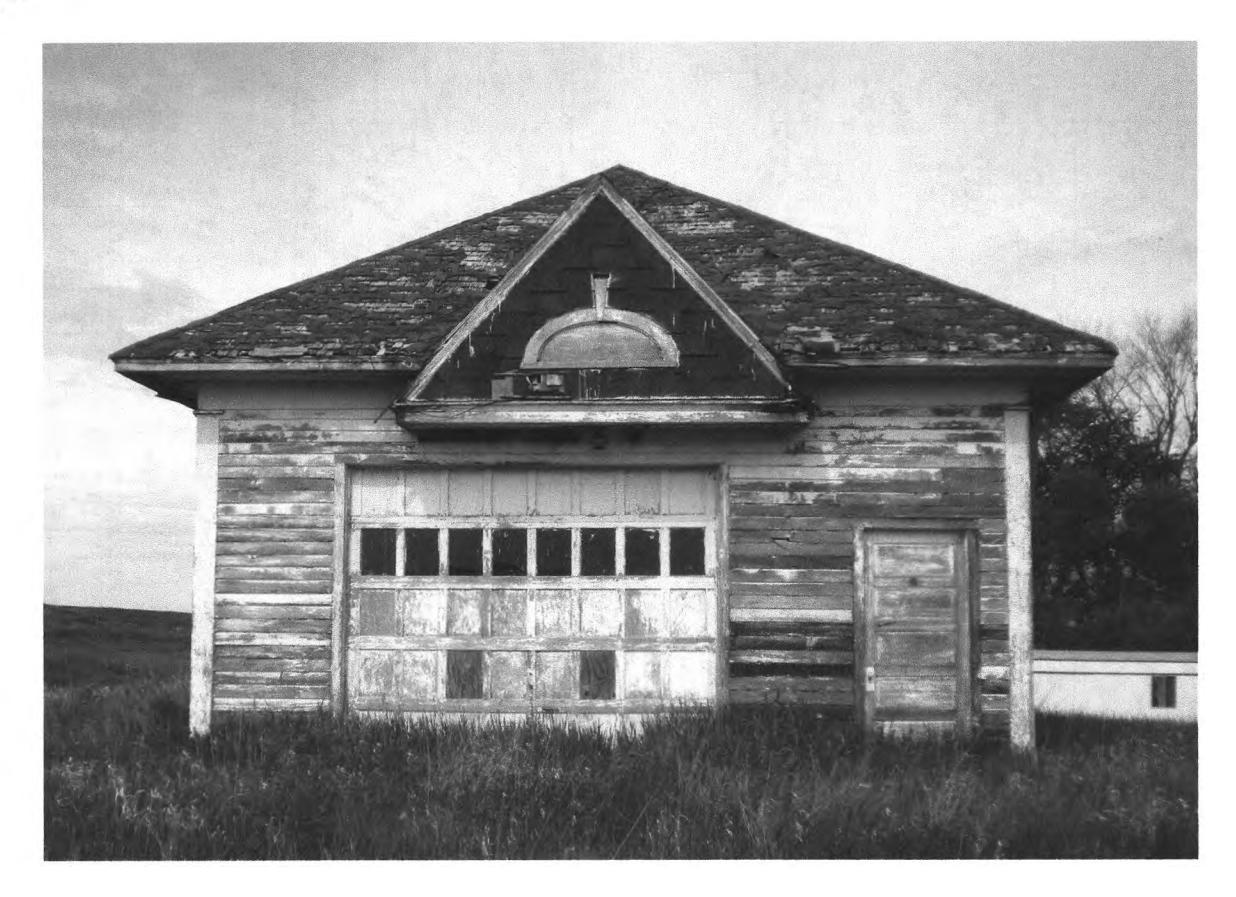
The entry door on the east is a 5 panel wood door. Inside the building I see tongue and groove hardwood flooring, lathe and plaster (and some wall board) on the walls with plaster falling away in areas. There is wallboard on the ceiling, some of that falling down as well. One electric light fixture still has the white milkglass fixture. The blackboards remain on most of the north wall and about 1/3 of the west wall. There is no wainscoat. The west end of the building is another room/rooms. Perhaps this was an entry at some point. No indication of a heat source other than the chimney.

East Side

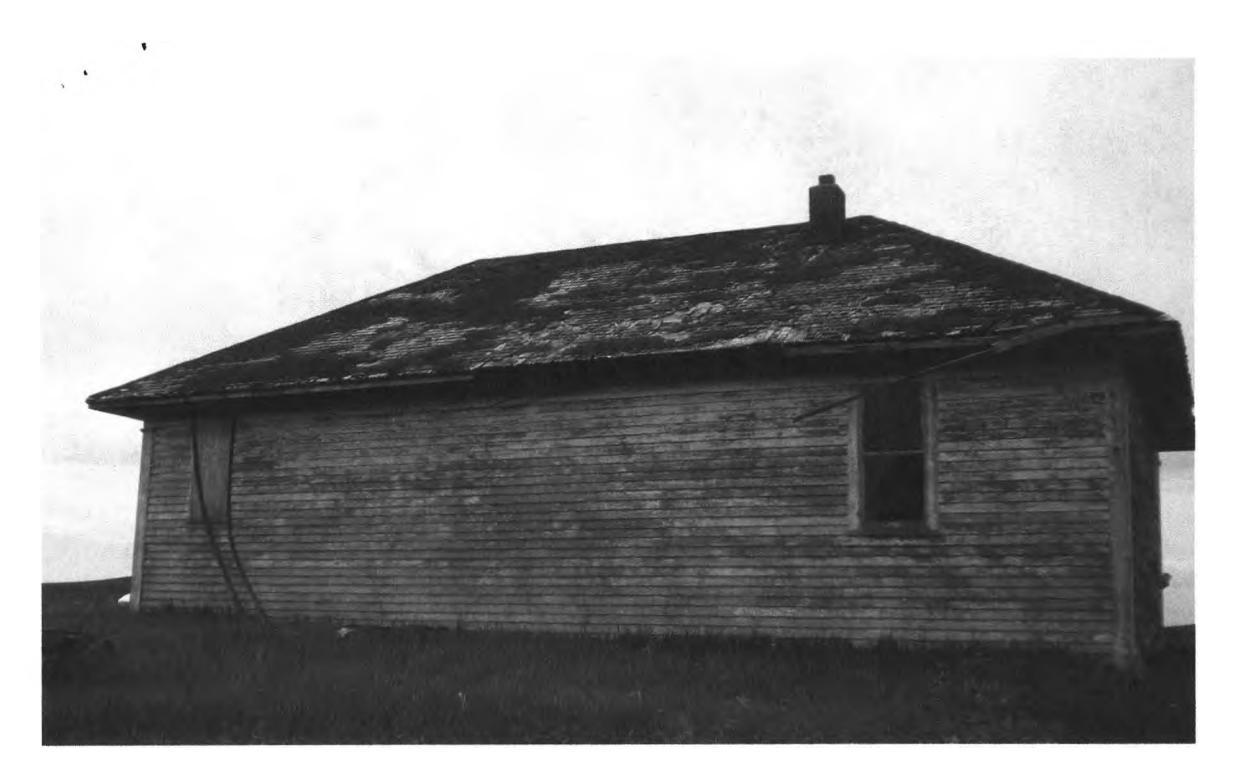
A wide header runs around the school just under the eaves. The remainder of the siding is 6 inch wood lap with 8 inch wood corner trim. There are several windows, many with glass still intact. On the south side there is a bank of 6 large, double hung, multi pane windows. One small window to the east of the large windows and yet another near the west end of the school. There is also remnants of a door to the left of the large windows. On the east side of the school there is a garage door, allowing access for work as a shop. On the north side there is a window near the west end of the building and two more on the north side. Only one window is covered.

South Side

North Side
