NDCRS ARCHITECTURAL FORM PAGE 1

Recorded By: Kathy Wilne	r Date Recorded: 8/2	5/2020
SHSND USE Component 2 Study Unit 20 Component Component	Verified Site CR Type	2
Additional Information:		
Contracting Firm or Agency Completing the Fo	orm:	
Project & Principal Investigator: Country School House Project Kathy Wilner 366 43rd Ave SE Bowdon ND 58418		
Reconnaissance Survey _	Intensive Survey	
Fieldwork Date:1		
Total Number of Architectural Features:	1	
Urban Legal Description:		
Street Name: County Road 20		
Street Number:		8 = NW¼
NAD1983 UTM 824793 City:	-	6 = SE¼ 7 = SW¼
NAD 1083 HTM 5402182		4 = W½ 5 = NE¼
LTL TN., RW., Sec LTL TN., RW., Sec	QQQ of the QQ of the Q QQQ of the QQ of the Q	$2 = E\frac{1}{2}$ $3 = S\frac{1}{2}$
LTL TN., RW., Sec	QQQ of the QQ of the Q	1 = N½
Map Quad LTL T. <u>160 N.</u> , R. <u>77 W.</u> , Sec. <u>15</u>		r1
Map Quad UphamNE Map Quad	Site Name Elm Grove School	
Field Code Elm Grove School	SITS# 32 ^{BU}	762

1. Feature Description, Integrity, Eligibility:

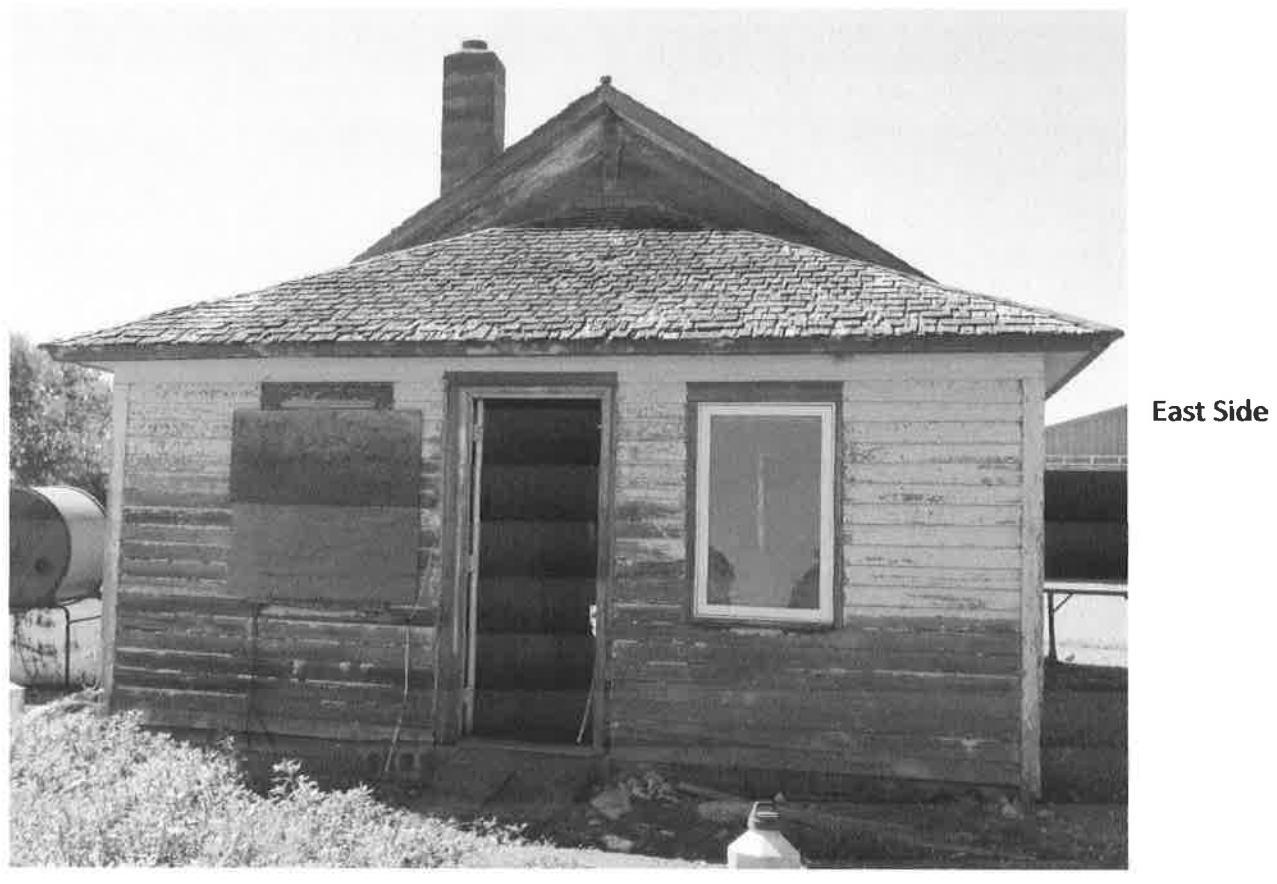
Elm Grove School

A rake board begins the siding under the eaves on all sides of the school. The rest of the siding is 6 inch wood lap with 6 inch vertical wood corner trim. The building has an overhead garage door on the west side with a concrete apron leading into the building. There looks to be one original double hung window and that is located in the middle of the south wall. There were originally 3 windows on both the south and north walls of the school and all but the middle openings were boarded up. There is a fixed pane window in the middle of the north side and another similar window to the right of the door in the entry. There is one more windows opening to the left of the door that is covered with plywood. the interior of the school was opened up between the entry and the main body of the building. As you step into through the entry door there is a room to the left with a plywood door. The room is crammed full. The floor in the entry is hardwood. Straw covers the floor in the larger part of the building, I believe cement is under the straw. The walls and ceiling in the entry are lathe and plaster with plaster starting to fail. The main part of the school has wallboard over lathe and plaster going up the walls to the sloped edges of the ceiling and across the ceiling as well. Outlets and lights indicate electricity. Shelves are hung along the north wall. There are blackboards between two windows on the south wall and there is also black slate along that same wall, below the windows, that runs the length of the room. Wainscot is on the walls in the original entry area.

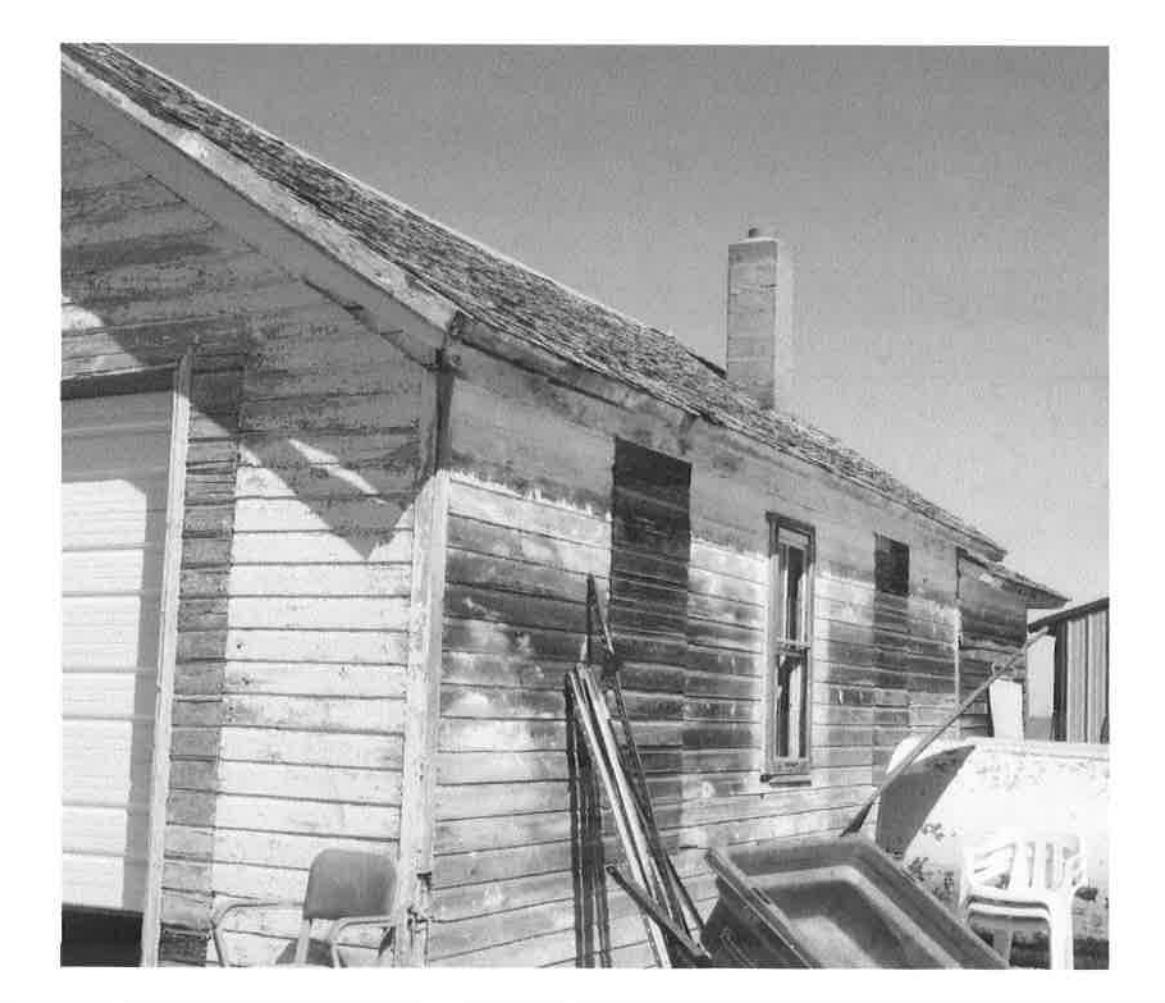
South Side

The feature is a one room prairie school on a poured concrete foundation. It was moved to this farm site to be used as a shop/garage. The gable roof of the school and the half hip roof of the entry are covered with wood shakes with some metal capping and finials. There is a newer cement block chimney on the south slope near the east end. The soffits are closed.
