NDCRS ARCHITECTURAL SITE FORM PAGE 1 SITS# 32 MH H5(a

SITE IDENTIFICATION			0110# 52 <u></u>	
Field Code Balfour Township School				
Map Quad Map Quad		me		
LTL TWP52 R77 LTL TWP R LTL TWP R LTL TWP R	SEC SEC SEC SEC	QQQ <u>6</u> QQQ QQQ QQQ	QQ <u>6</u> QQ QQ QQ	Q 6 Q Q
UTM UTM	N E	ZONE NAD 1927	NAD 1983	Subsection: $1 = N\frac{1}{2}$
City:				$2 = E\frac{1}{2}$ $3 = S\frac{1}{2}$
Street Number:				$4 = W\frac{1}{2}$ $5 = NE\frac{1}{4}$
Street Name: 40th St NE				6 = SE¼ 7 = SW¼
Urban Legal Description:				8 = NW ¹ ⁄ ₄
SITE DATA				
Total # Architectural Features:	1			
Fieldwork Date: 6/6/2016				
Reconnaissance Survey 🖌	Intensive Surve	У		
Project Title & Supervisor: Country Schoolhouse Project				
Report Title & Author(s):				•
Additional Information:				
SHSND USE Area of Significance Z Ecozone Area of Significance Ecozone Z		fied Site	. CR Type	2
Recorded ByKathy (First Name & Last Name)	Wilner	Date F	Recorded	1/19/2017 (mm/dd/year)

Balfour Township School

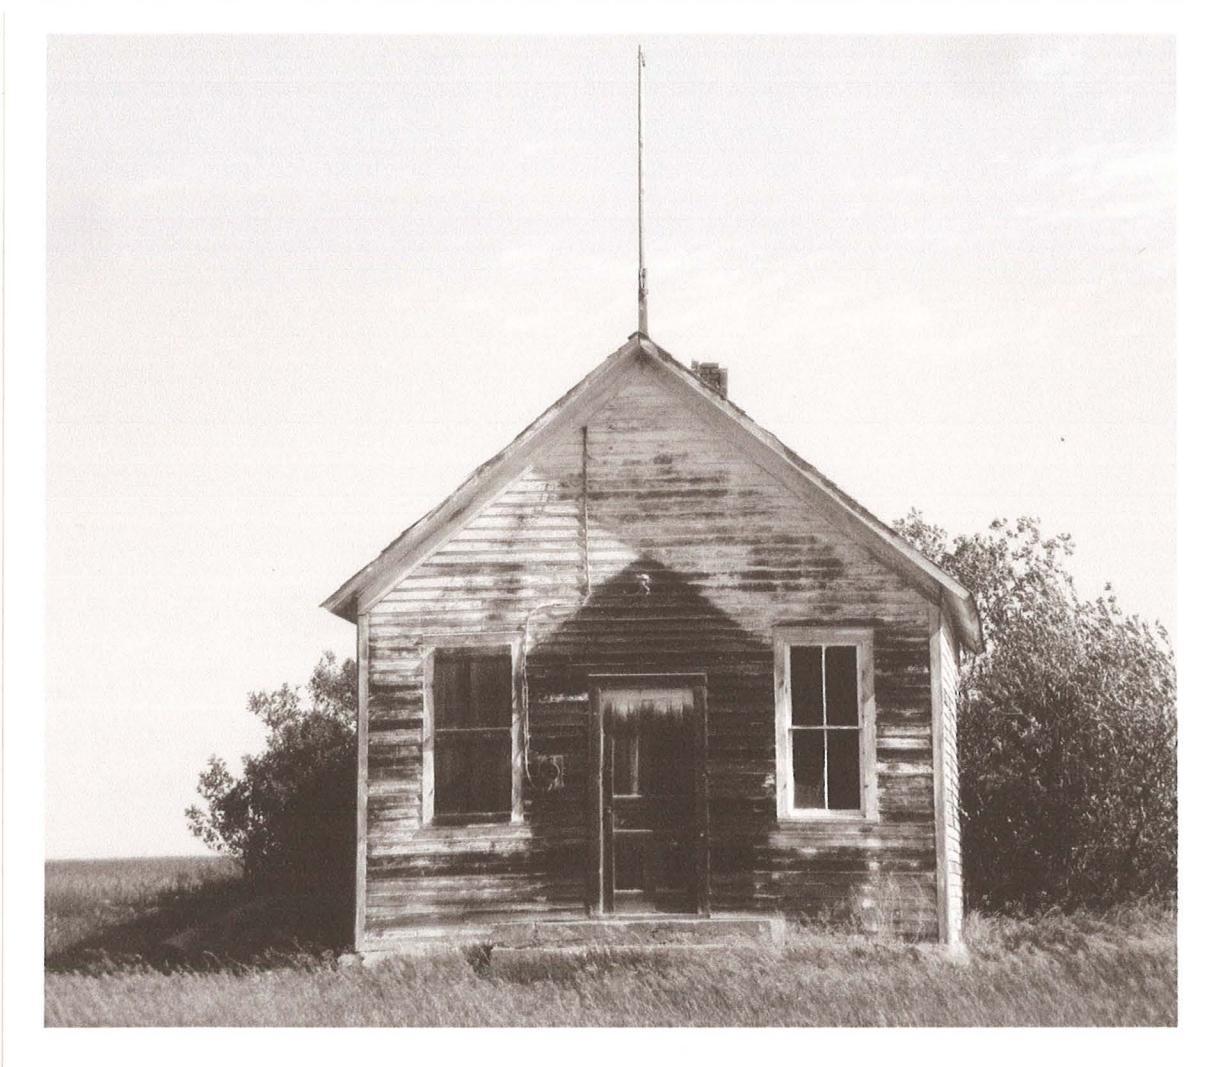
South Side

There is a wide trim board under the soffits at the peak ends of both the north and south walls. All other siding is 6 inch wood lap with 6 inch wood corner trim. The south wall shows lack of paint in a shape that would lead me to believe there was an entry there at some point. A large set of concrete steps leads to a 5 panel wood door. To either side of the entry door there are double hung windows, 2 over 2, with some glass on the right window and shutter over the left window. On the east wall there is a window opening that have been sided over. On the west side there are six double hung, 2 over 2, windows with little glass and 4 are shuttered. Conduit on the south wall as well as a light fixture over the door suggest electricity. The interior walls are beadboard as is the ceiling. Some of the ceiling is falling in. No blackboards hang in the school but is evident that they were on the east wall and 1/2 of the north wall. There is a door on the north wall. A furnace sits at the north end of the school room. Wainscot is on the lower third of the wall. The floor is narrow hard wood.
