NDCRS ARCHITECTURAL SITE FORM PAGE 1

| SITE IDENTIFICATION | SITS# 32 |
| Country Schoolhouse Project | |

Field Code Knoke School

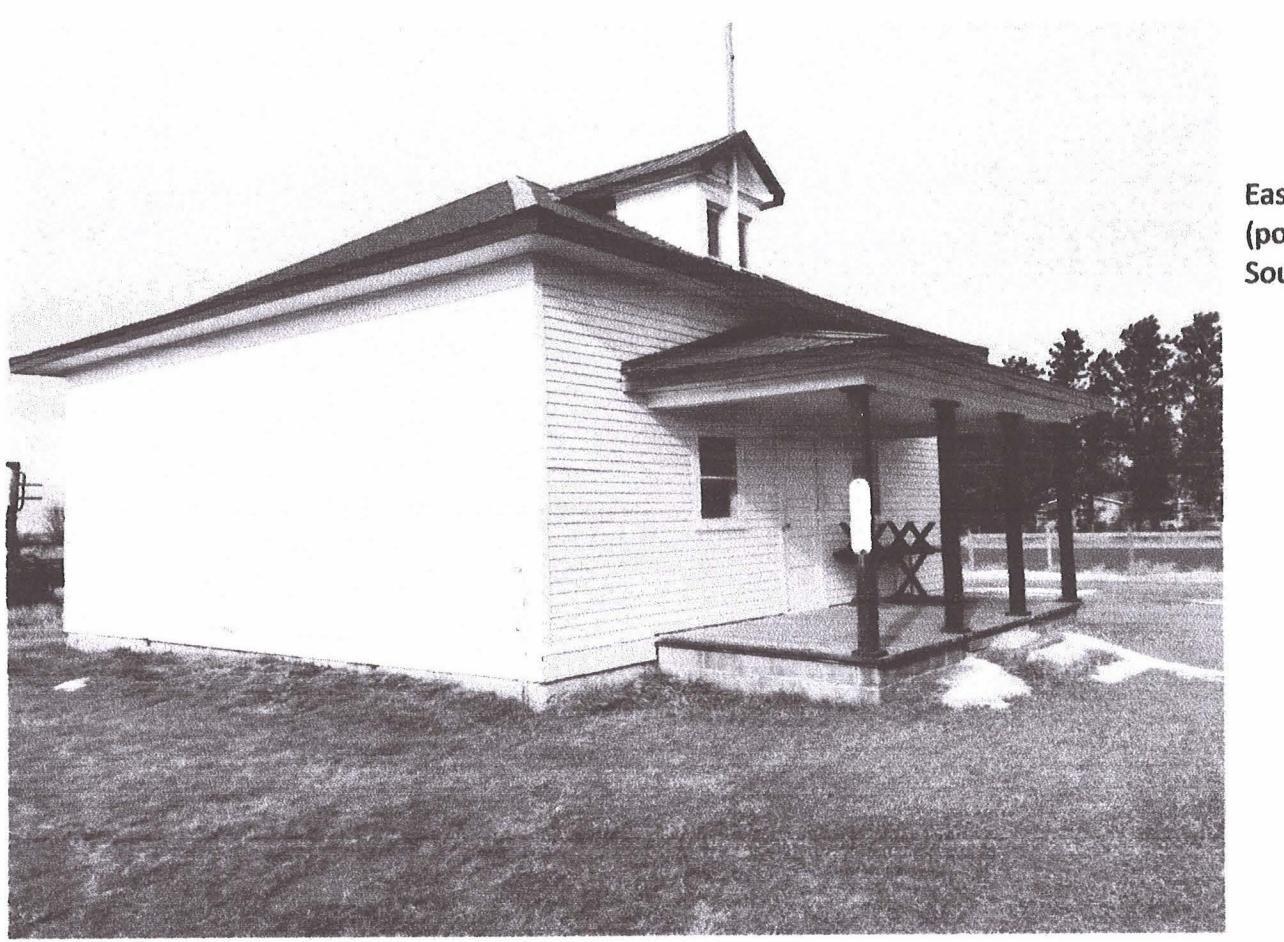
Knoke School

This feature is a one room prairie school house sitting on a poured concrete foundation. It is sitting in the original location. The hip roof was recovered with metal sheeting. There is a brick chimney. The soffits are closed. There is also metal sheeting on the porch roof as well as the dormer/cupola roof. The dormer/cupola has two window openings that have plexiglas in them today. The school measures 32 feet by 32 feet. Half of the flag pole remains near the dormer, it was cut back when the roofing was done.

There is a wide trim board running around all four sides of the school just under the soffits. The remainder of the siding is 4 inch wood lap, freshly painted summer of 2017. The corner trim is also 4 inch wood. There is a water board running above a wide trim board near the bottom of the building. The entry platform has a roof held up by four pillars. The pillars sit on a floor of concrete blocks and according to the owner it has always been there although they think it might have been enclosed at some point. The entry door is 5 panel wood door the opens into a hallway leading into the school room proper. There are a total of 5 doors on the east wall of the school room, the entry door, two to the right (south wall) which lead to the coal room nearest the outside wall and the coat room (window to the east) between the entry door and the coal room door. To the left of the entry door is a wash room (window to the east) and further to the north this door leads into the library and this room has the north side window. All the doors have decorative headers. A fuel oil furnace sits between the coat room and the coal storage room today with the stove pipe leading to the chimney on the north slope of the roof. There is a bank of 7 windows on the west side. The large windows are multipane, double hung with all glass intact. All but 1/2 of the middle window are covered. There is a small, double hung window on the north east corner and two more small, double hung windows either side of the entry door. The floor is tongue and groove hardwood. The walls and ceiling are lathe and plaster with a wide trim board running along the bottom of the wall at the junction with the floor. There are blackboards running along the north wall as well as between the two most north doors on the east wall as well as between the entry door and coat room. Exterior wiring and inside light fixtures indicate the presence of electricity. This school closed in 1947.

East (porch) South

West (windows) and North
