NDCRS ARCHITECTURAL SITE FORM PAGE 1

Field Code Jordan TownshipSchool SITS# 32 AD				
Complete one Page 2 <u>for <i>each</i> architectural feature</u> at the site.				
Architectural Feature #1	MANAMA .			
Construction Date	Feature Type9	Condition 5	to contributionals	
Feature Date 3	Context 7	Plan Shape	5	
Structural System 25	Primary Exterior 26	Style Other S	tyle	
Original Owner's Ethnicity	Secondary Exterior	Architect/Buil	lder	
Other Information:				
		Stories1		
D 11.1				
Feature Preservation Recommendation(s) (Check all that apply):				
Individual nomination				
Contributes to a potential district				
No nomination potential				
——Will not contribute to a district				
Potential district—feature would be a contributing element if other properties constitute a district				
Thematic nomination potential				
——Component of a historic site or landscape				
Moved (specify all applicable choices)—a) relocation occurred within a historic period; b) recreates original site, orientation, landscape, & spatial relationships; c) compatible in context —with neighboring structures; d) relocation has damaged eligibility

Jordan Township School 6/21/2016 Kathy Wilner AD

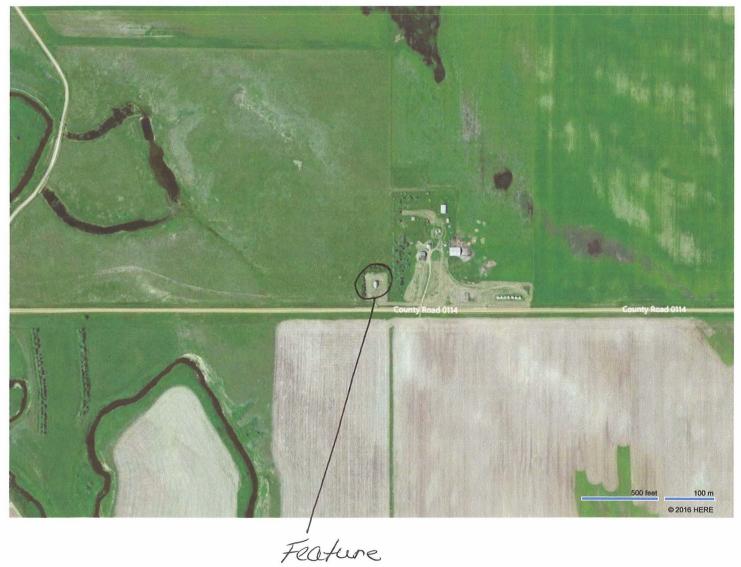
The feature is a one room school on a poured concrete foundation. The gable roof of the main body of the school and the entry are covered with metal sheeting with metal capping on the school and finials. The soffits are closed. A red brick chimney sits at the north end of the building on the east slope near the peak. The building measures 36 feet north to south and 22 fet east to west. The entry measures 10 feet by 10 feet.
