NDCRS ARCHITECTURAL SITE FORM PAGE 1

(First Name & Last Name)		Date Recorded	(mm/dd/year)
Recorded By Kathy Wilne	r	Date Recorded	1/13/2017
SHSND USE Area of Significance Area of Significance Area of Significance Area of Significance	Verified Site Non-Site	CR Typ	e <u>2</u>
Additional Information:	×		
Report Title & Author(s):			
Project Title & Supervisor: Country Schoolhouse Project			
Reconnaissance Survey Intens	ive Survey		
Fieldwork Date:5/3/2016			
Total # Architectural Features:1			
SITE DATA			
Urban Legal Description:			8 = NW ¹ / ₄
Street Name: 26th St SE		_	6 = SE½ 7 = SW½
Street Number:			$4 = W\frac{1}{2}$ $5 = NE\frac{1}{4}$
City: Valley City		_	$2 = E\frac{1}{2}$ $3 = S\frac{1}{2}$
UTMN UTME	ZONE _ NAD 19	 927 NAD 1983	- 111/2
LTL TWP R SEC _ LTL TWP R SEC _	15 QQQ 5 QQQ QQQ QQQ QQQ	QQ	Q <u>5</u> Q Q
Map Quad <u>Baldhill Dam</u> Map Quad	Site Name - -		
Field Code Getchell Hall	Site Name	petchell Hall	
SITE IDENTIFICATION

The feature is a one room prairie school sitting on a concrete foundation. The gable roof is covered with metal sheeting and the soffits are closed with metal as well. There is a red brick chimney near the east end of the roof. The building measu

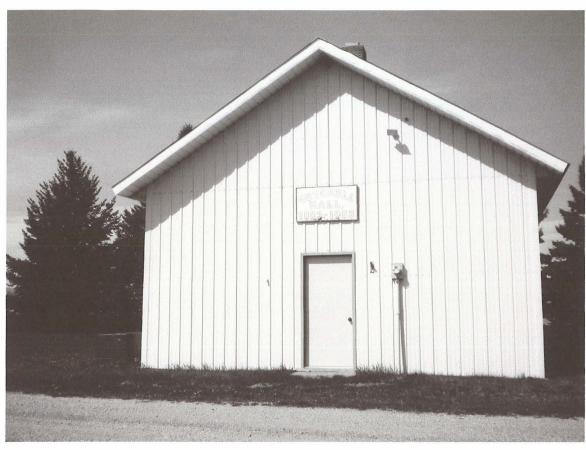
East Side

This building is entirely covered with vertical metal siding. There is an newer entry door at the southwest corner, locked as well as newer entry door on the east side, also locked. There is a small concrete pad just outside this east door. Electric conduit and a meter are just to the right of the entry door and there is an outdoor light high on the east wall.
