NDCRS ARCHITECTURAL SITE FORM PAGE 1

Field Code Svea Township School Site Name _____

Project Title & Supervisor:
Country Schoolhouse Project

Svea Township School

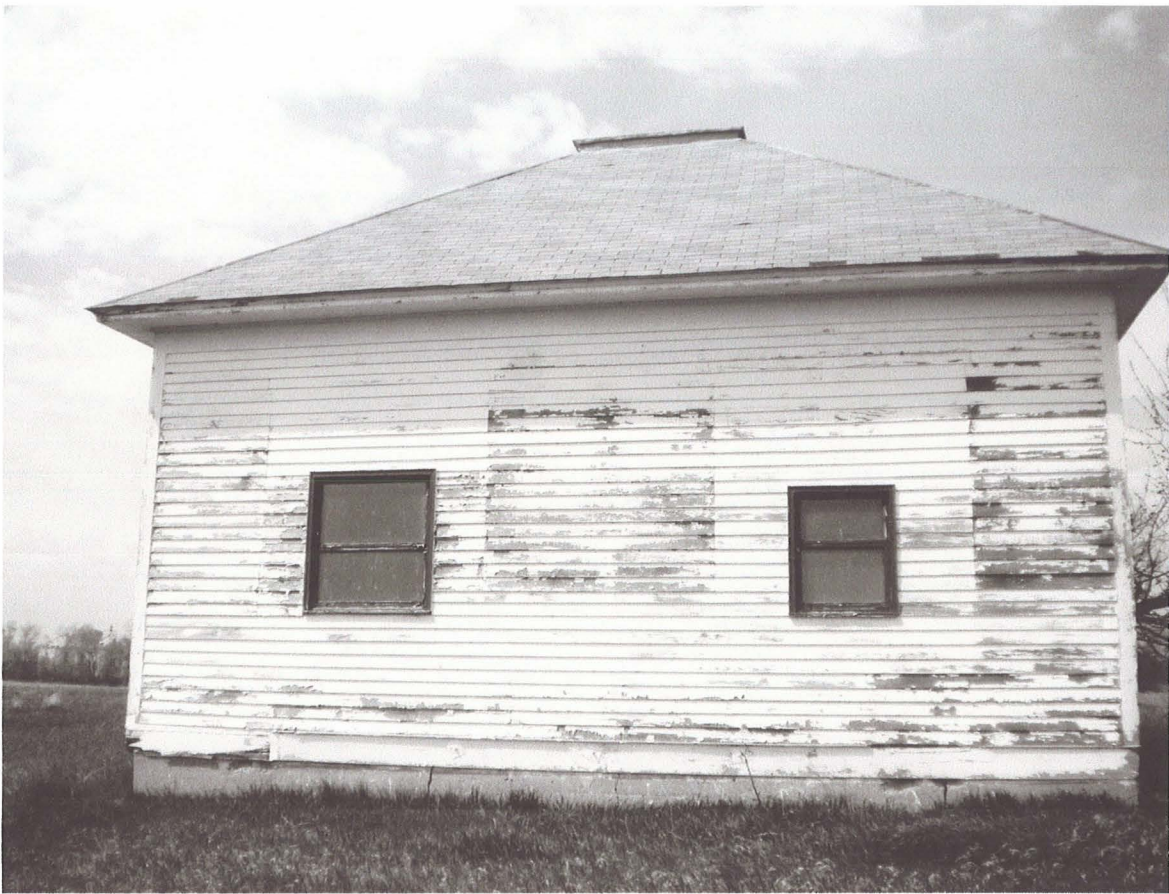
East Side

The feature is a one room prairie school sitting on a concrete foundation. The hip roof is covered with asphalt shingles and soffits are closed with beadboard. The concrete block chimney has fallen off the roof and lies in the yard. The building measures 28 1/2 feet north to south and 28 1/2 feet east to west.

The siding begins under the soffits with a wide trim board. The remainder of the siding is 6 inch wood lap with 6 inch corner trim and as a finish at the bottom of the walls there is a skirting board with water table. There are two nonconforming double hung windows on the east wall with visible seams where siding filled in other openings, perhaps larger windows. On the south side there is one nonconforming double hung window. On the west side there are two double hung windows that might be original to the school, also on the wall is a 5 panel wood door for entry into the school. Above the door there is an outside light fixture suggesting the presence of electricity. The north wall had three areas that were filled in and may have been windows. Entering the school from a concrete apron there is a small entry with a second 5 panel wood door giving access to the main room of the school. Inside the school the walls are a mixture of lathe and plaster and sheet rock. The sheet rock was used in the areas where windows were closed in. There is picture molding about 2 feet down from the ceiling. At the bottom of the walls there is a wide decorative trim board. Decorative moldings can be see above the interior doors. There are two small room on the west side of the school, used for a fuel oil barrel and storage. The floor is tongue and groove hardwood and the ceiling is wallboard. There is blackboard on the south wall. No wainscot.
