NDCRS ARCHITECTURAL SITE FORM PAGE 1

SITE IDENTIFICATION				
Field Code Heimes Landing #1	Site Name	Heime	s Londina	#1
Map Quad <u>Baldhill Dam</u> Map Quad				
LTL TWP141 R58 LTL TWP R LTL TWP R LTL TWP R	SEC Q0	QQ	QQ <u>7</u> QQ QQ QQ	Q <u>6</u> Q Q
UTM 5211423 UTM 570395		ONE <u>14N</u> AD 1927	NAD 1983 <u></u>	Subsection: 1 = N½
City:				$2 = E\frac{1}{2}$ $3 = S\frac{1}{2}$
Street Number:				$4 = W\frac{1}{2}$ $5 = NE\frac{1}{4}$
Street Name:				6 = SE½ 7 = SW¼ 8 = NW¼
Urban Legal Description:				0 - 1444/4
SITE DATA				
Total # Architectural Features:	1			
Fieldwork Date: 5/6/2016	_			
Reconnaissance Survey <a>	Intensive Survey _			
Project Title & Supervisor: Country Schoolhouse Project				
Report Title & Author(s):				
Additional Information:		-		
SHSND USE Area of Significance Ecozone Area of Significance	Verified Non-Si		CR Type	2
Recorded By Kathy (First Name & Last Name)	Wilner	Date R	ecorded	1/15/2017 (mm/dd/year)
(i nativalne di Last Name)				(IIIIIIIIIIIIIIIIII)

Heimes Landing #1

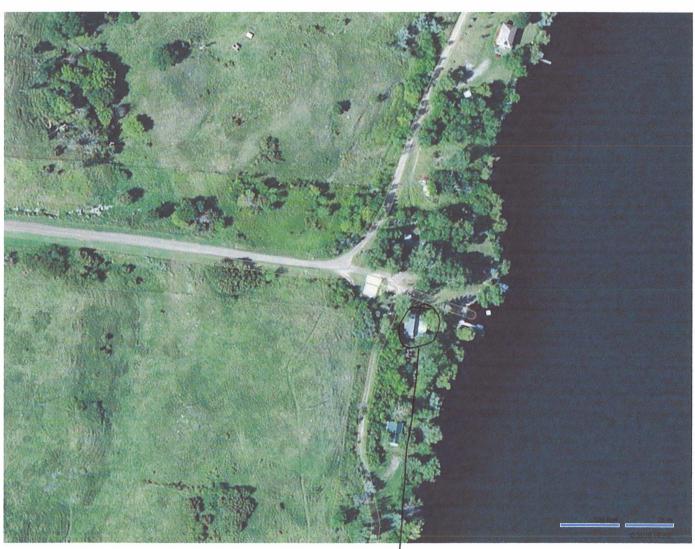
Feature

The feature is a one room prairie school sitting on a concrete block foundation. This building was moved to this location to be used for a cabin. The gable roof of the building is covered with asphalt shingles and the addition to the lake side has metal sheeting. There is a short, concrete chimney at the north end of the gable. The building measures 36 feet north to south and 20 feet east to west minus the addition toward the lake. The entry, located at the south end of the building, measures 6 feet by 10 feet.

There is a wide trim board just under the peak ends of the roof with 6 inch wood lap and 6 inch wood corner trim to finish the wall. There windows are mostly replacements with two windows that could be original windows. There is also a slider in above the entry. The entry door is new with an exterior storm door. There is electricity. Little of the original remains inside the bulding.
