### NDCRS ARCHITECTURAL SITE FORM

Field Code Wilkin School	PAGE 1	SITS# 32 BA	1700
SHE IDENTIFICATION		SITS# 32[	1200
Map Quad Dazey	Site Name Wilk	in School	
Map Quad	_Site Name		
LTLTWP R SEC _ LTLTWP R SEC _	12 QQQ 6 QQQ QQQ QQQ QQQ _	QQ QQ	Q 5 Q Q
NAD 1983, UTM 5220198 N NAD 1983, UTM 559450 E	ZONE 14N		Subsection: 1 = N½
City: Dazey			2 = E½ 3 = S½
Street Number: 1943			4 = W½ 5 = NE¼ 6 = SE1/
Street Name: 108th Ave SE			6 = SE¼ 7 = SW¼ 8 = NW¼
Urban Legal Description:			0 - NVV74
SITE DATA	_		
Total # <u>Architectural</u> Features: 1	]		
Fieldwork Date: 4/24/2019			
Reconnaissance Survey Intensi	ve Survey		
Project & Principal Investigator:			
Report Title & Author(s):			
Contracting firm or Agency completing the form	I		
Additional Information:			
SHSND USE Area of Significance Ecozone Area of Significance Ecozone	Verified	Site _L CR	Туре <u>2</u>
Recorded By Kathy Wilner		Date Recorded 4/	/224/2019
(First Name & Last Name)		_ 4.0 1.0001404	(mm/dd/year)

Wilkin School

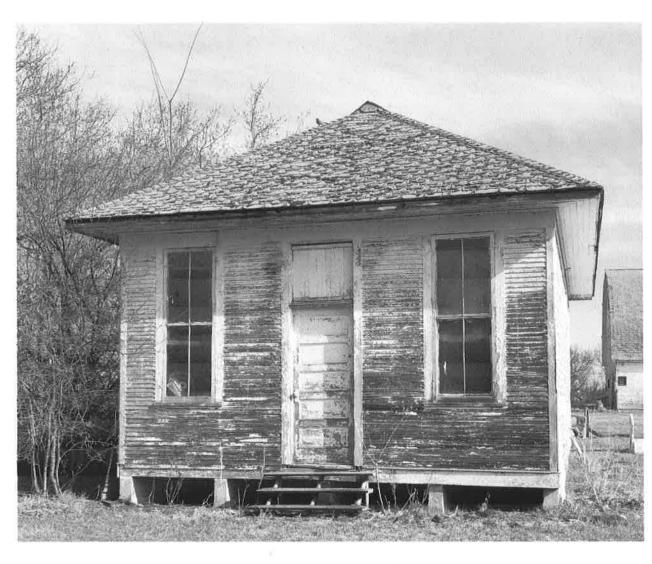
South Side

There is a rake board running just under the eaves on all side of the school. 6 inch wood lap with 6 inch wood corner trim with a wide trim board and waterboard at the bottom of the walls complete the siding. On the east side of the school all the windows were removed and a stud wall filled in that gap. 6 inch wood lap siding finished the outside. Three small access doors, two low and one high gave access for grain storage. On the south side of the school two double hung windows, with glass, remain along with a 5 panel wood entry door. On the west side there is one double hung window with intact glass. A transom opening above the door has been filled in with wood. Simple wood steps allow access to the building.

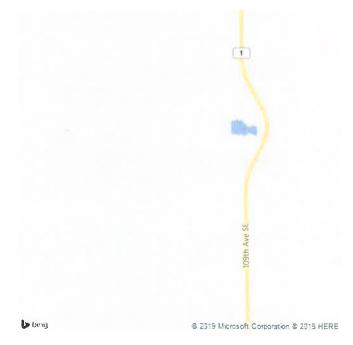
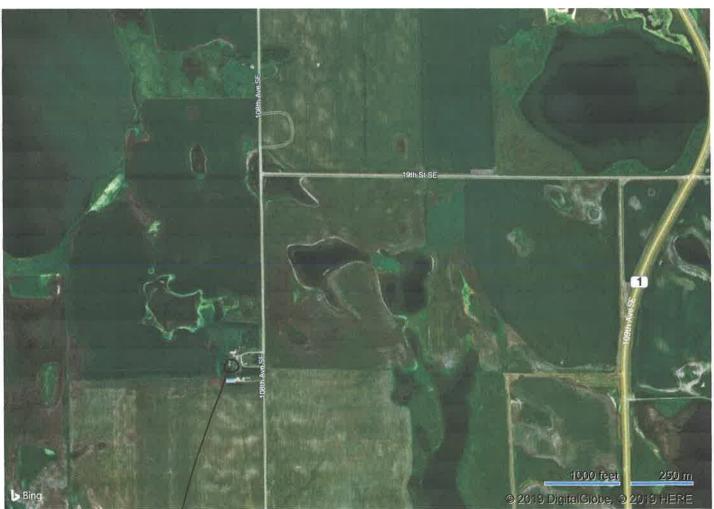
The feature is a one room prairie school moved to a farm yard for use as a grainery. The foundation is four horizontal concrete pillars that run north to south under the school. The hip roof is covered with asphalt shingles. There is no chimney. The soffit is closed with beadboard all sides. The building measures 34 feet north to south and 20 feet east to west.
