NDCRS ARCHITECTURAL SITE FORM

Field Code York Township School #1

Country Schoolhouse Project

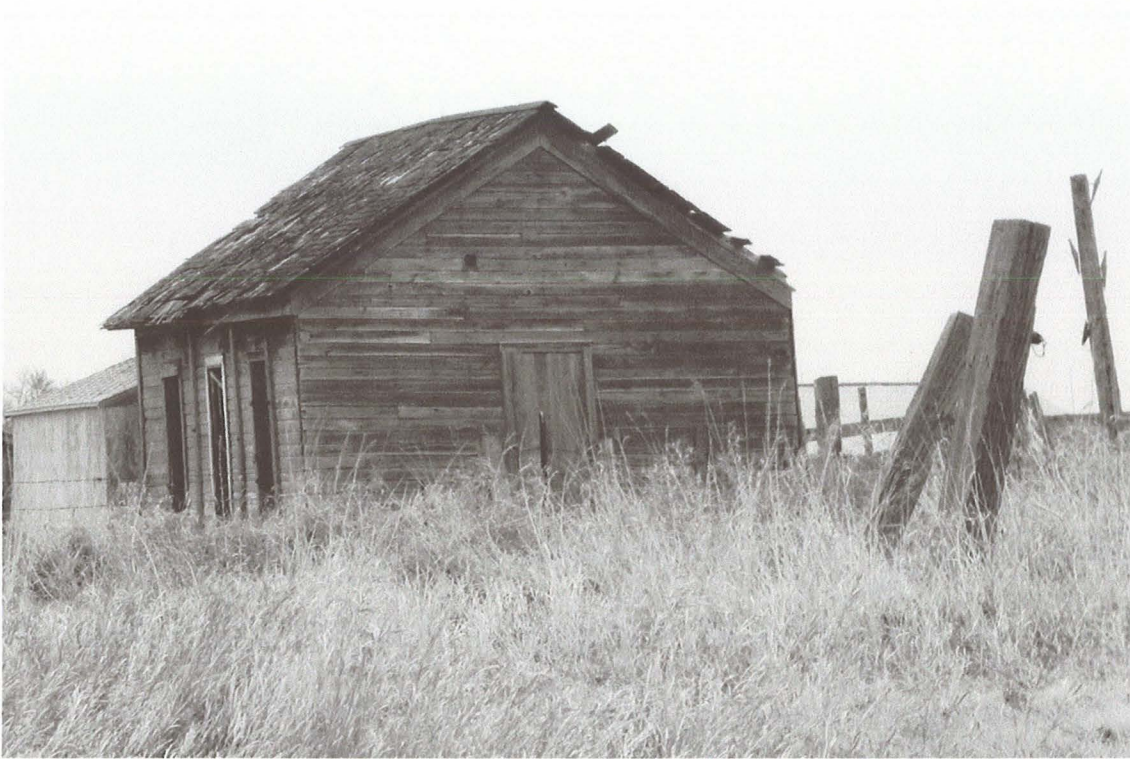
West Side

The feature is a one room prairie school. It was moved to this location. The roof is partially covered with wood shakes and there is metal capping at the peak. Much of the under planking has holes in and some is missing. This building is in very tough shape. There is no chimney and soffits are open.

The siding is 6 inch wood lap with 4 inch corner trim. The door is on the west side and looks to be a sheet of wood. The window openings, 3 on the south and three on the north are all void of glass and any framing. I did not get close to this building.
