NDCRS ARCHITECTURAL SITE FORM PAGE 1

Field Code Lein Schoo	I #2	SITS# 32_	BL				
Complete one Page	2 for each architectural for	eature at the site.					
Architectural Feature	#1						
Construction Date1906	6 Feature Type	9 Condition 7					
Feature Date 3	Context 7	Plan Shape	5				
Structural System 25	Primary Exterior	26 Style Other S	Style				
Original Owner's Ethnicity	y Secondary Exteri	or Architect/Bu	ilder				
Other Information:							
Foundation Concrete foo	tings	Stories1					
Roof/Cornice Gable							
Window Double hung			·				
Dating Method(s):	ekstop Junction	records	···				
Peature Preservation Recommendation(s) (Check all that apply): Individual nomination Contributes to a potential district No nomination potential Will not contribute to a district Potential district—feature would be a contributing element if other properties constitute a district Thematic nomination potential Component of a historic site or landscape Moved (specify all applicable choices)—a) relocation occurred within a historic period; b) recreates original site, orientation, landscape, & spatial relationships; c) compatible in context with neighboring structures; d) relocation has damaged eligibilit

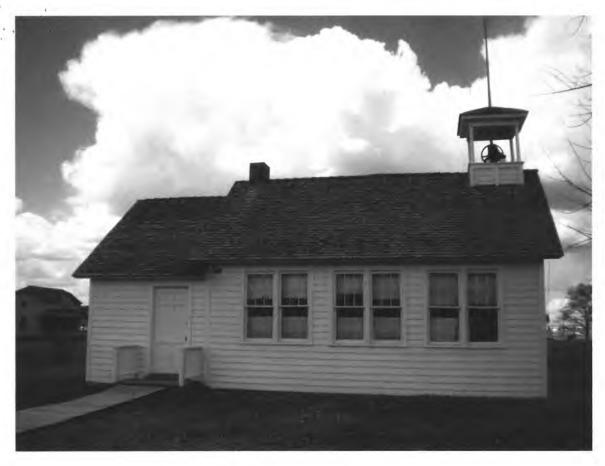
South Side

There is an 8 inch header board running under the peaked ends of the school as well as the entry. The siding is 6 inch wood lap with 4 inch wood corner trim. The paint is in great shape. All the soffits are enclosed. There are three pairs of windows on the south side of the main body of the school. The windows are double hung, 6 panes on the top half and a single pane on the bottom of each window. There also windows in the entry, three of the windows are small, two pane, double hung windows with a third that matches the larger windows. A 6 panel door leads into the entry from a wood single step porch. There are wood, spindle railings either side of the porch.
