# NDCRS ARCHITECTURAL SITE FORM

Field Code SX-EH-37

PNE Wind Turbine Survey; William Harding

A Class I and Class III Cultural Resource Inventory of 71 Wind Turbine Locations and Access Roads, Burleigh and Emmons Counties, North Dakota; Jolene Schleicher

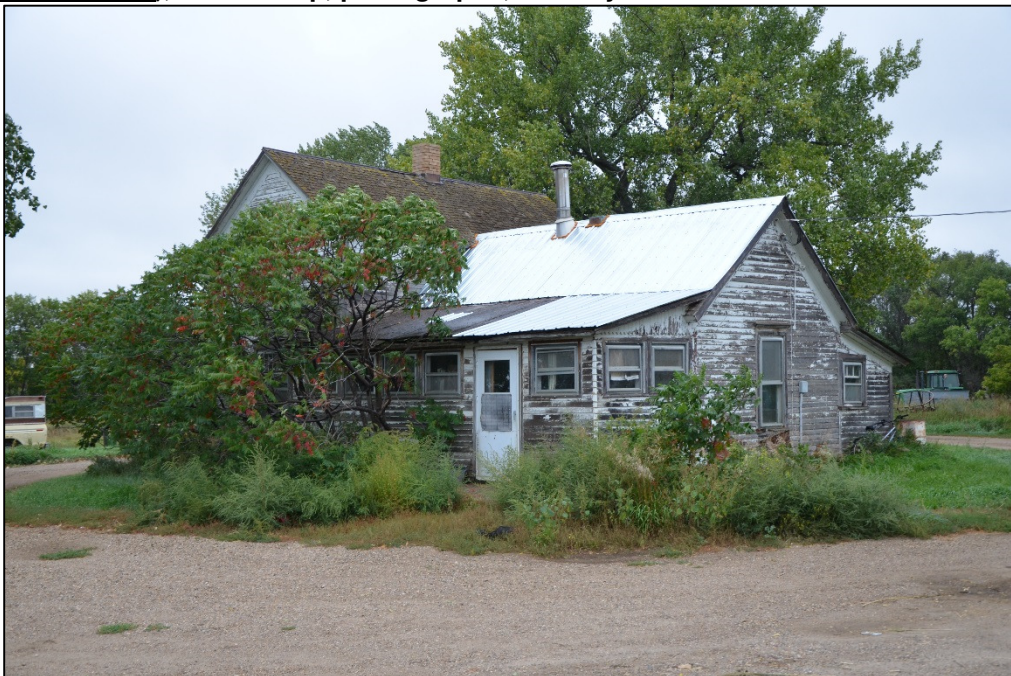
**Figure 3. Feature 1, facing northwest.**

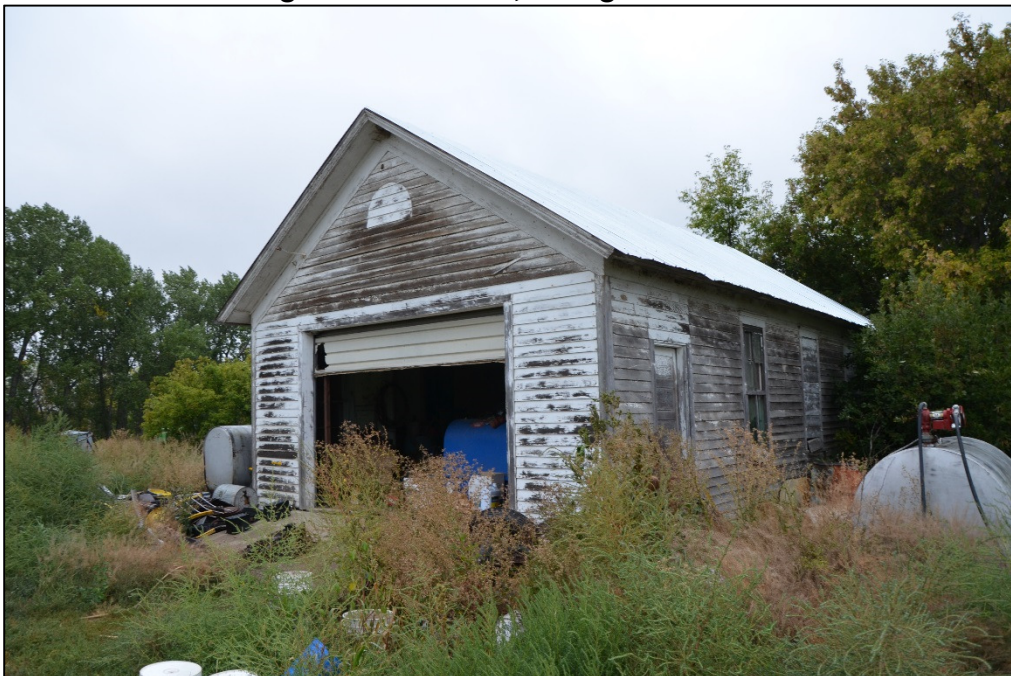
Feature 2 is a schoolhouse that has been converted into a garage. The schoolhouse has a similar lintel on its windows as those on the house and appears to date to the same time period (late nineteenth to early twentieth century). The building is a tall single-story, gable-roofed structure with regularly spaced four-over-four double-hung wood sash lighting the east and west sides of the building. These windows have been boarded over from the exterior, and one has been replaced with a paneled wood pedestrian door. An overhead track garage door has been added to the south side of the building, removing the original entrances and most of the vestibule. The building is clad with clapboard siding and roofed with corrugated aluminum. Paint in the south gable end reveals the former location of a fan-shaped sign or decoration.

**Figure 4. Feature 2, facing northwest.**

Further research on the history of this property is recommended.
