# NDCRS ARCHITECTURAL SITE FORM PAGE 1

PAGE 1 SITS# 32_BU_/	810
SITE IDENTIFICATION	00
Field Code Dalen Town Hall Site Name	
Map QuadSite Name Map Quad	
LTL       TWP       163       R       76       SEC       19       QQQ       5       QQ       5       Q       5         LTL       TWP       R       SEC       QQQ       QQQ       QQ       QQ       Q       Q       Q       Q       0	
UTMN       ZONE       Substant         UTME       NAD 1927NAD 1983       1 = N         2 = E       2 = E	
City:	1/2
Street Number: 5 = N	E¼
Street Name:         105th St NE         6 = S           7 = S         7 = S	W1/4
Urban Legal Description:	W1⁄4
SITE DATA	
Total # Architectural Features:1	
Fieldwork Date:6/16/2016	
Reconnaissance Survey Intensive Survey	
Project Title & Supervisor: Country Schoolhouse Project	
Report Title & Author(s):	
Additional Information:	ar
SHSND USE	
Recorded By Kathy Wilner Date Recorded 1/23/20 (First Name & Last Name) (mm/dd/	)17 year)

Field Code Dalen Town Hall

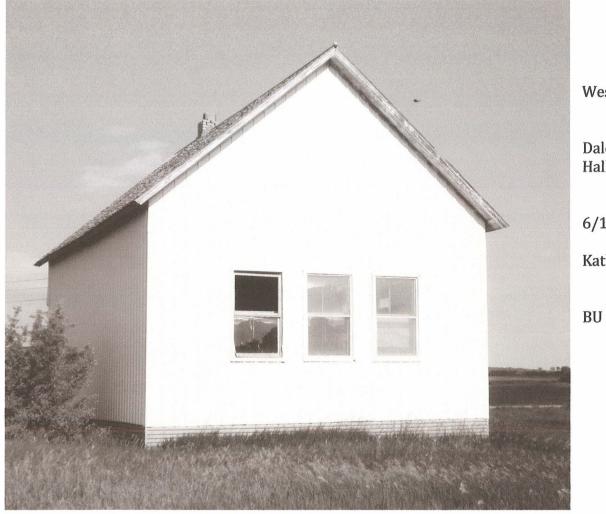
West Side

The siding of this building is vertical, metal ribbed sheeting over. The double hung windows, three on the south side and three on the west side, are all replacement double hung windows with storm windows. There is a small entry on the east side and the shed roof is covered with wood shakes. There is a locked wood door for entry. The interior of the school (seen through a broken window) has wallboard on the ceiling and walls. The floor is tongue and groove hardwood. At the east end of the main body of the school are 5 panel doors on near south and north ends of the east interior wall which I am guessing leads to the coatrooms. There are transoms with intact glass above both doors. Two small blackboards are on the east wall on either side of the chimney and another blackboard runs the length of the north wall. Electric light fixtures inside the school indicate electricity.

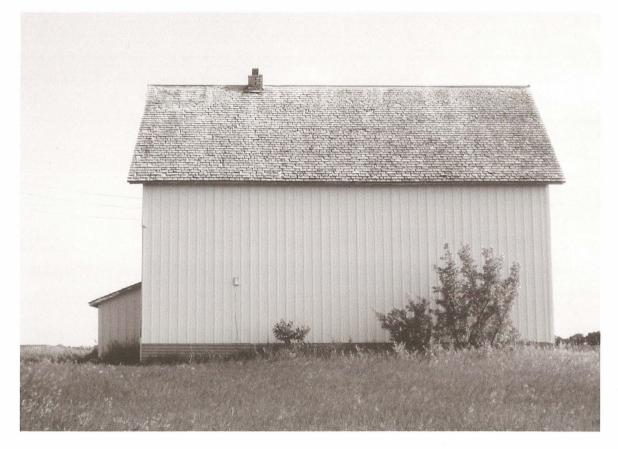
The feature is a town hall today but the interior tells it is a one room prairie school on a concrete foundation which has been covered with metal sheeting. The gable roof is covered with wood shakes with metal capping. A small, brick chimney is at the peak of the roof near the east end. The sofffits are closed. The building mearures 32 feet east to west and 25 feet north to south.
