# NDCRS ARCHITECTURAL SITE FORM PAGE 1

SITS# 32 BU 187

Field Code Chatfield Township School Site Name \_\_\_\_\_  
Site Name \_\_\_\_\_

Project Title & Supervisor:  
Country Schoolhouse Project

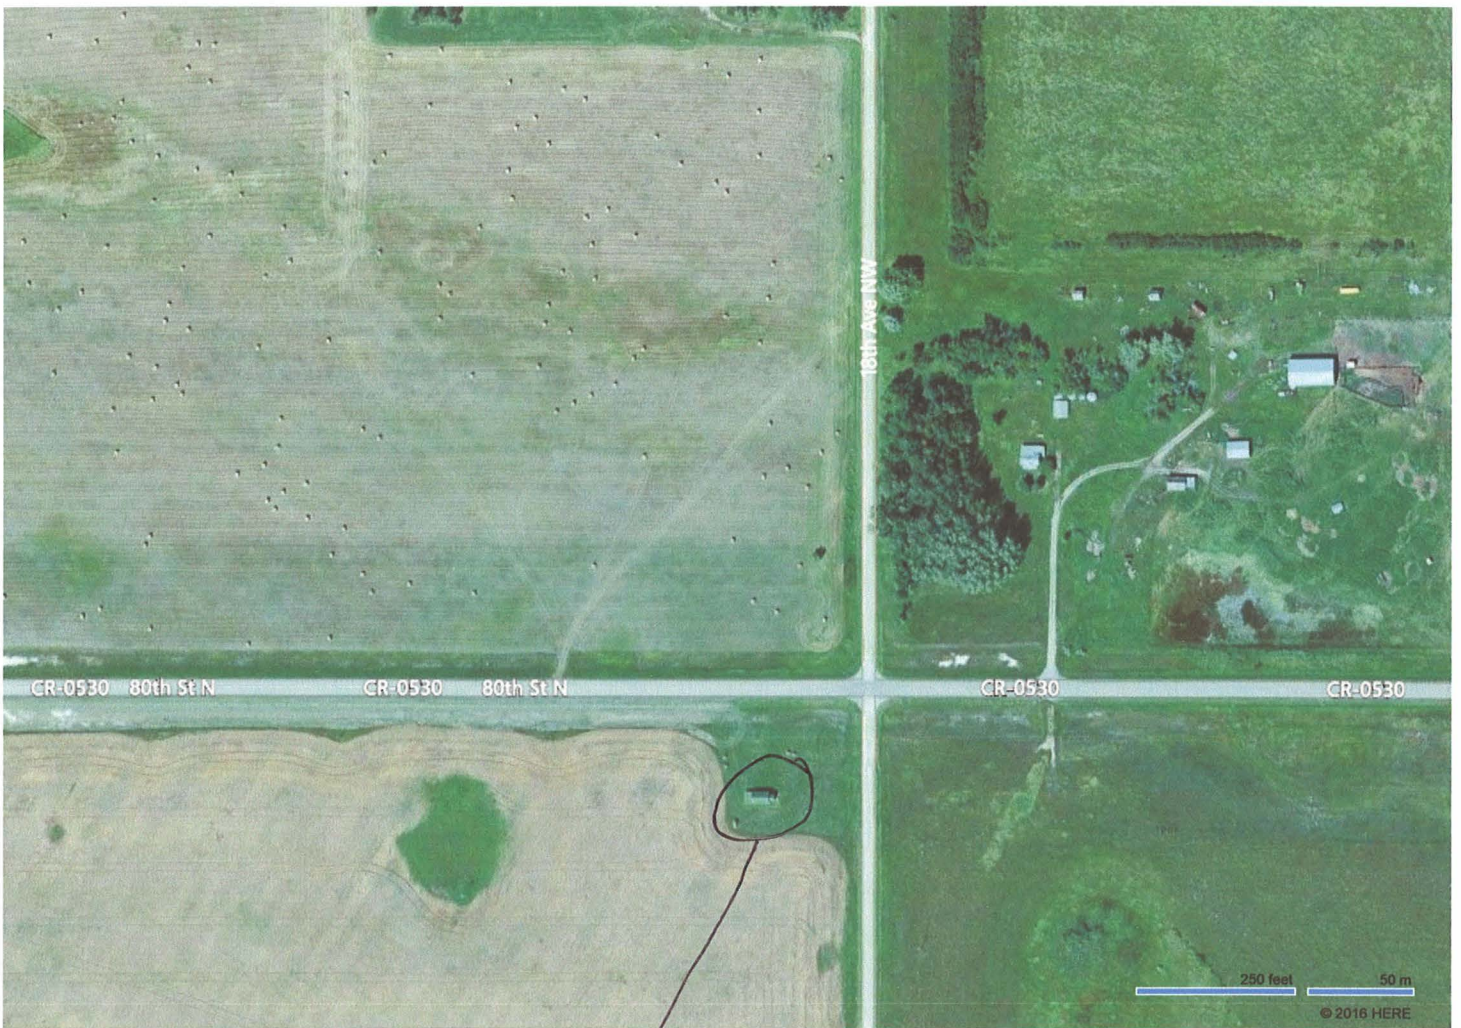
The features is a one room prairie school on a concrete foundation. The gable roofs of the school and entry as well as the shed roof on the west addition are covered with asphalt shingles. There is a yellow brick chimney at the west end of the roof at the peak. The soffits are closed. The shed measures 10 feet east to west by 18 feet north to south, the main body of the school measures 28 feet east to west by 18 feet north to south and the entry measures 8 feet east to west by 10 feet north to south.

There is a wide trim board under the soffits at the peak ends of the school. The remainder of the siding is 6 inch wood lap with 6 inch wood corner trim with the exception of the shed and here there is metal corner caps. The entry is reached from a concrete step, the 5 panel door is broken and standing open. The entry ceiling is missing while the ceiling in the main school room is beadboard. The floor is tongue and groove hardwood. The walls in the interior of the school are a mixture of lathe and plaster and wallboard with sheet rock filling some of the window opening. There is beadboard wainscot. The school originally had three double hung, two over two, windows on both the north and south walls but 4 of the six have been either shuttered or filled in with siding. The north wall has no windows visible today and the south wall has two and the glass is intact. There is a small boarded up opening on the south side of the shed that might have been used for fuel. There is also a window opening on the north side of the shed, no glass. There are two doors leading into the shed from the main school room, one 5 panel door is intact. There is a blackboard on that west wall is between these two door. An old fuel oil stove sits near the west end of the school room. Light fixtures and wiring on the outside of the school suggest electricity.
