NDCRS ARCHITECTURAL FORM  
PAGE 1

Field Code Loon Lake School #1

Country School House Project  
Kathy Wilner  
366 43rd Ave SE  
Bowdon ND 58418

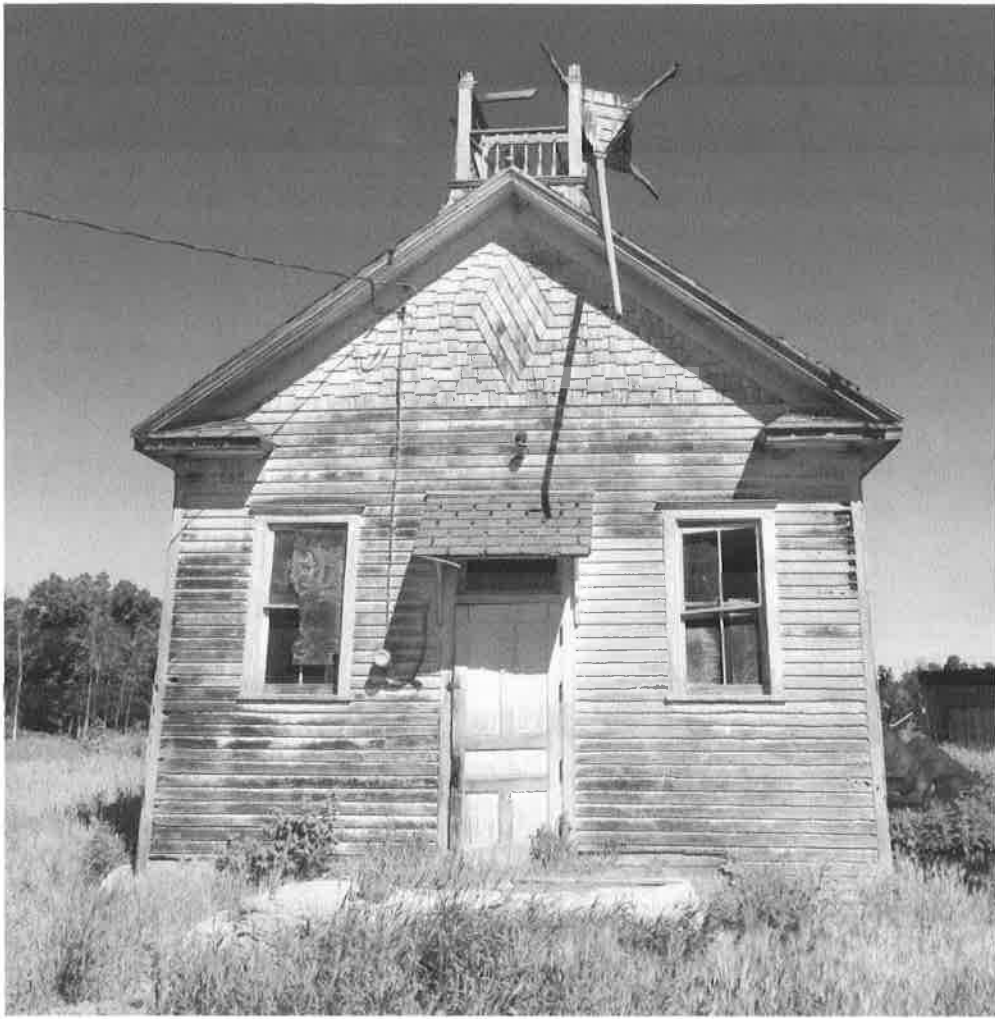
**South Side**

Rake boards begin the siding that continues with 6 inch wood lap on the north, east and west walls with 4 inch wood corner trim. The south side has wood shakes from the peak to just above the cornice returns with a decorative, diamond shaped piece in the middle. The remainder of the siding on the south side is 6 inch wood lap. A canopy hangs out above the door, this covered with asphalt shingles. A 5 panel wood door with a transom window above it give entry from a large concrete porch platform. Upon going into the entry door openings are seen to both the left and right. All interior doors are gone. They door openings to the coat rooms have decorative cornices and wide trim. The windows also have similar trim. The walls in the entry and main school room have lathe and plaster walls. The ceiling throughout has wallboard. Light fixtures in the ceiling are indicative of electricity. Doors opened into the school room from the entry and both coatrooms. All those doors are gone and they have some barricads to keep calves in the big room. The floor was cut from side to side just as you would step into the big room. The floor in the entry and coat rooms is tongue and groove hardwood, the floor in the remainder is straw covered dirt. There are four double hung, two over two, windows on the west side of the school room, one on the north and two more windows on the south side, one in each coat room. There is some glass, most of the framing and some are covered. As mentioned this building was used for housing calves. The north side of the school has a side sliding door. There are remnants of black boards on parts of the south and west walls as well as framing on the east wall where the blackboards have been removed.
