NDCRS ARCHITECTURAL FORM
PAGE 1

Site Name Loon Lake School #3

Loon Lake School #3

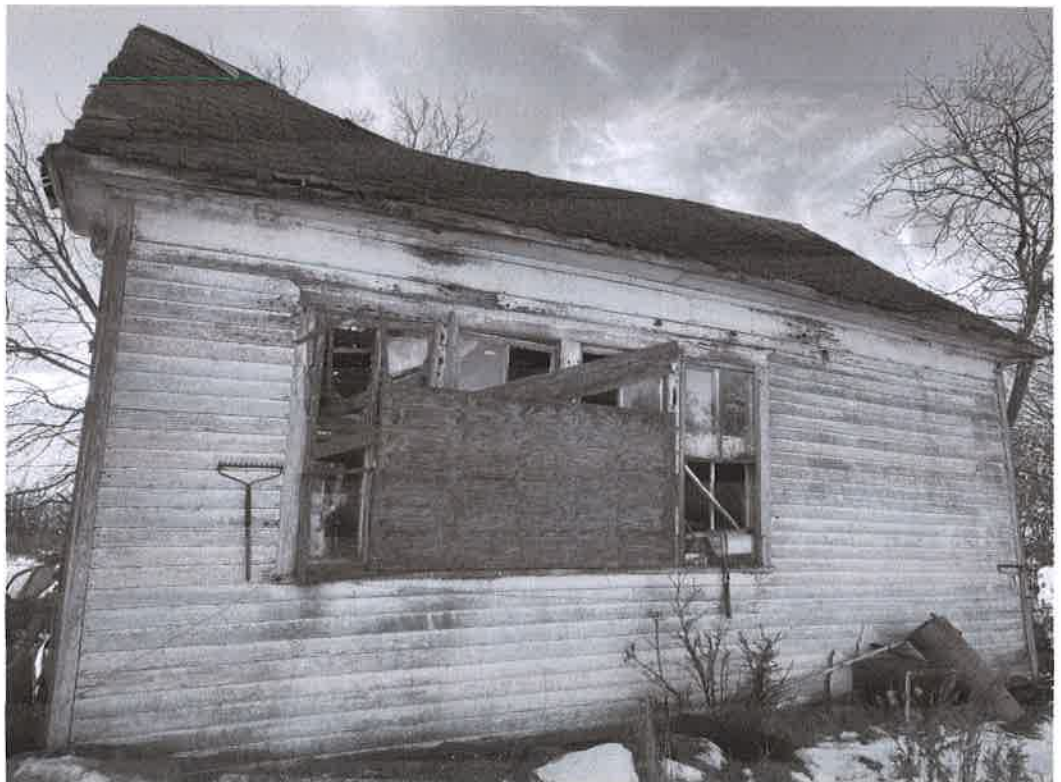
North Side

The feature is a one room prairie school sitting on a poured concrete foundation. The school was moved to this location for storage. The roof is starting to fail in on the north side. It is mostly covered with asphalt shingles over wood shakes. There is metal capping. There is a yellow brick chimney located inside the school, covered outside. Located above the door is a small asphalt shingled canopy supported by decorative brackets. The soffits are mostly closed as they are falling into disrepair. There are cornice returns on both the peak ends of the school. The school measures 34 feet long by 24 feet wide.

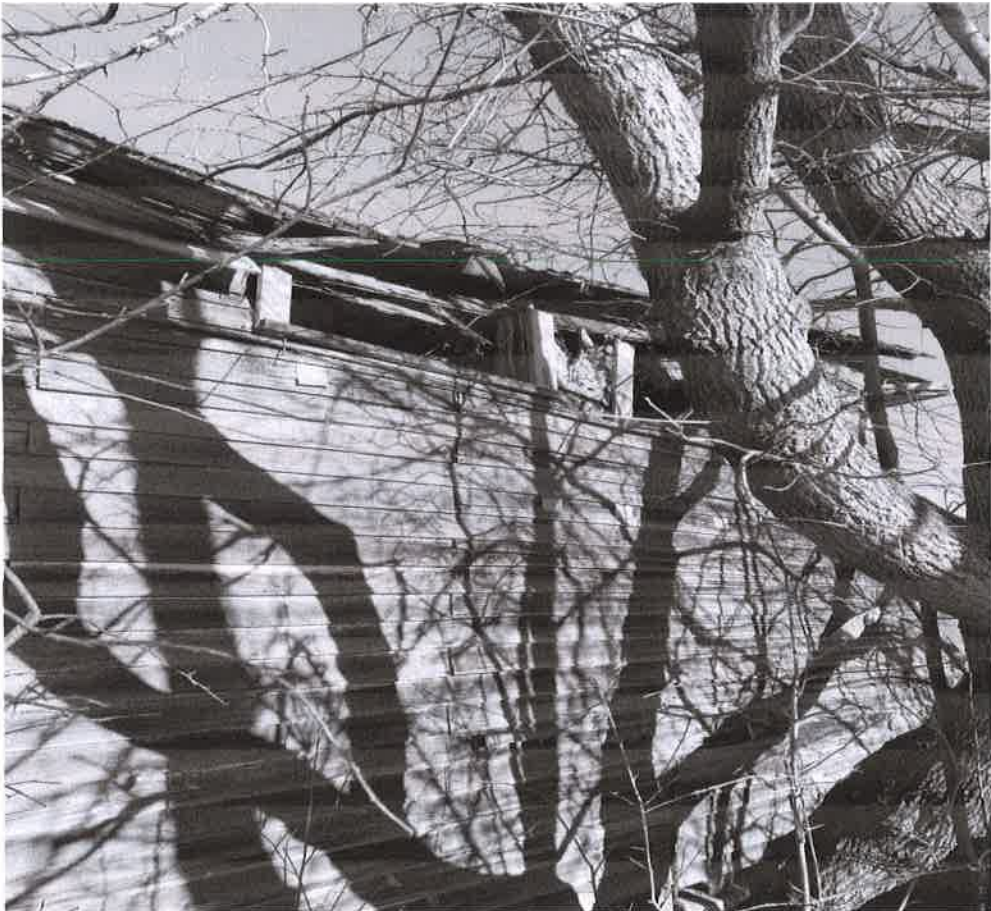
South Side

A rake board begins the siding at the peak ends as well as along the sides of the building. The remainder of the siding is 6 inch wood lap with 4 inch wood corner trim. There are double hung windows on three sides of the school, some with glass, some covered and all have original trim. Two windows are located on either side of the entry door. A bank of 4 windows is located on the north side, about half of which are covered with plywood. A bank of 4 more windows, with some glass, is located on the west side. A five panel wood door gives entry into the school. A transom window is located above the door, under the canopy. Above the transom window there is decorative siding in the shape of a fan rising above three part circles (sun trim). There is an entry area just inside the door that leads to a second 5 panel wood door which gives entry into the school. Two coat rooms are located on either side of the entry. The walls in the school are lathe and plaster with wainscot. The ceiling is wallboard and most of that has fallen in along with several of the boards supporting the ceiling. The exterior roof is also falling in. The floor is tongue and groove hardwood. There is a blackboard on the south wall. Light fixtures in the ceiling indicate the presence of electricity.
