NDCRS ARCHITECTURAL FORM

Field Code Sergius School

SITS# 32BU 787

Country School House Project
Kathy Wilner
366 43rd Ave SE
Bowdon ND 58418

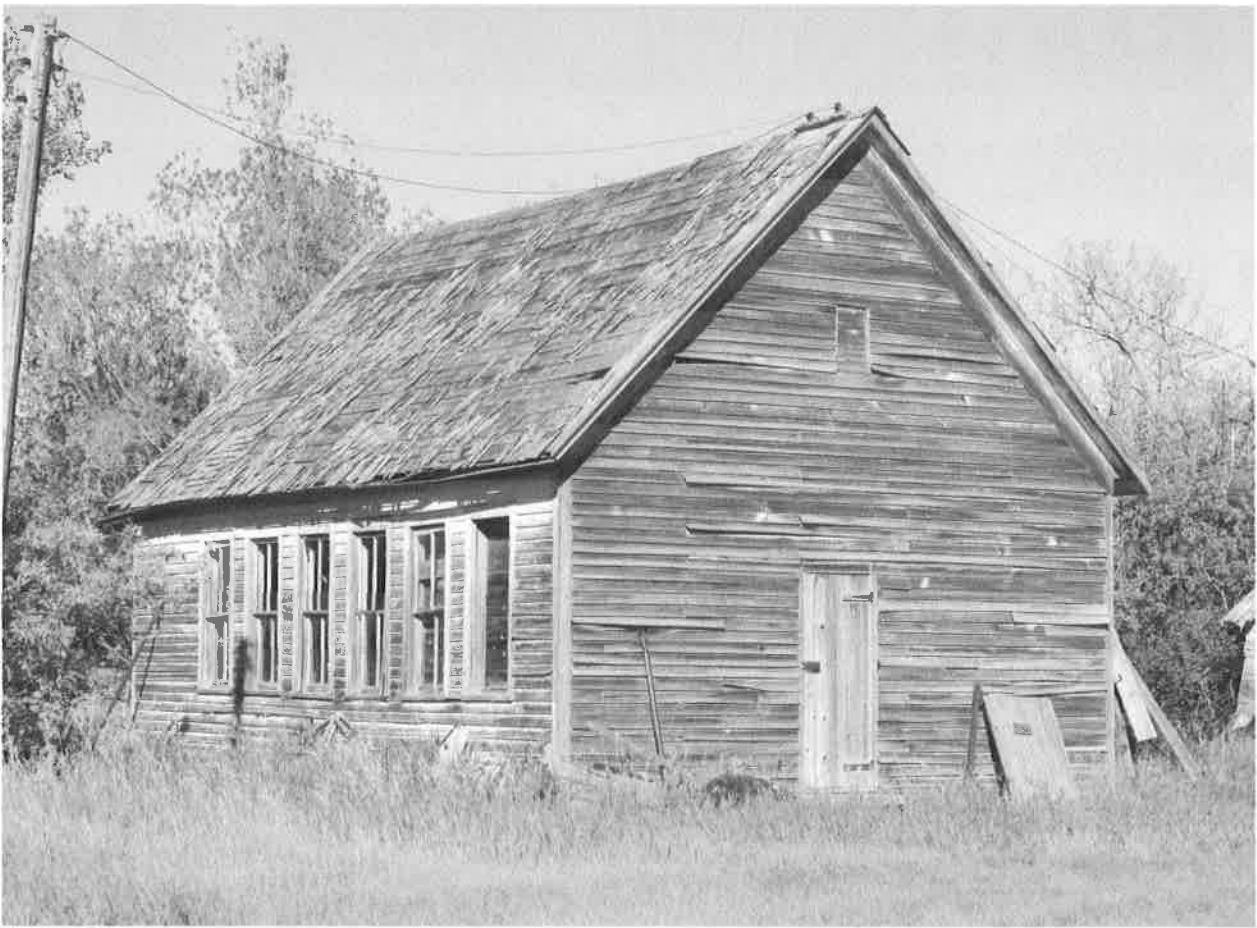
East Side

The feature is a one room prairie school on a concrete block foundation. This school was moved into a farm yard for storage. The roof has remnants of wood shakes and there are many holes. The chimney is gone. The soffits are closed. The building measures 20 feet north to south and 32 feet east to west.

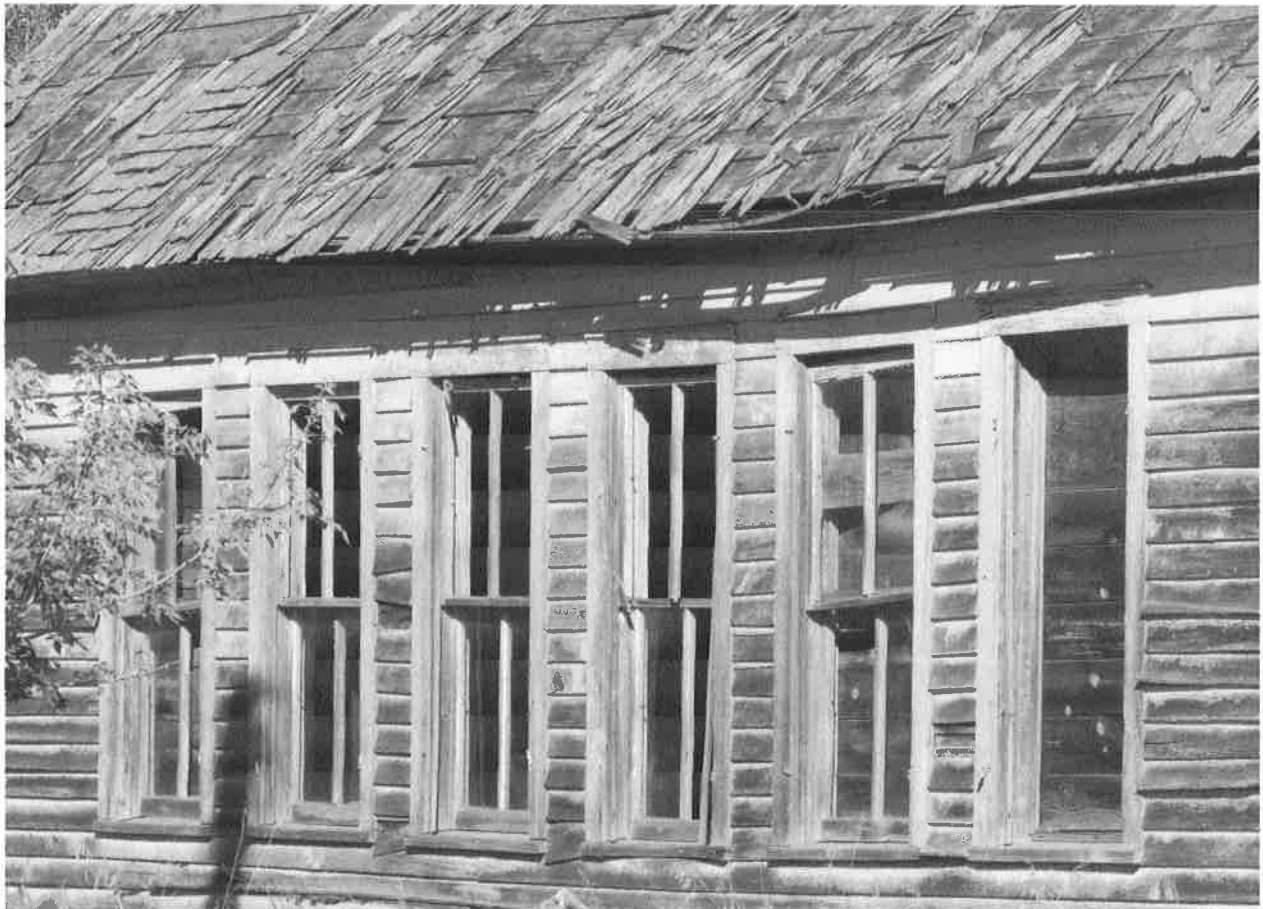
South Side

The siding begins with a rake board under the eaves at the peak ends of the school. The remainder of the siding is 6 inch wood lap with 6 inch wood corner trim. 6 double hung, 2 over 2, windows run along the south side with one more similar window to the right of the entry door in the coat room. There is some glass in the windows. There is a four panel wood entry door on the west side. Immediately inside the school are three more 4 panel wood doors, one to the left leads into a fuel room with an exterior fuel door on the north wall, another leads into the coat room and a third gives entry into the school room. Another door was added on the east side of the school. The interior of the entry walls are finished with beadboard. The school room walls are lathe and plaster. The ceiling inside the school has only lathe remaining, all the plaster has fallen away. There is wainscot on all walls inside the school. Blackboards are on all four walls with wall space between windows having small blackboards. The floor is tongue and groove hard wood. There was electricity present in the school.
