NDCRS ARCHITECTURAL SITE FORM PAGE 1

Field Code North Olga Township School Site Name _____

Project Title & Supervisor:
Country Schoolhouse Project

**NDCRS ARCHITECTURAL SITE FORM
PAGE 3—Feature Data**Field Code North Olga Township SchoolSITS# 32 CV**Complete a Page 3 for each feature.****1. Feature Description, Integrity, Eligibility:**

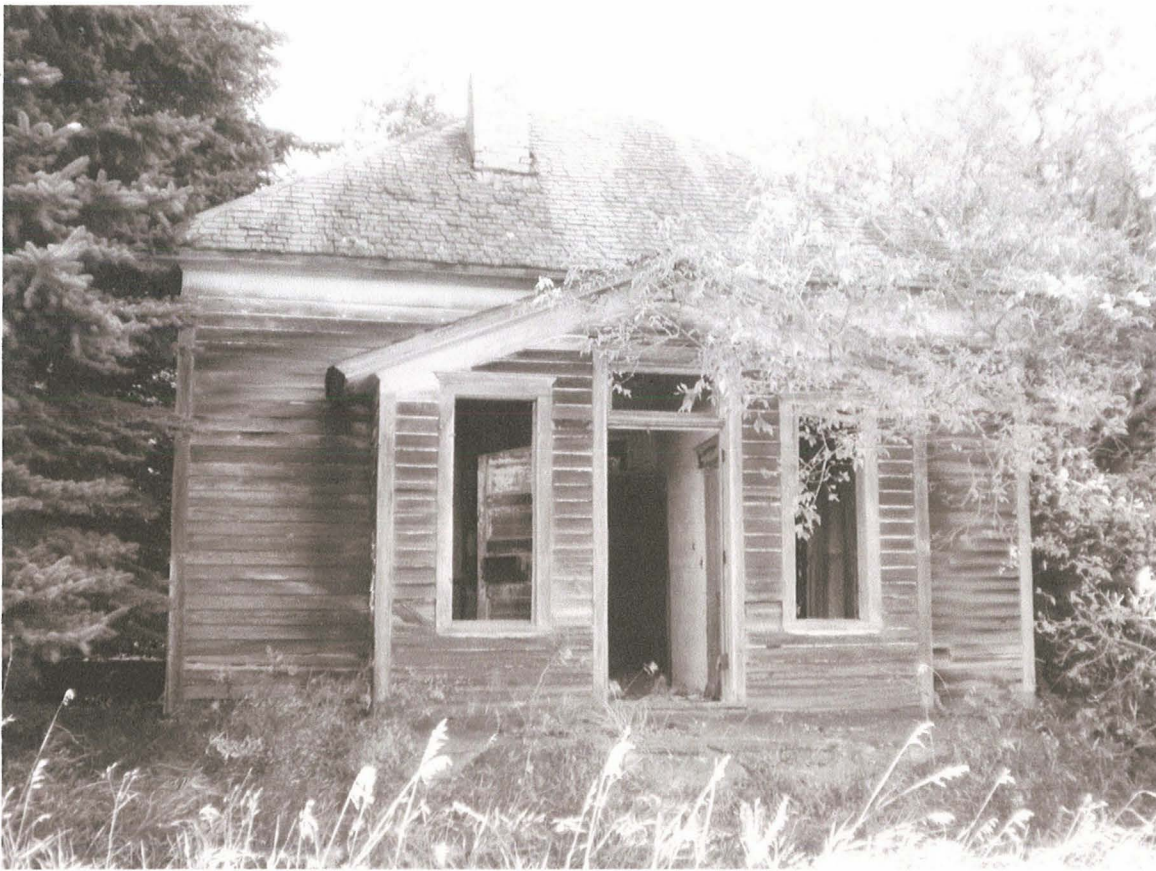
South Side

The feature is a one room prairie school on a concrete foundation. The hip roof of the main body and the gable roof of the entry have wood shakes with metal capping. A crumbling yellow brick chimney is on the south slope of the roof. The soffits are closed.

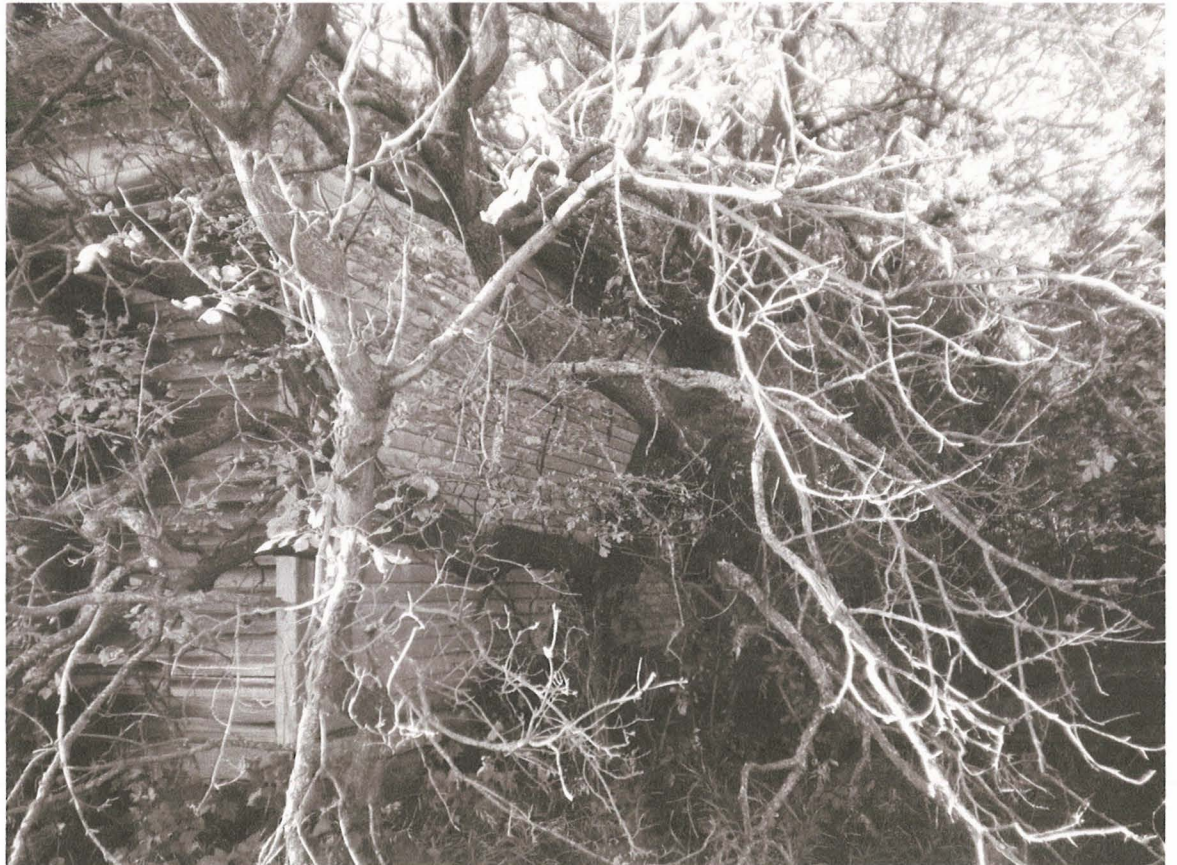
East Side

(Many trees)

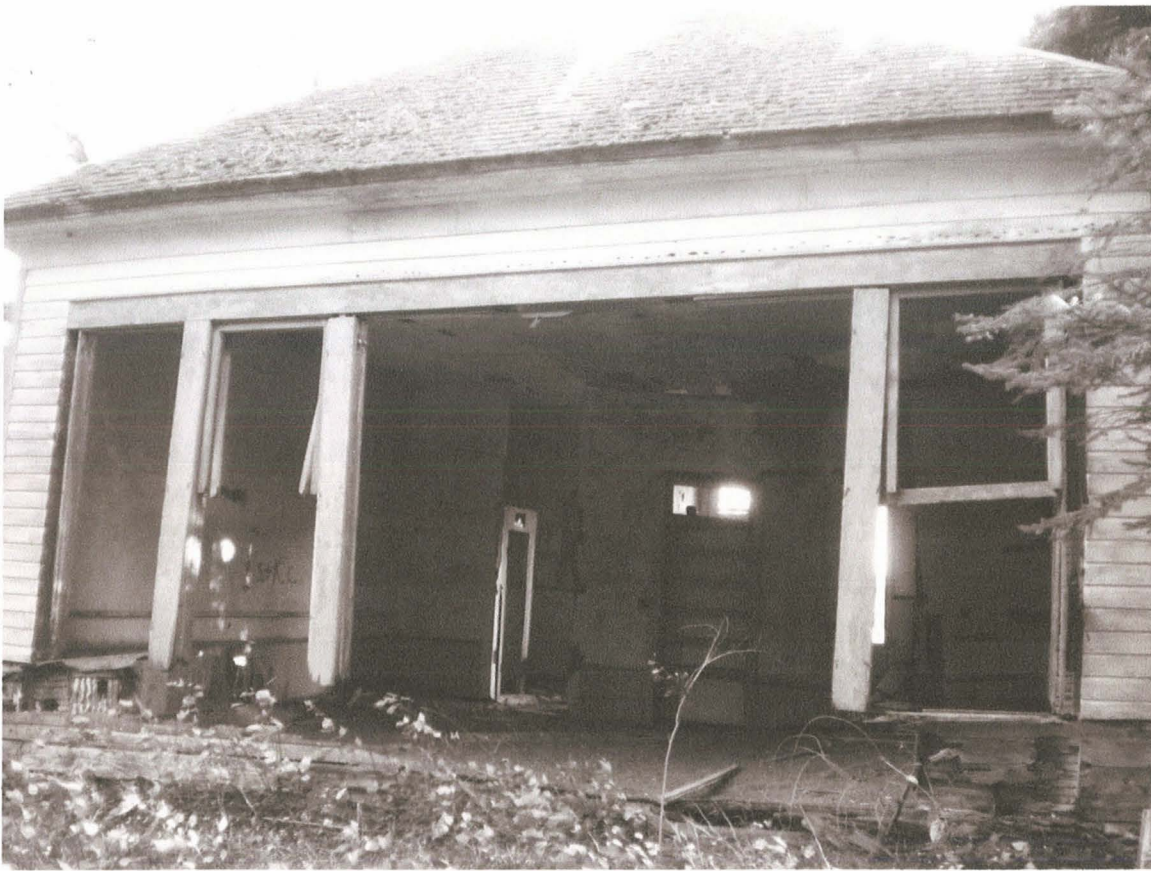
North Side

There is a wide trim board under the soffits on all side of the school. The remaining siding is 6 inch wood lap with 6 inch wood corner trim. On the west side there are two double hung windows with some framing and no glass. The north side is nearly gone, the lower wall is completely gone and some of the supports between windows are left hanging, there is a bit of framing in one opening and wide open spaces. Two window openings are either side of the entry door, these windows and interior door openings have decorative cornices. The entry door is missing. There is a transom opening above the entry door. A concrete porch leads to that entry. Entry walls are a mixture of lathe and plaster and beadboard and beadboard wainscot. One 5 panel wood door leads into one of the coatrooms. Entry into the school room is through doors from the coatrooms. Directly in the middle of the coatroom doors is a built in bookcase and there is a transom above the bookcase. The floor is tongue and groove hardwood. The interior school room walls and ceiling are covered with lather and plaster and weather is wearing that away. Wainscot on all the school room walls. No blackboards remain.
