NDCRS ARCHITECTURAL SITE FORM PAGE 1

Field Code Moscow Township School Site Name

Project Title & Supervisor: Country Schoolhouse Project

**NDCRS ARCHITECTURAL SITE FORM
PAGE 3—Feature Data**Field Code Moscow Township SchoolSITS# 32 CV**Complete a Page 3 for each feature.****1. Feature Description, Integrity, Eligibility:**

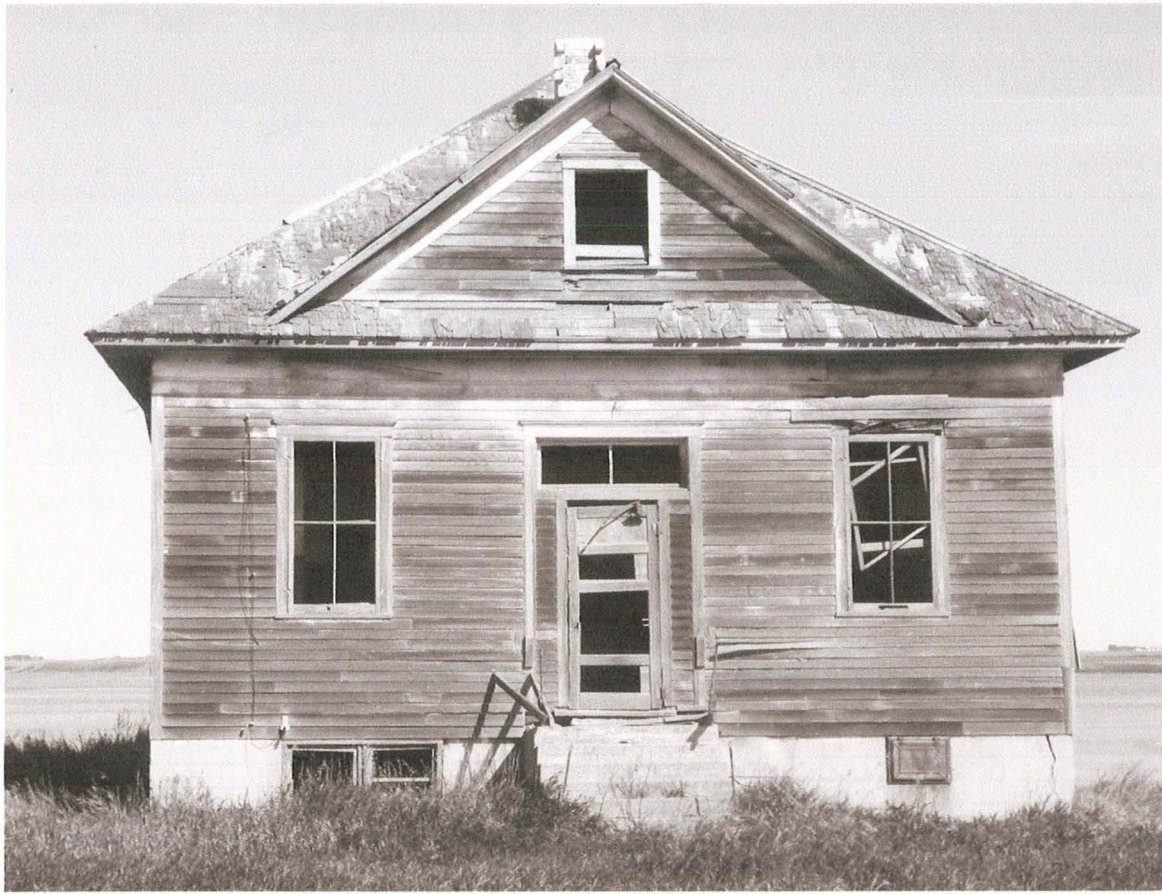
South Side

The feature is a one room prairie school on a basement of concrete blocks. There are few wood shakes remaining on the hip roof of the school as well as the gable bumpout roof on the south slope. A yellow brick chimney has few bricks left and many of the fallen ones are still on the roof in the valley made by the bumpout. Bits of metal capping can be seen on some of the hips. The soffits are closed with beadboard. The building measures 36 feet by 36 feet.
