NDCRS ARCHITECTURAL SITE FORM PAGE 1

Field Code Hay Township School Site Name

Project Title & Supervisor: Country Schoolhouse Project

Hay Township School

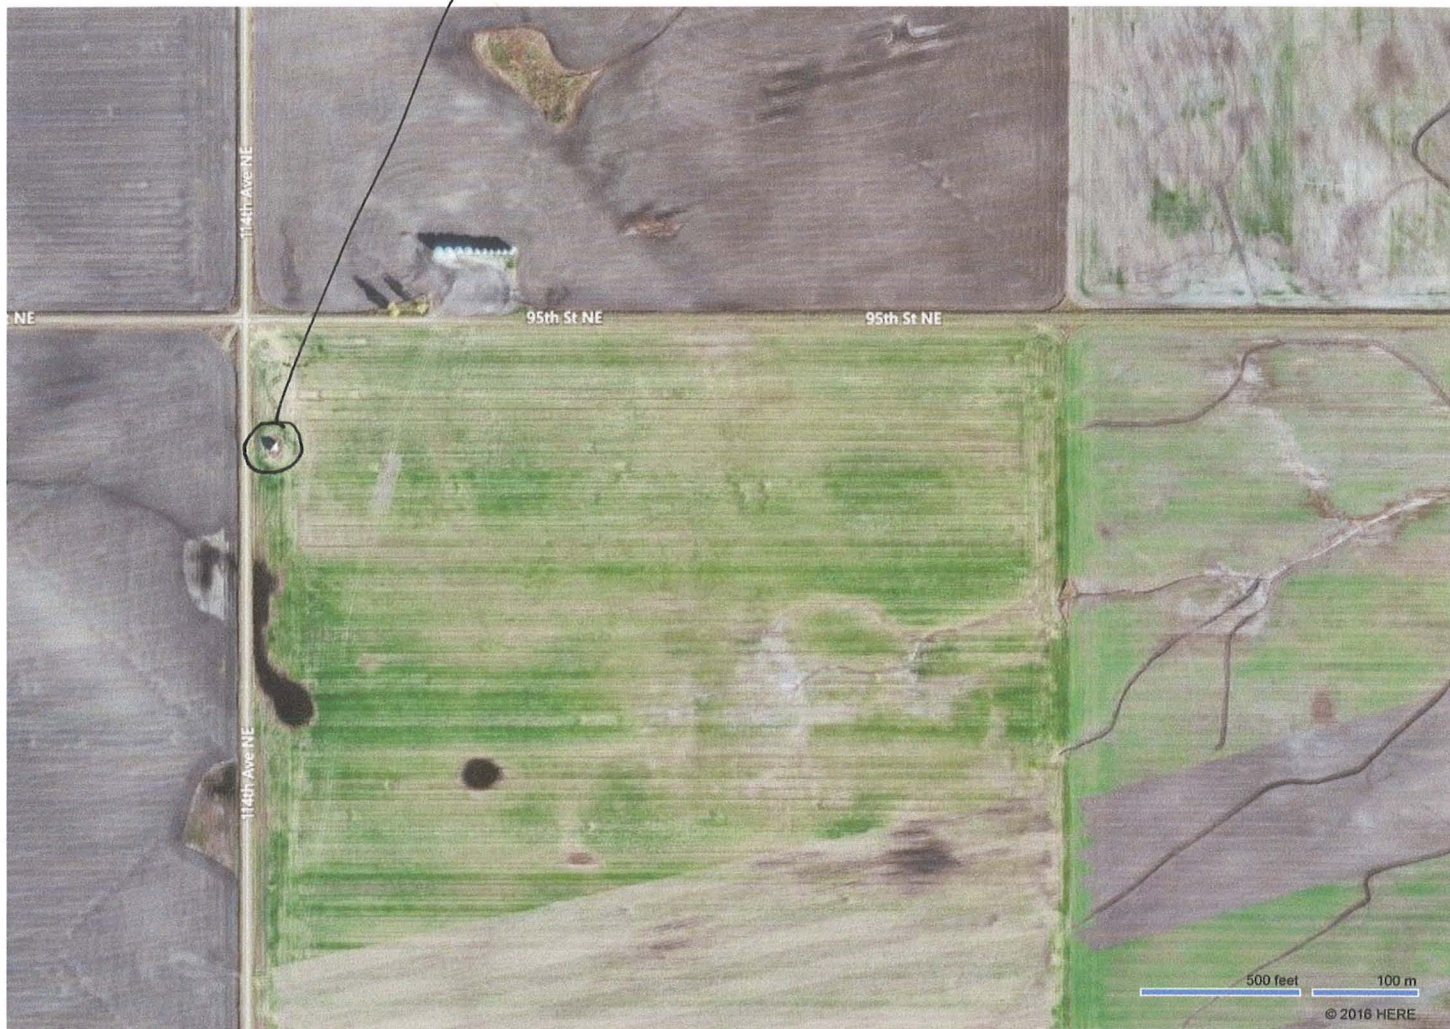
The feature is a one room prairie school on a concrete foundation. The hip roof and small gable bumpout on the south roof slope are covered with wood shakes with metal capping and finials. The soffits are closed. The chimney was located on the gable roofed bumpout and has fallen into the school. The building measures 24 feet north to south and 28 feet east to west.
