NDCRS ARCHITECTURAL SITE FORM

Field Code East Alma Township School Site Name _____

Country Schoolhouse Project

NDCRS ARCHITECTURAL SITE FORM
PAGE 3—Feature DataField Code East Alma Township SchoolSITS# 32 CV**Complete a Page 3 for each feature.****1. Feature Description, Integrity, Eligibility:**

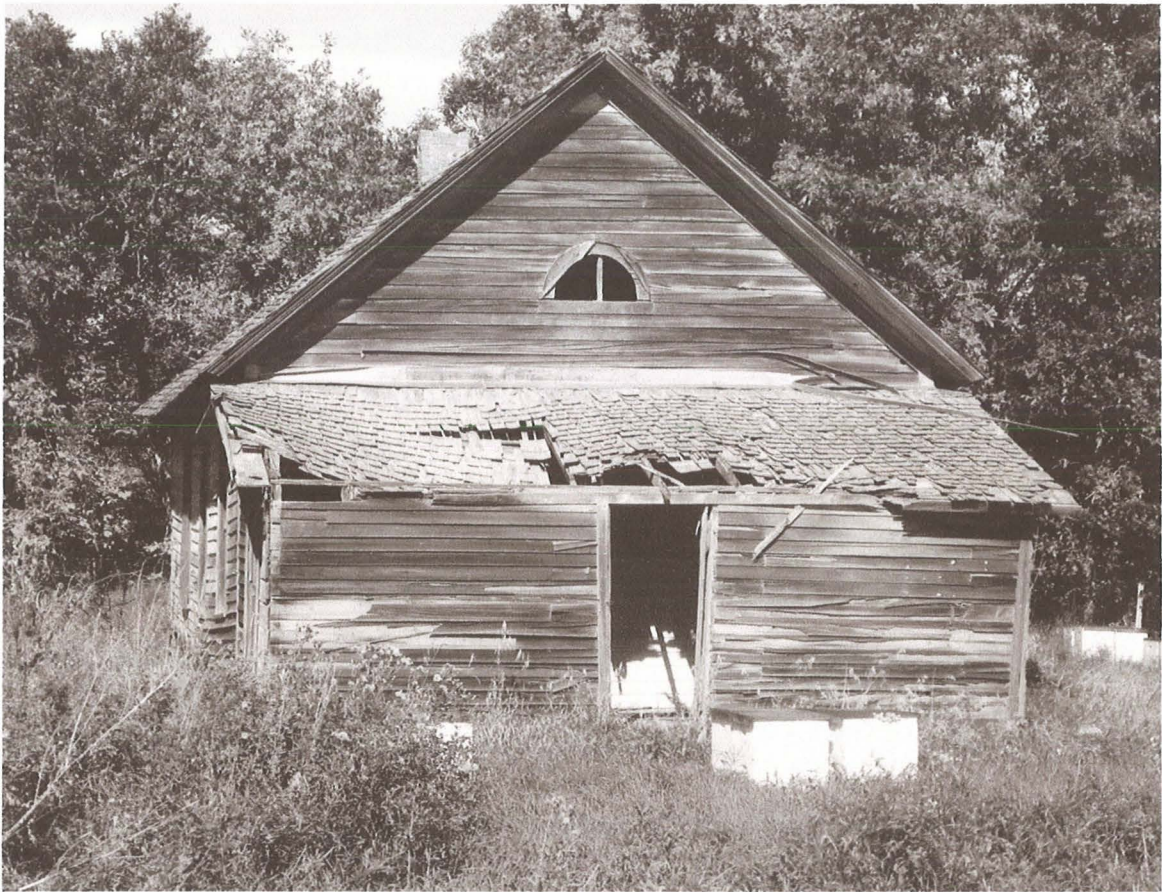
South Side

There is a wide trim board under the peak of the roof at the south end. The remainder of the siding is 6 inch lap with much of that falling away from the under planking. Corner trim is also falling away. There is a door opening on the south side of the entry, a window opening on the west side and a halfmoon window opening on the south wall of the school room above the entry. There are three double hung, two over two, windows on both the east and west walls of the school with some framing and no glass. Because of bee hives in the yard we did not see the interior.
