# NDCRS ARCHITECTURAL SITE FORM PAGE 1

SITS# 32 CV 157

Field Code Montrose Township School Site Name \_\_\_\_\_

Project Title & Supervisor:  
Country Schoolhouse Project

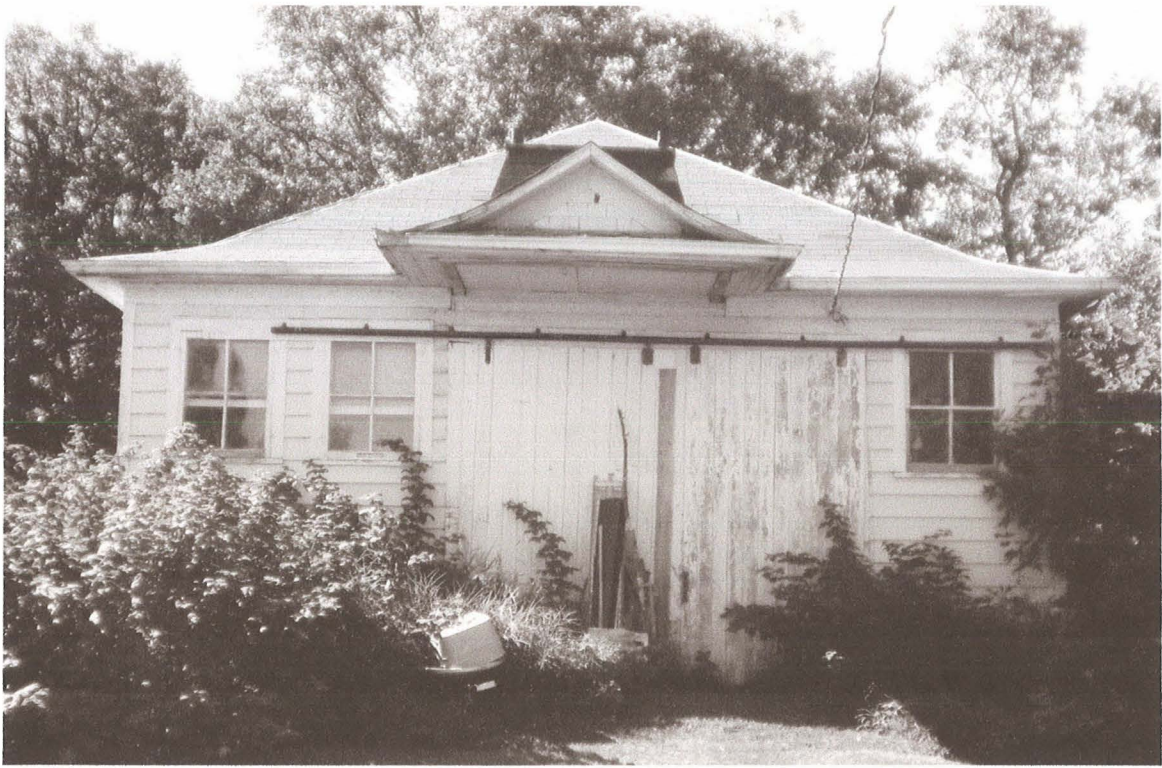
East Side

The siding is 6 inch wood lap on the north and west sides and 10 inch wide composite siding on the east and south walls. The east wall has two four pane windows near the south side and one near the north side and in the middle there is a large sliding door, installed to give access for vehicles. Another 4 pane window is near the west side of the south wall. A 5 panel wood door is located at the southeast corner of the south wall, covered with siding. Decorative cornices top interior windows and door. There are four large, four over four, double hung windows on the west wall with all glass intact. The interior walls and ceiling are lather and plaster. There was a blackboard on the entire north wall but it has been removed. The floor is tongue and groove hardwood. Light fixtures suggest electricity.

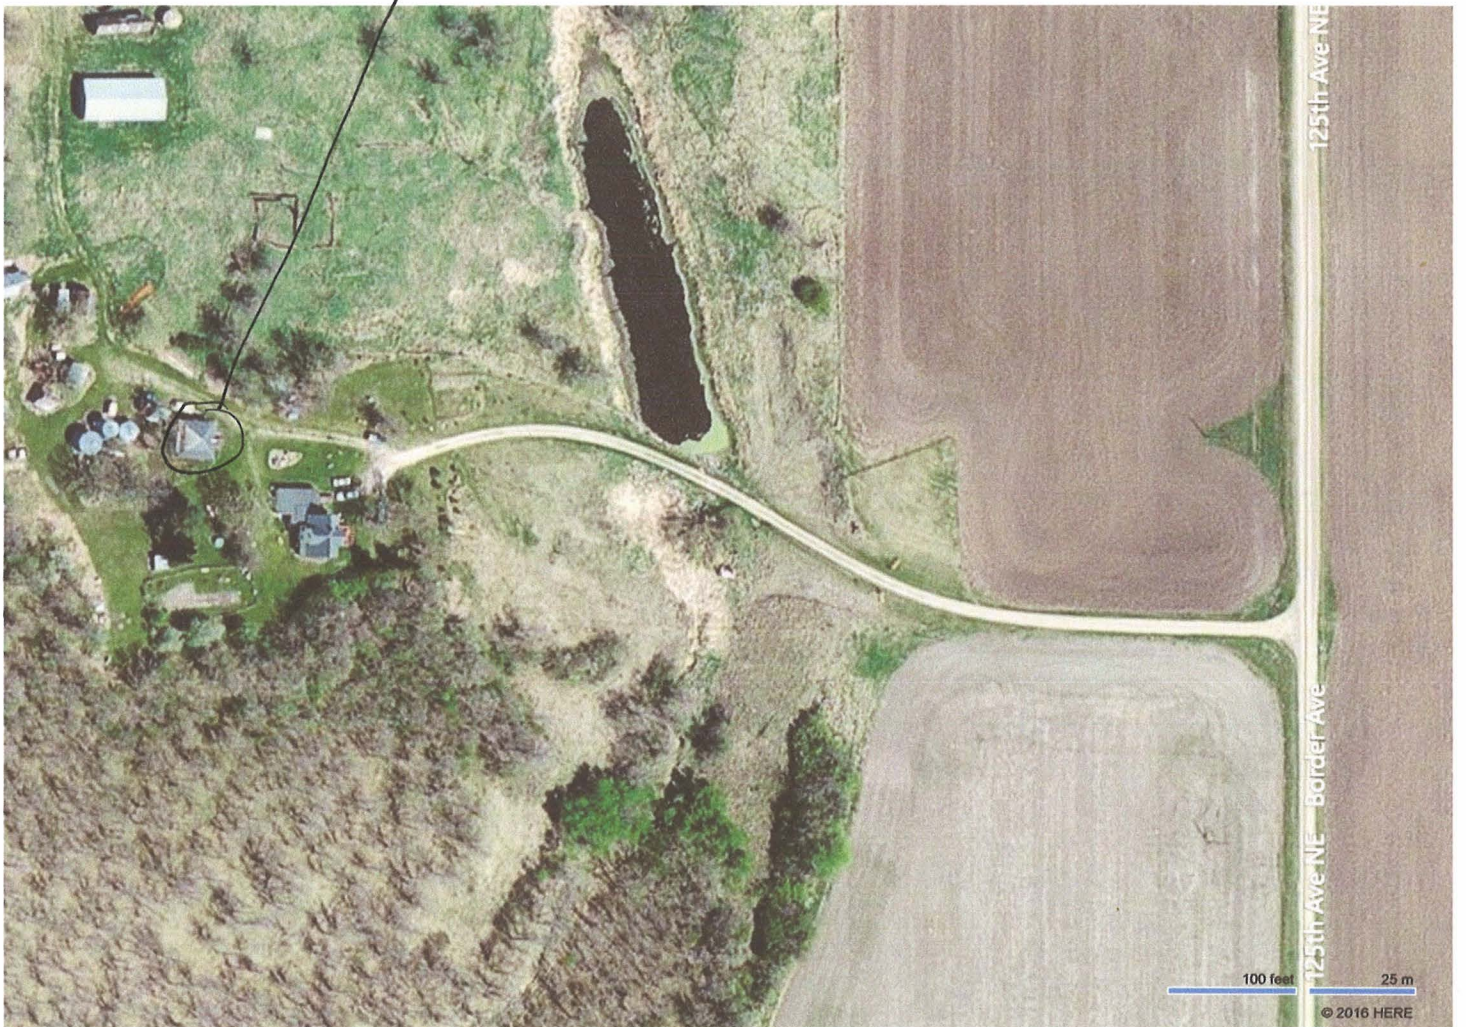
Feature

The feature is a one room prairie school on a concrete foundation. It was moved to this location from about a mile north. The school is used for storage and shop today. The hip roof is covered with asphalt shingles with eaves troughs all sides. There is a gable porch roof on the east side and the remains of a bell tower. The building measures 24 feet north to south and 28 feet east to west.
