# NDCRS ARCHITECTURAL SITE FORM PAGE 1

Field Code Fairville Township School #2 Site Name Fairville Township School #2

Country Schoolhouse Project

**Architectural Feature # 1**

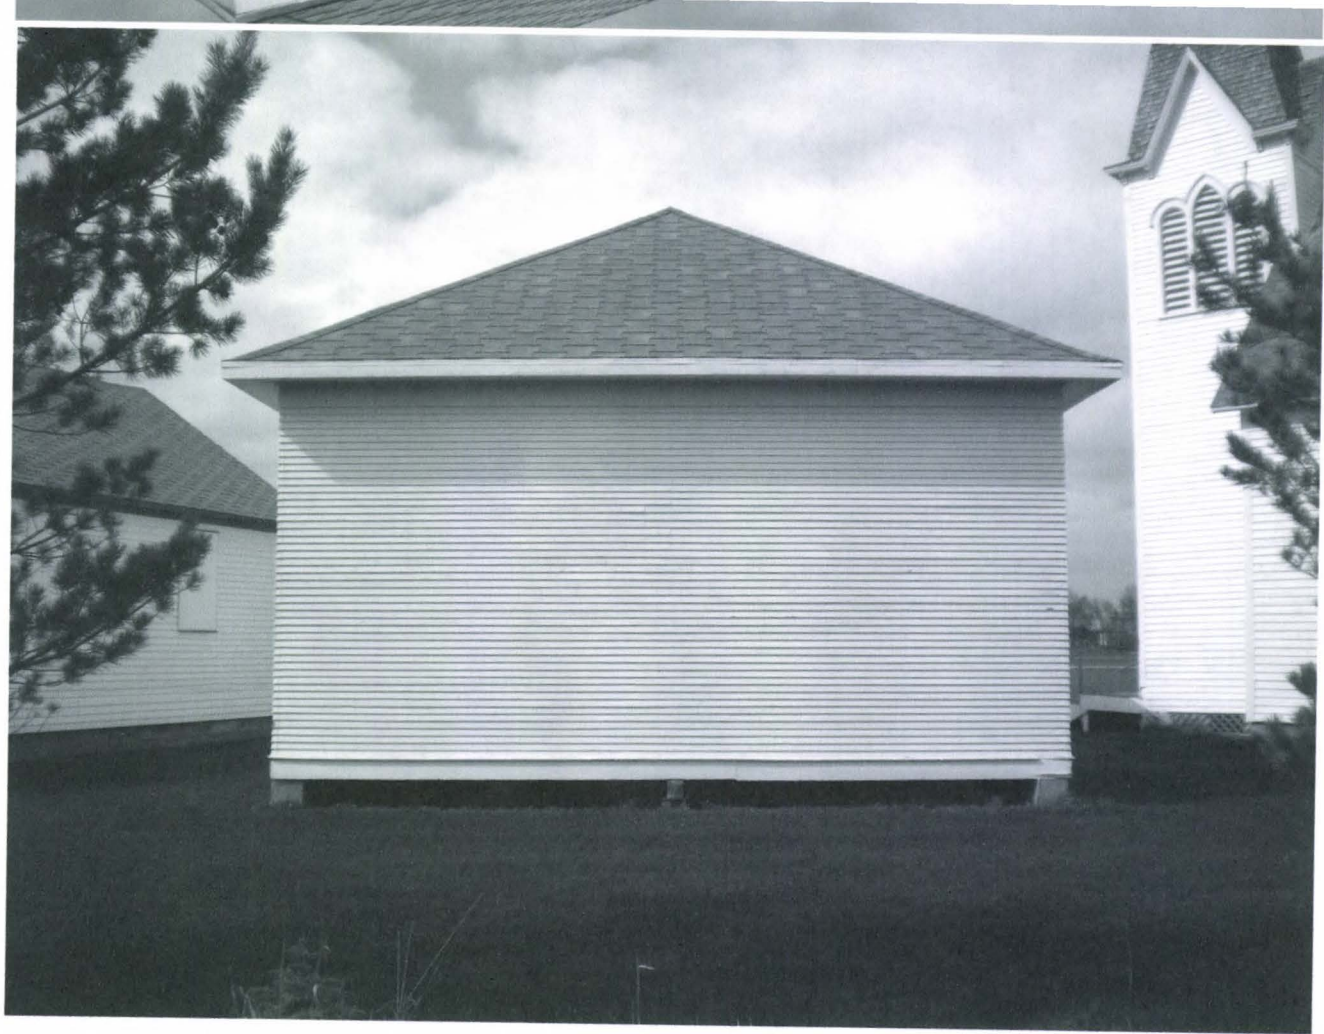
Fairville Township School # 2 South Side May 2010 Kathy Wilner

This school was moved its present location in 1993 where it was set on concrete foundation along the east and west sides with a large wood post running the length of the building at the middle. The school has wood lapping on the walls and asphalt shingles on the roof. The underside of the overhang I see 4 inch, grooved pieces of wood, set side by side. There is a trim board running along the underside of the roofing. The windows are usually covered but an event at the threshing grounds was reason to uncover them. There are two fixed panes of glass on the east and west sides of the entry, they are located behind doors either side that used to lead to the basement. Two more smaller windows are found either side of the entry. There is a small roof overhang above the wood steps. On the school roof at the front of the school is a small addition that perhaps was a bell tower.

The school closed in 1962. The building is in very good shape and appears well cared for.
