NDCRS ARCHITECTURAL FORM
PAGE 1

Site Name Grandfield Twsp School #3

Reconnaissance Survey

Grandfield Township School #3

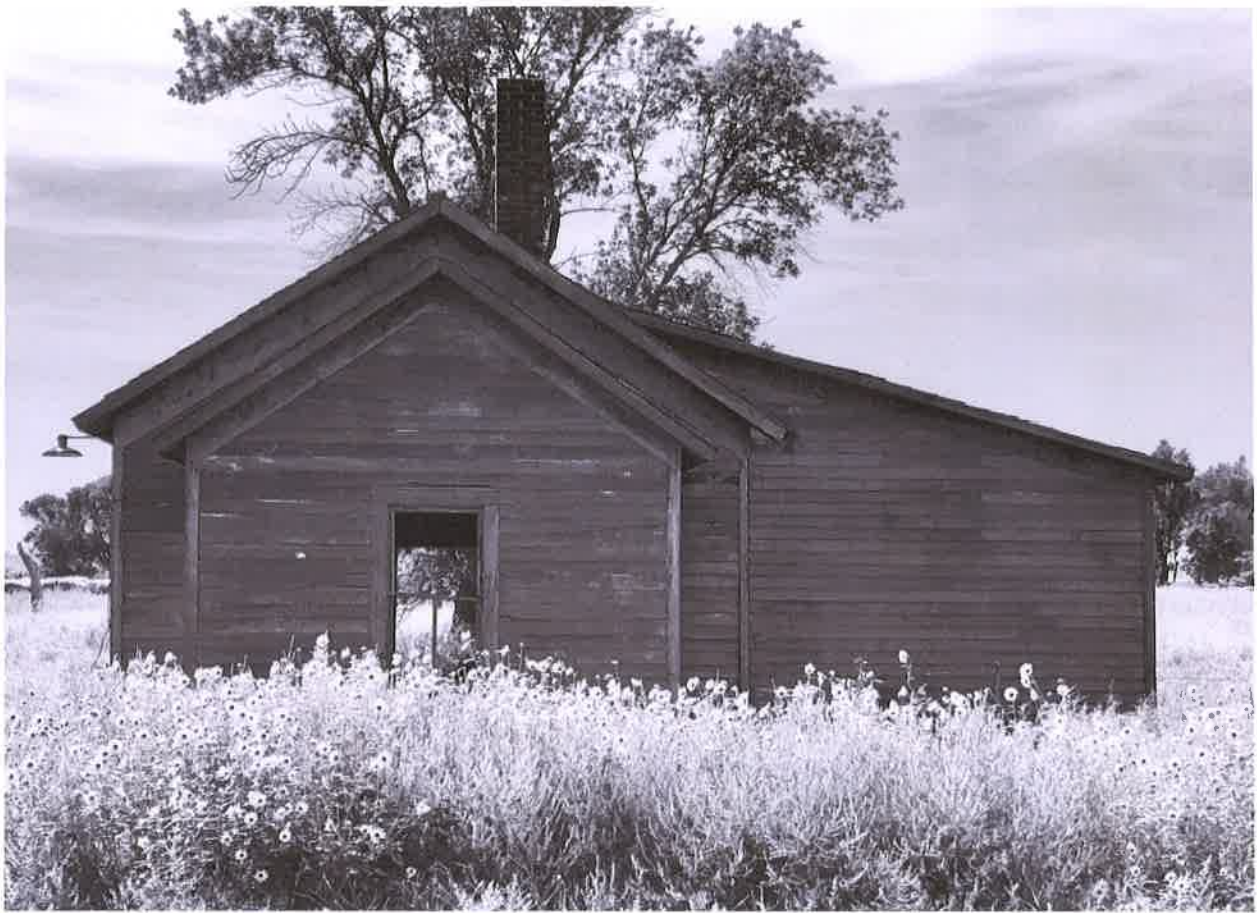
North Side

The feature is a one room prairie school on a poured concrete foundation. The gable roof of the school and entry and the shed roof of the west addition are covered with failing wood shakes. The gable roof has metal capping with finials. There is a red brick chimney located at the west slope near north end of the school roof. The eaves are open.

The siding begins under the eaves with a rake board at the peaked ends of the school as well as along the walls of the west addition. The remainder of the siding is 6 inch wood lap with 6 inch wood corner trim. An entry is located at the north end of the school. The walls and ceiling of the entry are finished with beadboard. A concrete platform and step lead to the door opening on the east side of the entry. All the doors are gone. A double hung window opening faces north and has no glass. There is a similar window opening located on the west wall of the addition. The east side has three pairs of double hung, two over two, windows with some glass present. The windows are covered from the inside. The south wall has a large opening, it looks like it was cut to allow entry for equipment. There is no door. The interior walls were finished with lathe and plaster and much of the plaster is gone. The ceiling was finished with wallboard and most of that has fallen in. A blackboard is located on the west half of the south wall. The floor is tongue and groove hardwood and is broken in many places. A light fixture near the entry and light fixtures inside the school are indicative of electricity present at some point.
