NDCRS ARCHITECTURAL FORM

Field Code Elzas Township School

Site Name Elzas Township School

NDCRS ARCHITECTURAL FORM**PAGE 3 – Feature Data****Field Code** Elzas Township School**SITS#** 32 **EM** 1052**Complete one Page 3 for each architectural feature at the site.****1. Feature Description, Integrity, Eligibility:**

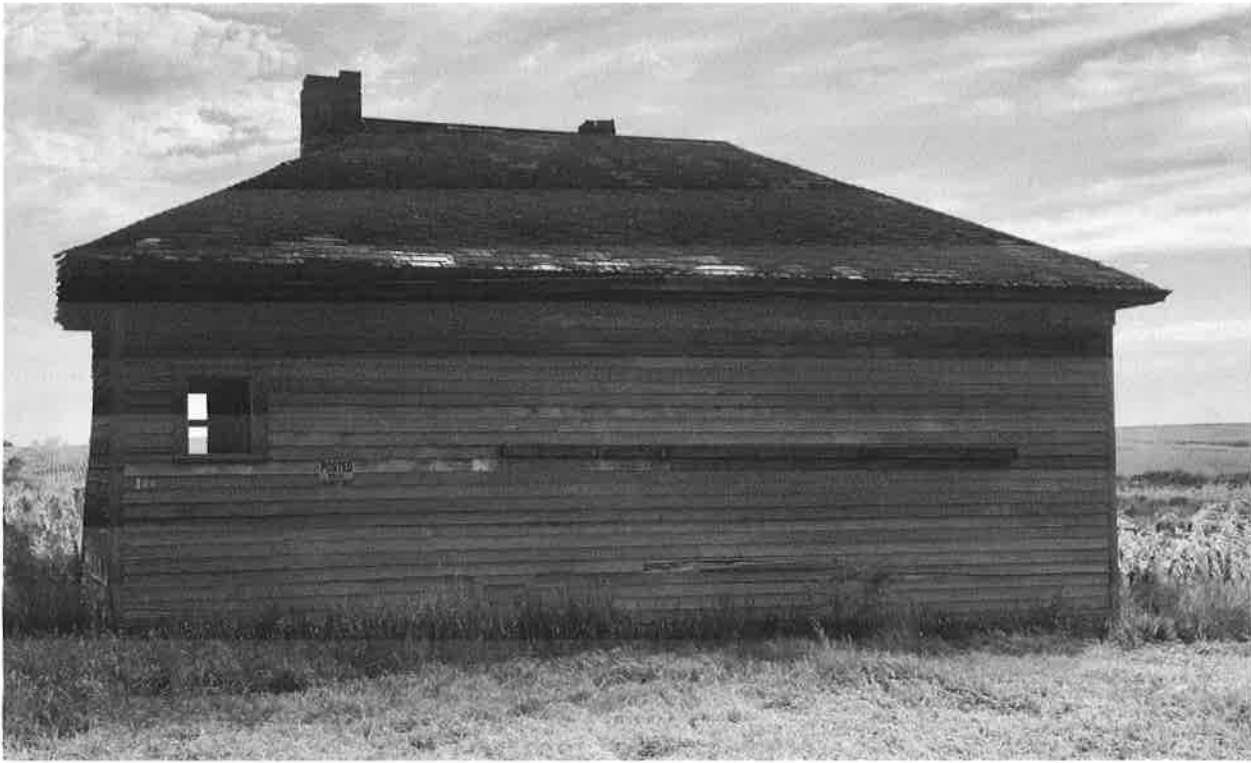
North Side

The feature is a one room prairie school on a poured concrete foundation. The hip roof is partially covered with failing asphalt shingles with metal capping. There is a large, red brick chimney at the peak on the east slope of the roof. Another square opening is at the peak in the middle of the school. I believe that was for getting grain into the building. The soffits are closed.

A rake board begins the siding under the eaves on all four sides. The rest of the siding is 6 inch wood lap and 4 inch corner trim with a waterboard at the bottom. The entry door on the east side is missing. Inside the entry there are door openings to the left and right, leading into coatrooms. Another door opening leads into the school proper. There are two double hung window openings with some framing and not glass near the east side of the school on both the north and south sides that are located in the coatrooms. A bank of 8 windows run along the entire south wall of the school room. Double hung openings have some framing, no glass and are boarded up from the inside as the building was used for a granary. The floor is tongue and groove hardwood. The walls and ceiling are finished with lathe and plaster.
