NDCRS ARCHITECTURAL FORM
PAGE 1

Field Code Baumgartner School

Site Name Baumgartner School

Country School House Project
Kathy Wilner
366 43rd Ave SE
Bowdon ND 58418

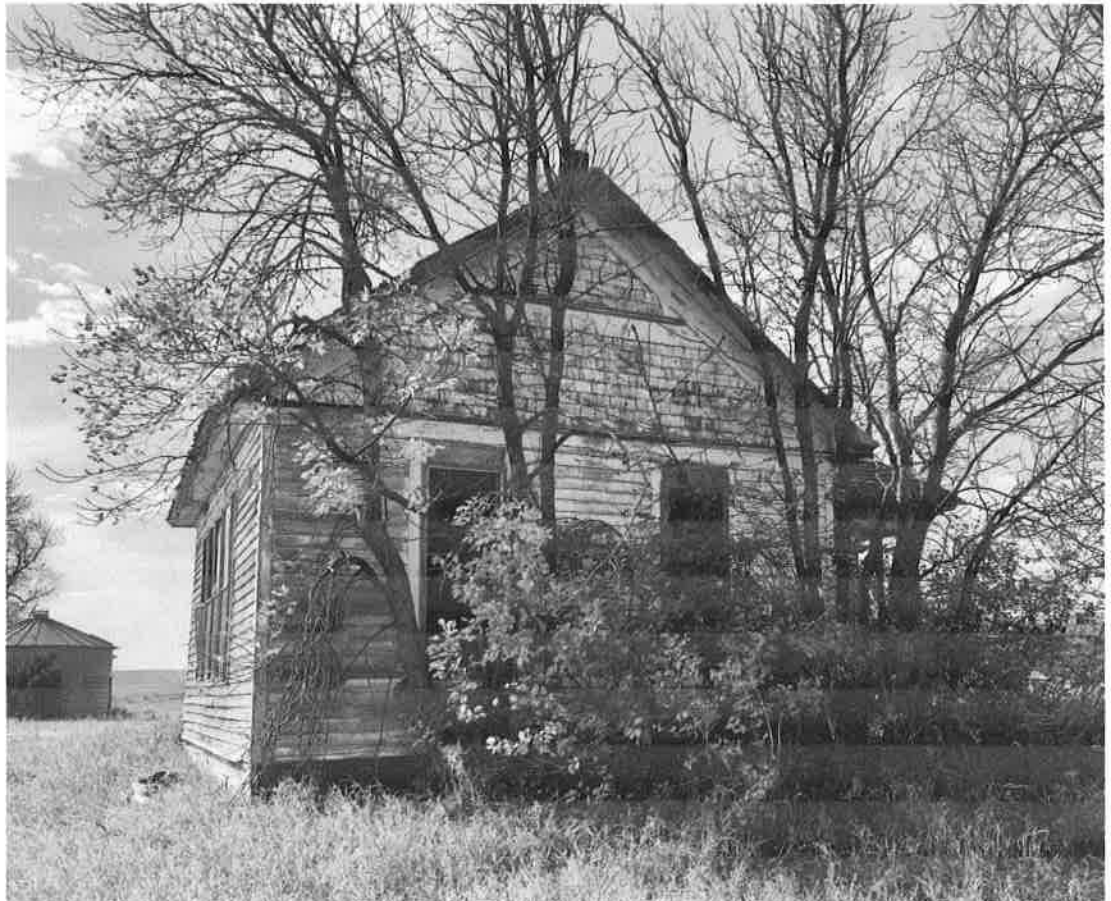
North Side

The siding begins with a rake board under the eaves at the peak end of the school as well as all side of the entry. Most of the rest of the siding is wood lap with 4 inch wood corner trim. On the north end of the school, above the windows, the siding is wood shakes. This was obviously the front of the school as the entry is also facing north. There are four double hung windows on the east side, some with screens. Two more double hung windows are on the north side. The entry has one small fixed pane window facing south and another facing west. There is an overhead door on the south side. The interior walls and angled ceiling are finished with wallborad. There is a picture rail on some of the walls. The floor of the building is tongue and groove hardwood. On the west wall of the school there is a book case to the right of the door coming from the entry. To the north of the door there is a blackboard. Another small blackboard is located on the east wall near the overhead door. The entry is on the west side of the school with a 5 panel wood door for access. There is an overhanging roof supported by a corner post for the wood porch. Light fixtures indicate electricity was present at some point.
