# NDCRS ARCHITECTURAL SITE FORM PAGE 1

### NDCRS ARCHITECTURAL SITE FORM PAGE 3—Feature Data

Field Code Pleasant View Twsp School

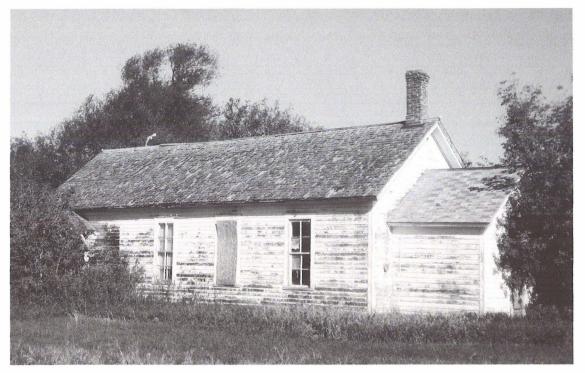
South Side

The feature is a one room prairie school on a concrete basement. The gable roof of the entry is covered with asphalt shingles and the main body of the school is covered with wood shakes, many missing. There is a large red brick chimney at the peak at the east end. The soffits are closed. The building measures 36 feet west to east and 18 feet north to south. The entry is 10 by 12. There is a small porch roof, supported by brackets, over a second door at the southwest corner. This part of roof also has wood shakes.

There is a wide trim board under the soffits at the peak ends of the school. The siding is 6 inch wood lap with 6 inch corner trim. Concrete steps lead to both doors. The south 5 panel wood is locked as is the door at the southwest corner. On the north side of the school there are three, four over four, large windows with two more smaller ones further to the west. Three more similar windows are on the south side, all have intact glass. One of the south windows is covered. There is a single covered window on the west side. The interior walls and ceiling are wallboard. No wainscot or blackboards. The building is used for storage and is full.
