NDCRS AR		L SITE FORM		
	PAGE 1	SITS# 32	GV	343
SITE IDENTIFICATION				
Field Code Burkey School	Site Name	Buckey Scho	0	
Map Quad_ <u><i>Golva_</i></u> Map Quad		······································	annahisen parking ang ang ang ang ang ang ang ang ang a	
LTL TWP137 R105 LTL TWP R LTL TWP R LTL TWP R	SEC QQQ SEC QQQ	8 QQ 8 QQ QQ QQ QQ	Q <u>5</u> Q Q Q	
UTM5172619 UTM583223	N ZON E NAD	e <u>13N</u> 1927 NAD 1983 _]
City: Golva		Newpublication	$2 = E\frac{1}{2}$ $3 = S\frac{1}{2}$	
Street Number: 16444			$4 = W\frac{1}{2}$ $5 = NE\frac{1}{4}$	
Street Name: 49th St SW			6 = SE¼ 7 = SW¼	
Urban Legal Description:			8 = NW¼	
SITE DATA				
Total # Architectural Features:	1			
Fieldwork Date: 6/22/2016				
Reconnaissance Survey 📈	Intensive Survey			
Project Title & Supervisor: Country Schoolhouse Project				
Report Title & Author(s):				
Additional Information:				-
SHSND USE Area of Significance Ecozone Area of Significance Ecozone	Verified Si		ре _2

NDCRS ARCHITECTURAL SITE FORM PAGE 3—Feature Data

Field Code Burkey School

The feature is a one room prairie school on a poured concrete foundation. The gable roof is covered with ribbed metal sheeting. At the peak near the south end is

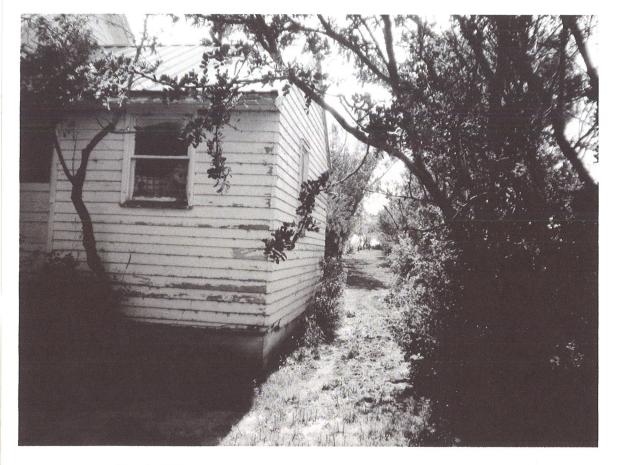
North Side

There is a wide trim board on the wall under the soffits on the peak ends. The remainder of the siding is 6 inch wood lap with 6 inch wood corner trim. The entry to the school is located at the north side, a 4 panel wood door with a window at the top leads into the entry from the east side. There is one small window to the right of the entry door and another smaller, double hung one the west wall of the entry. Yet one more small windows it on the north wall. There is a 4 panel door, at a concrete step, that gives entry on the south side. A closed in area above the door and other straight line wood cuts make we wonder what this looked like originally. The interior walls of the schoool are composite wall tiles. The ceiling has 12 inch composite tiles. The hardwood floor is covered with linoleum, failing in places. At the north end of the main room there is a stage that spans the room, side to side. A 5 panel wood door opens into the entry at the west end of the north wall. A blackboard covers the east half of the north wall. The windows in the main room are 4 sets of two double hung, two over two, windows with glass intact. Light fixtures, in and out, suggest electricity.
