NDCRS ARCHITECTURAL SITE FORM PAGE 1

Field Code Strahon School	 SITS# 32 GV

The feature is a one room prairie school on a wood foundation. It was moved to this farm site for use as a shop/garage. The gable roof of the school and the shed roof of the entry are covered with metal sheeting. The chimney is gone and the soffits are closed. There building measures 34 feet north to south and 20 feet east to west.

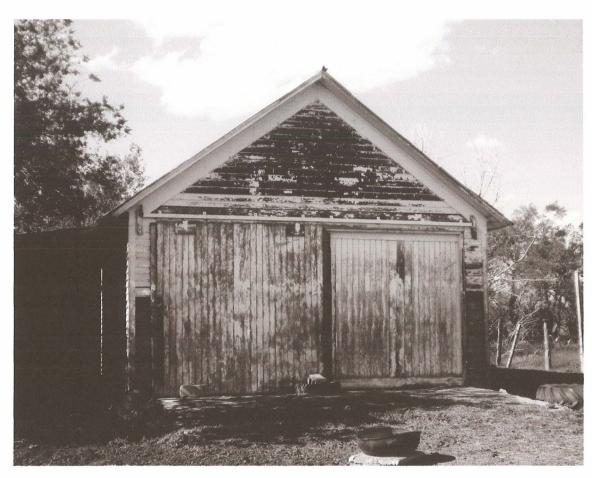
South Side

There is a wide trim board on the wall under the soffits on all the peak ends. The remainder of the siding is 6 inch wood lap with 6 inch wood corner trim. On the south wall of the buildling the wall has been opened up and a side sliding entry door was installed to give access to the interior. The north entry has a 5 panel wood door leading into what was a coat room. There is a wall to cut the entry in half. There are two doors leading from the entry into the main body of the school, both 5 panel wood doors. On the west wall of the school there are three shuttered, double hung, two over two, windows with intact glass. Three more double hung, two over two, windows are on the east wall have glass intact and are not shuttered. The walls in the building are lathe and plaster with beadboard wainscot. The ceiling is lathe and plaster with much of it falling in. The floor is hardwood. Light fixtures and wiring suggest electricity.
