NDCRS ARCHITECTURAL SITE FORM PAGE 1

Site Name Stoddard School

Project Title & Supervisor:
Country Schoolhouse Project

**NDCRS ARCHITECTURAL SITE FORM
PAGE 3—Feature Data**Field Code Stoddard SchoolSITS# 32 GV**Complete a Page 3 for each feature.****1. Feature Description, Integrity, Eligibility:**

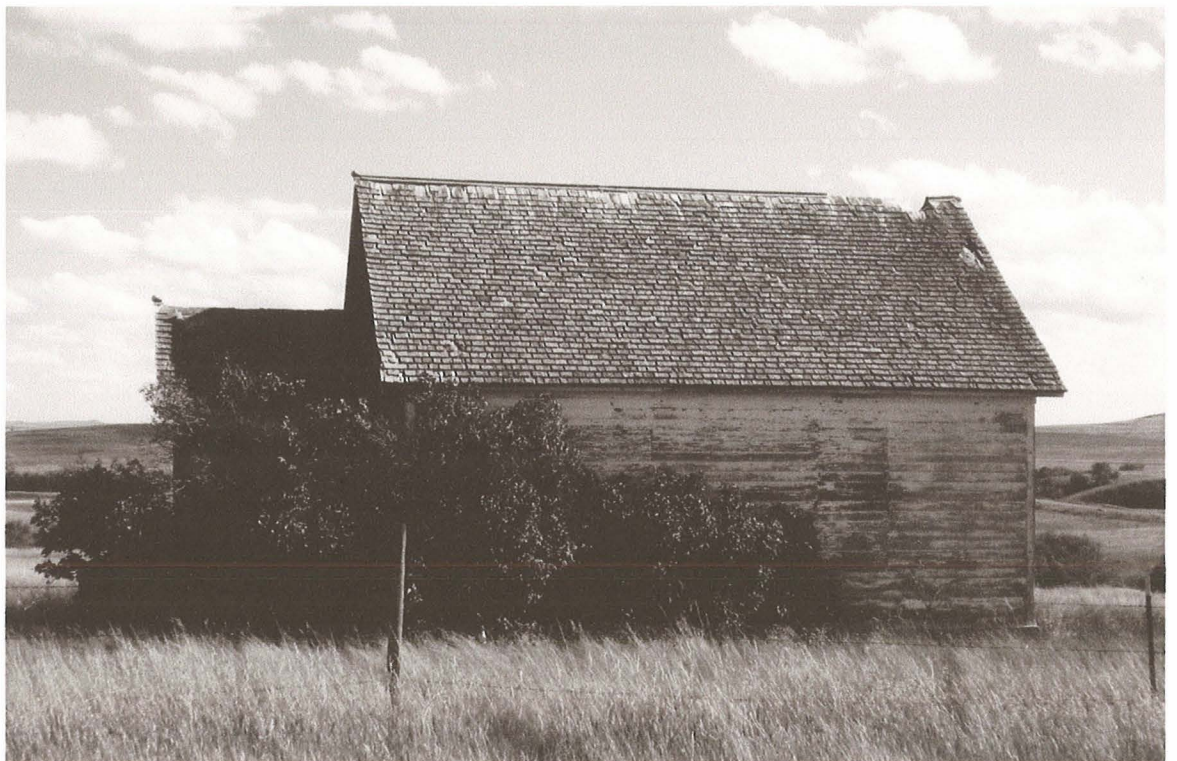
North Side

There is a wide trim board on the wall under the soffits on all the peak ends. The remainder of the siding is 6 inch wood lap with 6 inch wood corner trim. On the north wall there were two windows that have been filled in and sided over. The west wall has 4 double hung, two over two, windows that have some glass and are covered with metal sheeting. The south wall also has 4 double hung, four over four, windows that are shuttered with wood, some of that glass remains. A 5 panel wood door leads into the entry. This entry may have been added at a later date as the three entry walls are wallboard with the fourth being the school wall with original lap siding. Another 5 panel wood door leads into the main room of the school. The walls are covered with wallboard. The ceiling has wallboard that looks like tiles, attached to the lathe, beginning to fall away. The floor is tongue and groove hard wood. A bed inside the school suggests use as a house or hunting lodge. There are light fixtures on the ceiling suggesting electricity.

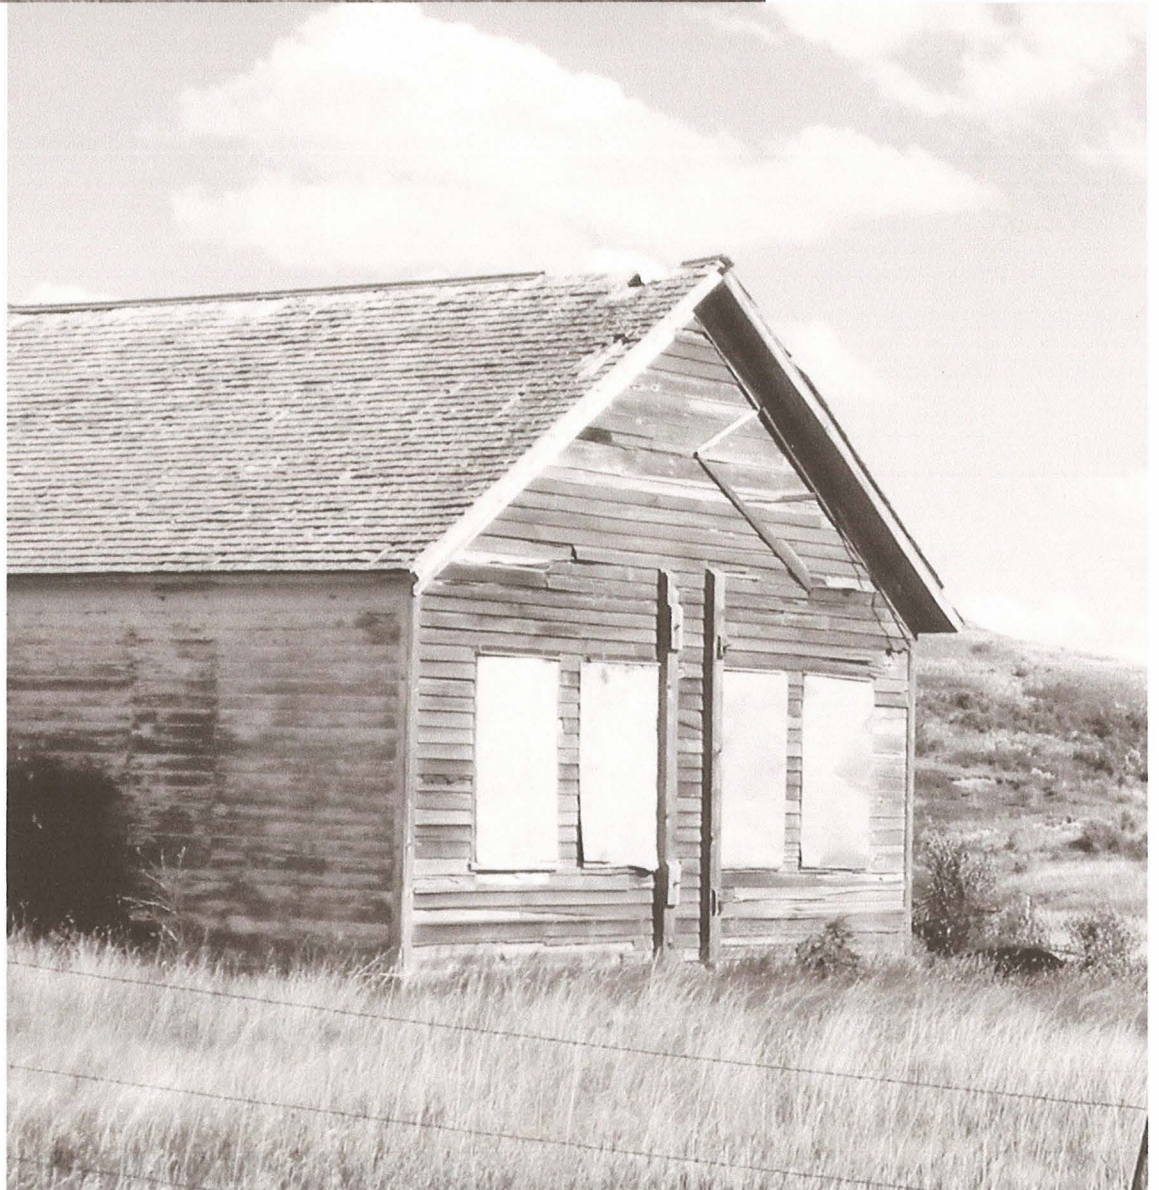
West Side

The feature is a one room prairie school on a concrete foundation. The gable roofs are covered with wood shakes with metal capping and finials. There is a hole at the west end at the peak where the chimney used to be, many of the bricks have fallen into the school. The soffits are closed. The building measures 24 feet east to west by 20 feet north to south. The entry measures 8 feet by 8 feet.
